# Structural Stability and Safety Factor Assessment

For Compliance with the EPA Coal  
Combustion Residuals (CCR) Rule  
40 CFR §257.73(d)  
40 CFR §257.73(e)

Former B.C. Cobb Power Plant  
Ponds 0-8 and Bottom Ash Pond

June 29, 2021

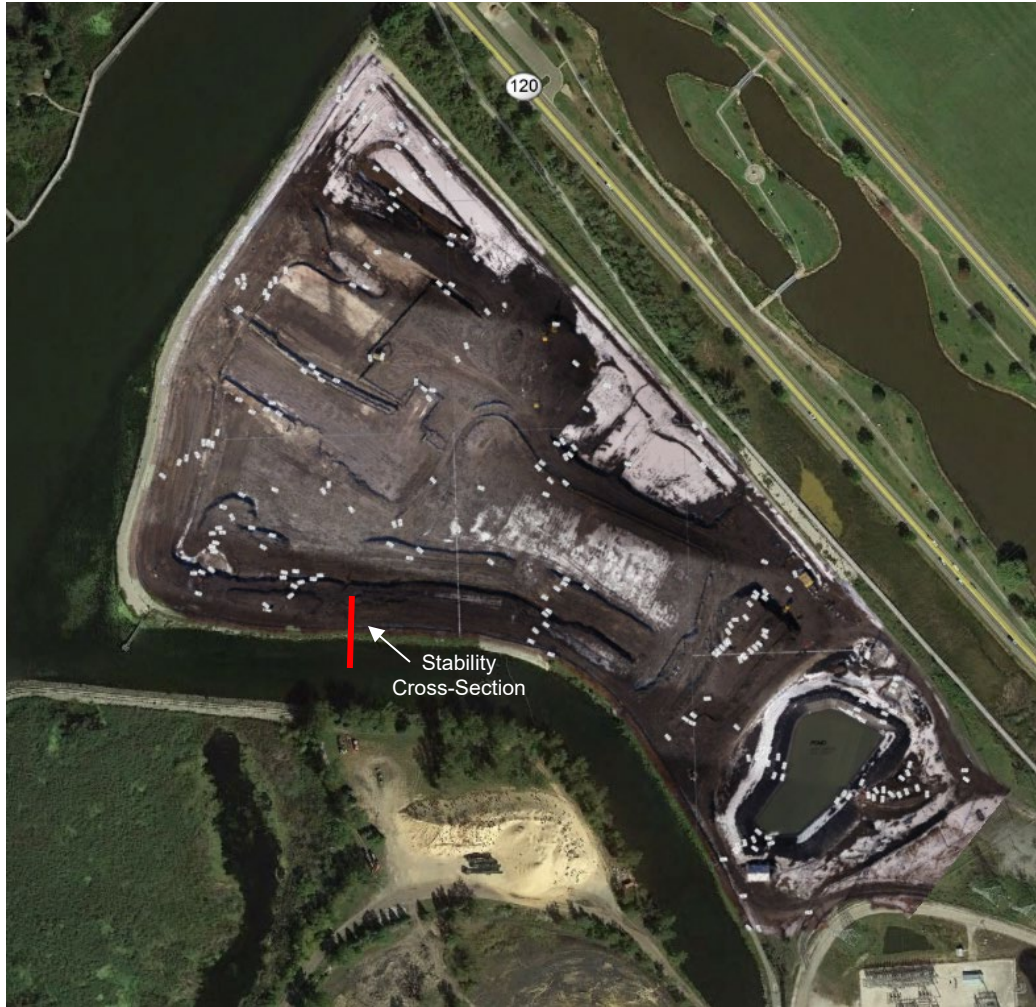
Figure 4. Location of Stability Cross-Section

- The stability cross-section chosen for the Safety Factor Assessment is located along the South Embankment. The stability location was selected due to the geometry of the slopes at this location compared to the other areas where the slopes have been bridged (i.e. material from within the impoundment has been placed adjoined to the interior slope to provide additional passive resistance to the embankment) to support slope stability (which was taken from March 2021 topographic survey provided by MERG). Due to the pond side slopes that are present in this portion of the perimeter embankment, it was deemed more critical than the other portions of the perimeter embankment alignment.

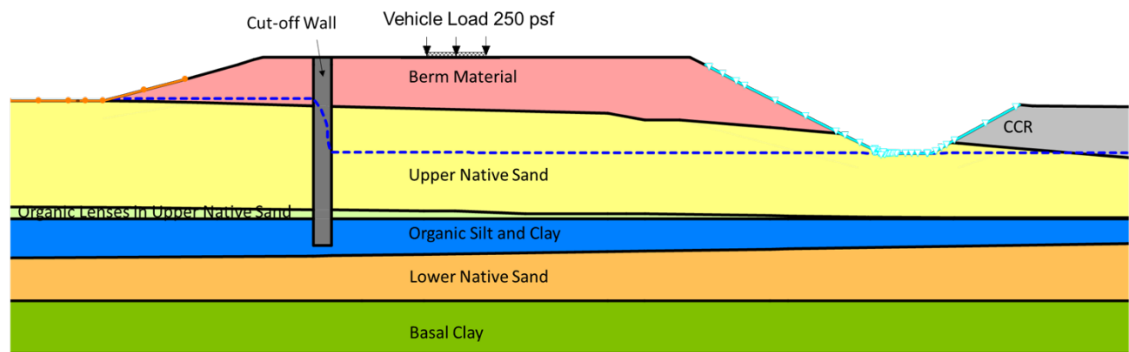
Figure 5. Stability Cross Section Geometry and Stratigraphy (phreatic surface for NWSE case)

The phreatic surface for the stability model was developed based on current water level conditions of the Discharge Channel along with the current dewatered state within the impoundment. The water from the Discharge Channel was modeled as the headwater in this case as the interior of the site is no longer impounding water. The headwater was selected to be at El. 579.4 feet, the approximate Normal Water Surface Elevation (NWSE) of the Discharge Channel (Ref. [8]). The maximum pool surcharge condition was assumed to be the Muskegon Lake 1,000-year flood at El. 585.7 feet as per Golder's B.C. Cobb Generating Facility Ponds 0-8, Inflow Design Flood Control System Plan (Ref. [9]). Consideration was given to the monitoring well MW-17001R installed in the vicinity of the selected cross-section. The monitoring well measured a phreatic surface elevation of 570.4 feet when dewatering activities were active. A steady state seepage analysis was set up with the soil-bentonite wall and seepage face boundary condition on the pond side slope. The NWSE steady state seepage analysis resulted in a phreatic surface that is at Elevation 570.4 feet on the impoundment side of the cut off wall. This agrees with the observed phreatic surface in well MW-17001R at 570.4 feet.

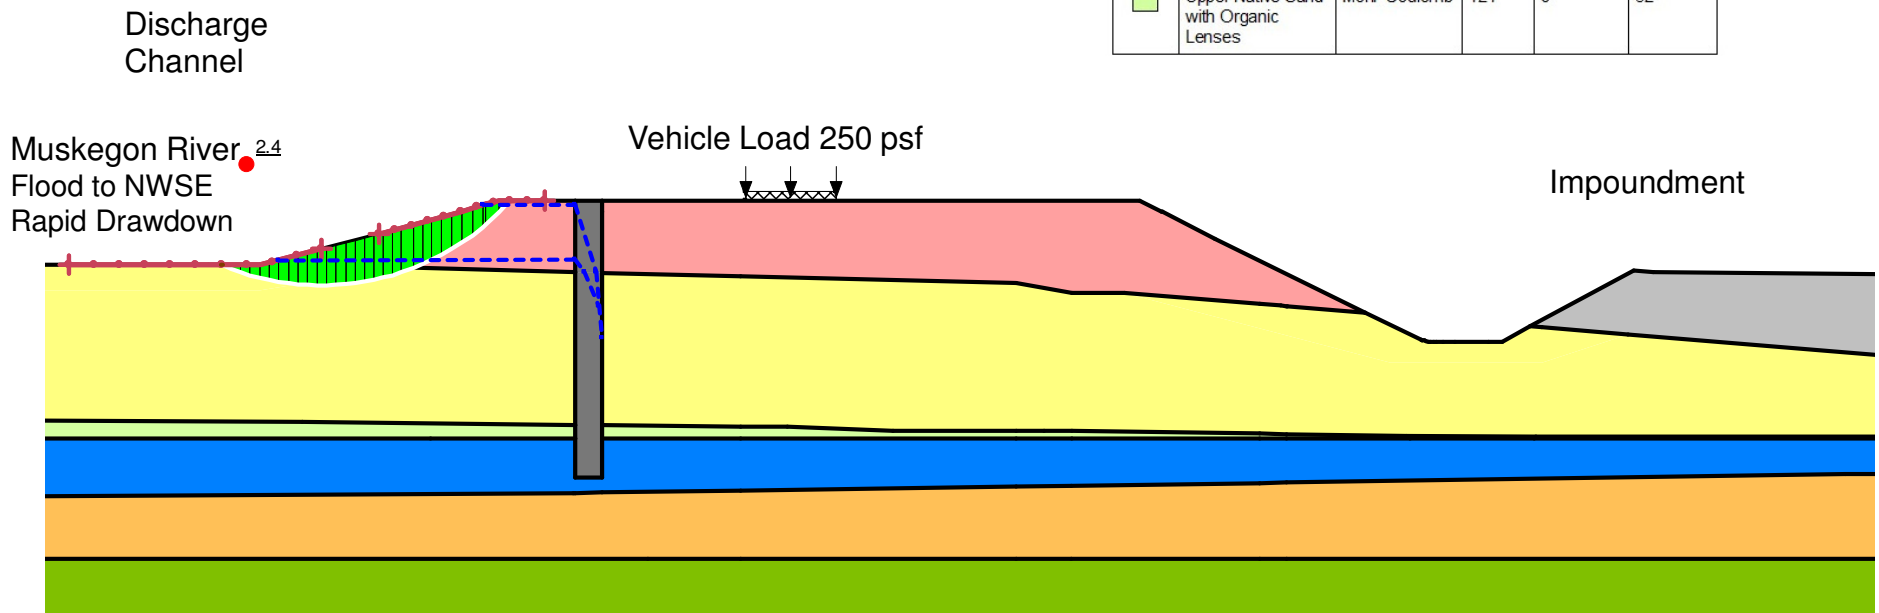
Name: B.C.Cobb Ash Pond - Critical Section  
 Description: Rapid Draw Down Analysis- Flood to Normal Water Surface  
 Method: Morgenstern-Price  
 FS: 2.4
