2022 Annual Inspection Report

For Compliance with the EPA Coal Combustion Residuals (CCR) Rule
40 CFR §257.83(b)

Former B.C. Cobb Power Plant
Ponds 0-8 and Bottom Ash Pond

May 26, 2022

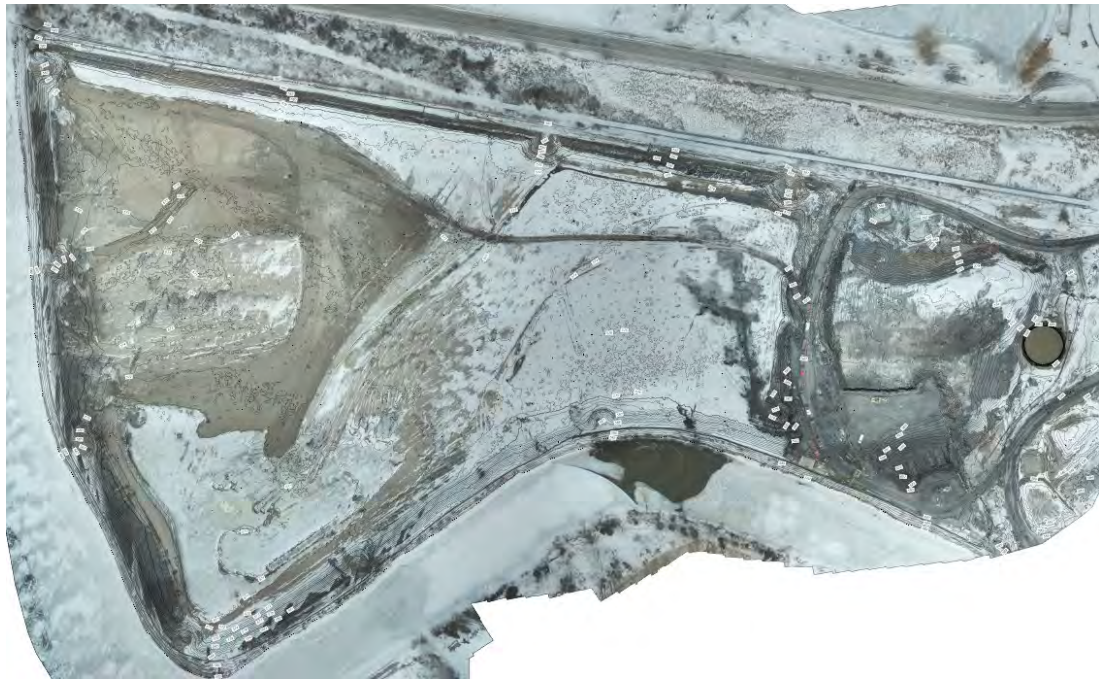
Figure 2. Aerial Image of Impoundment During Excavation

Figure 2 presents an aerial view of the CCR impoundment as of February 2022, displaying the ongoing excavation of Ponds 0-8 and the Bottom Ash Pond.

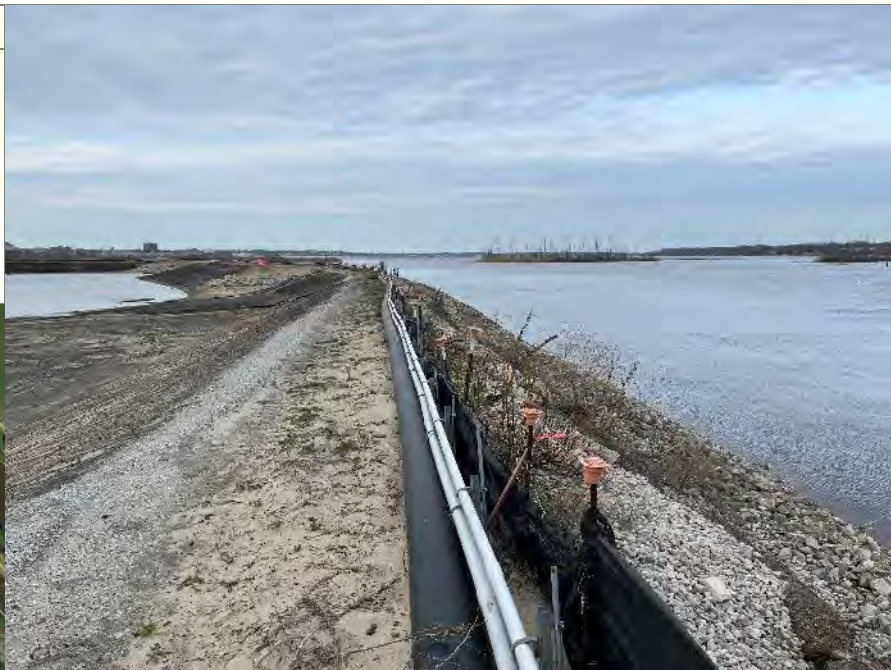
| Client Name: | Site Location: | Photographic Log |
|---|--|--|
| Photograph No. 5 | | |

- Rip-rap protects the exterior slope (Photo 5), which was in good condition.
- Some minor vegetation overgrowth was observed on the exterior slope (Photo 5).

| Client Name: | Site Location: | Photographic Log |
|---|--|--|
| Description: Exterior slope of West Embankment adjacent to Muskegon River. Note vegetation on exterior slope. | | |

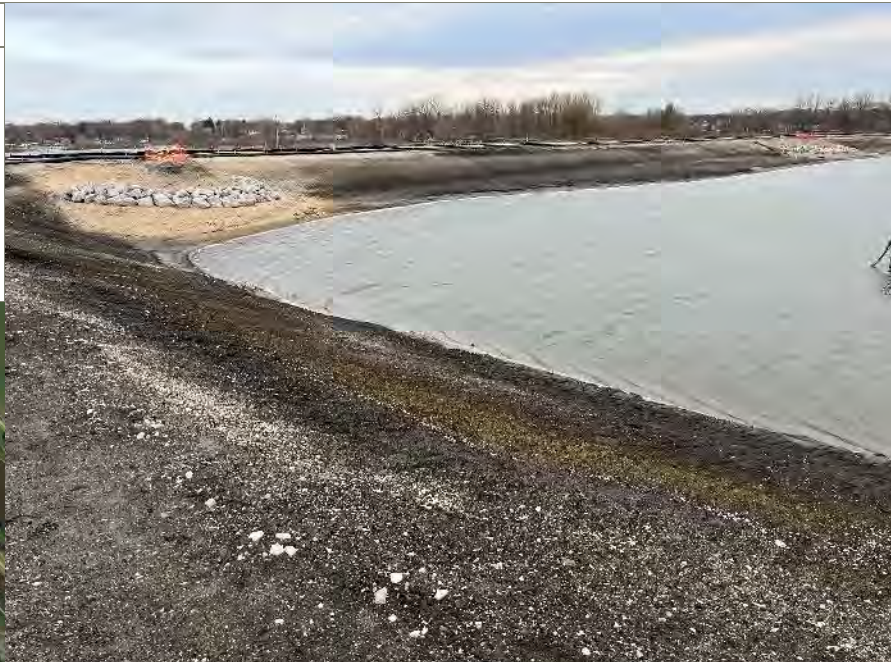
| Client Name: | Site Location: | Photographic Log |
|---|--|--|
| Photograph No. 6 | | |

| Client Name: | Site Location: | Photographic Log |
|---|--|--|
| Description: Interior slope of South Embankment adjacent to Discharge Channel. Note rip-rap protected monitoring wells at top left of photo. | | |

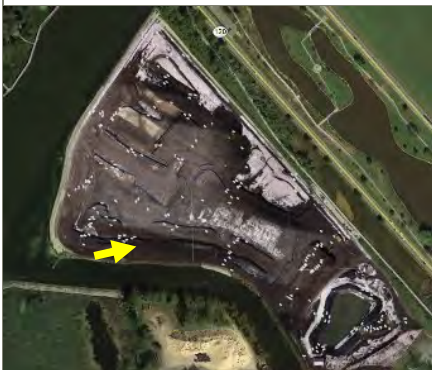
| Client Name: | Site Location: | Photographic Log |
|--|--|--|
| Photograph No. 8 | | |

- The crest of the embankment consisted of a gravelly/soil surface (Photos 7 and 8). Minor rutting of the crest was observed but the crest was in good condition.
- Rip-rap protects the exterior slope in one area near the outflow (Photo 10) due to previous erosion repair, which was in good condition.
- Vegetation has become overgrown on the exterior slope (Photos 8 and 10).

| Client Name: | Site Location: | Photographic Log |
|--|--|--|
| Description: Crest of South Embankment adjacent to Discharge Channel. Note vegetation on exterior slope. | | |
