2022 Structural Stability and Safety Factor Assessment

For Compliance with the EPA Coal
Combustion Residuals (CCR) Rule
40 CFR §257.73(d)
40 CFR §257.73(e)

Former B.C. Cobb Power Plant
Ponds 0-8 and Bottom Ash Pond

August 17, 2022

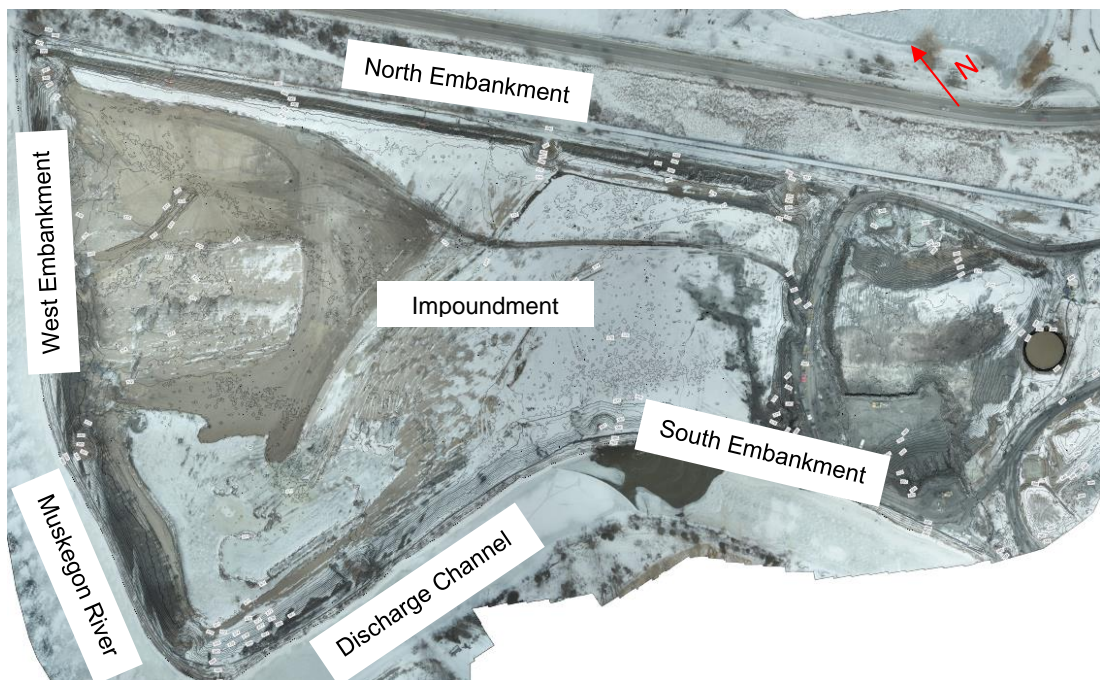
Figure 2. Aerial Image of Impoundment During Excavation

Figure 2 presents an aerial view of the CCR impoundment as of February 2022, displaying the excavated impoundments, as well as the terminology of the embankment sections used in this report.

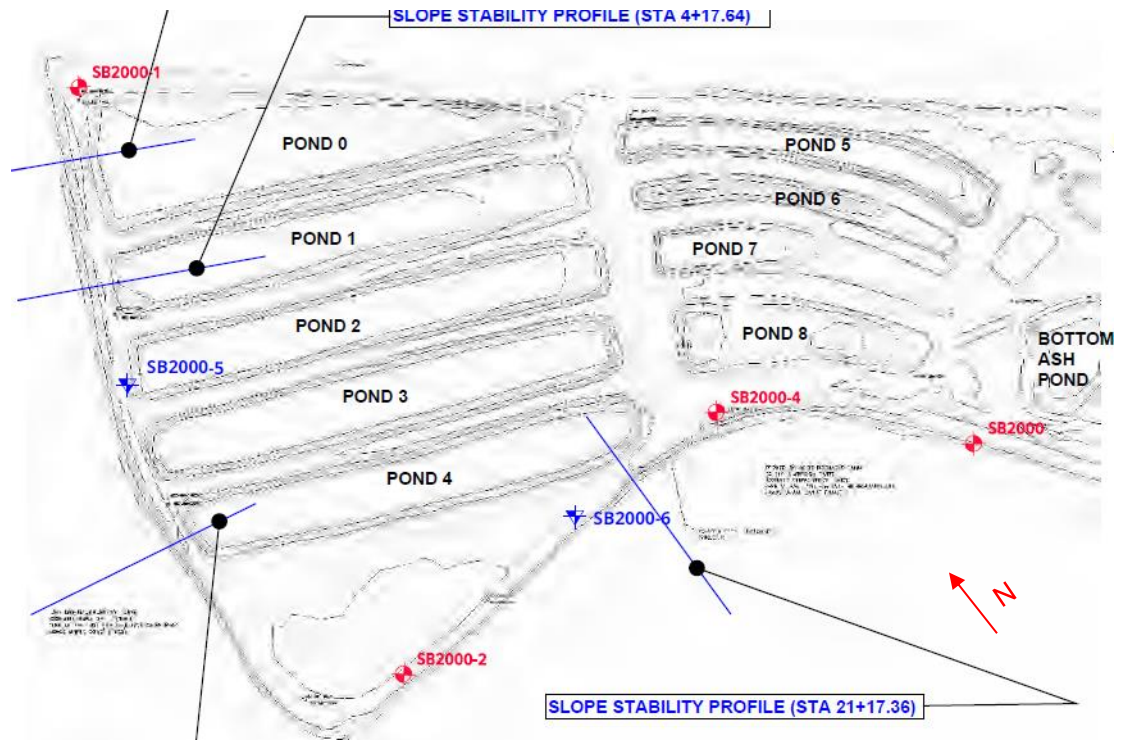
Figure 3. Approximate Boring Locations

The approximate locations of the borings performed by SME are shown on Figure 3 of SME 2020 (Ref. [19]) and also in Figure 3 below. The boring logs are provided in Attachment 1.

The recent boring logs prepared by SME 2020 indicate that the foundation of the perimeter embankments (top of the natural sands encountered in the borings) ranges from approximately El. 573 to 582 feet. The foundation material is comprised primarily by alternating layers of granular material (i.e., sand, silty sand, sandy silt) from the foundation surface to depths of approximately 25 to 33 feet (approximately El. 543 to 547 feet) below the original foundation grade where it is underlain by cohesive material consisting of silty clay and lean clay. Traces of silt and gravel, organic clay, peat, and organic matter were observed in the alternating sand and silt layers.

Field density tests performed on the granular material (Standard Penetration Test (SPT) blow counts) indicated that the granular soils ranged from very loose to dense, with blow counts ranging from 0 to 41 blows per foot. Undrained shear strengths obtained from field estimates with a hand penetrometer or torvane in the cohesive soils ranged from 400 psf (soft) to 2,100 psf (stiff). Moisture contents in the cohesive soils ranged between 22 and 79 percent.

Based on subsurface investigation documentation and the history of no observed instability in the foundation materials, the foundation is demonstrating stability and competency. The assessment of abutment stability required by the CCR Final Rule is not applicable, as the embankments are continuous.

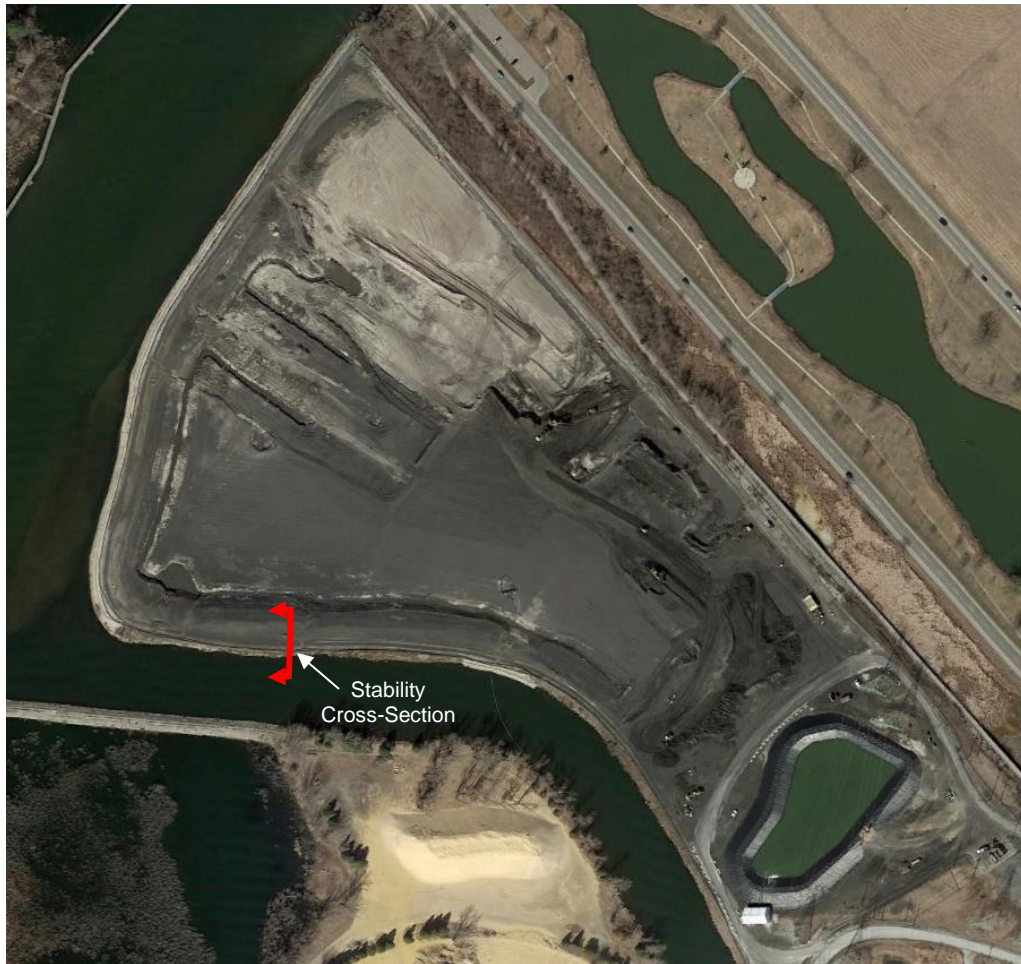
Figure 4. Location of Stability Cross-Section

One embankment section was considered critical based on geometry, described below, and located along the South Embankment as shown on Figure 4 with the section cut on Figure 5.

- The stability cross-section chosen for the Safety Factor Assessment is located along the South Embankment. This section was selected due to the geometry of the slope at this location compared to the other geometries observed from May 2022 topographic survey. Due to the pond side slopes that are present in this portion of the perimeter embankment, it was deemed more critical than the other portions of the perimeter embankment alignment.

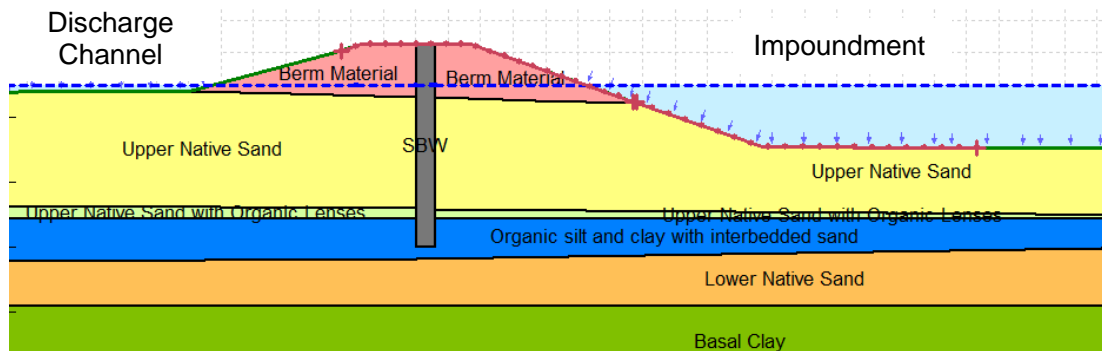
Figure 5. Stability Cross Section Geometry and Stratigraphy (phreatic surface for NWSE case)

The phreatic surface for the stability model was developed based on current water level conditions of the Discharge Channel along with the excavated impoundment refilling with water. For the maximum storage pool condition, the water in the impoundment and the Discharge Channel was modeled to be at El. 580.0 feet, the approximate Normal Water Surface Elevation (NWSE) of the Discharge Channel (Ref. [8]).

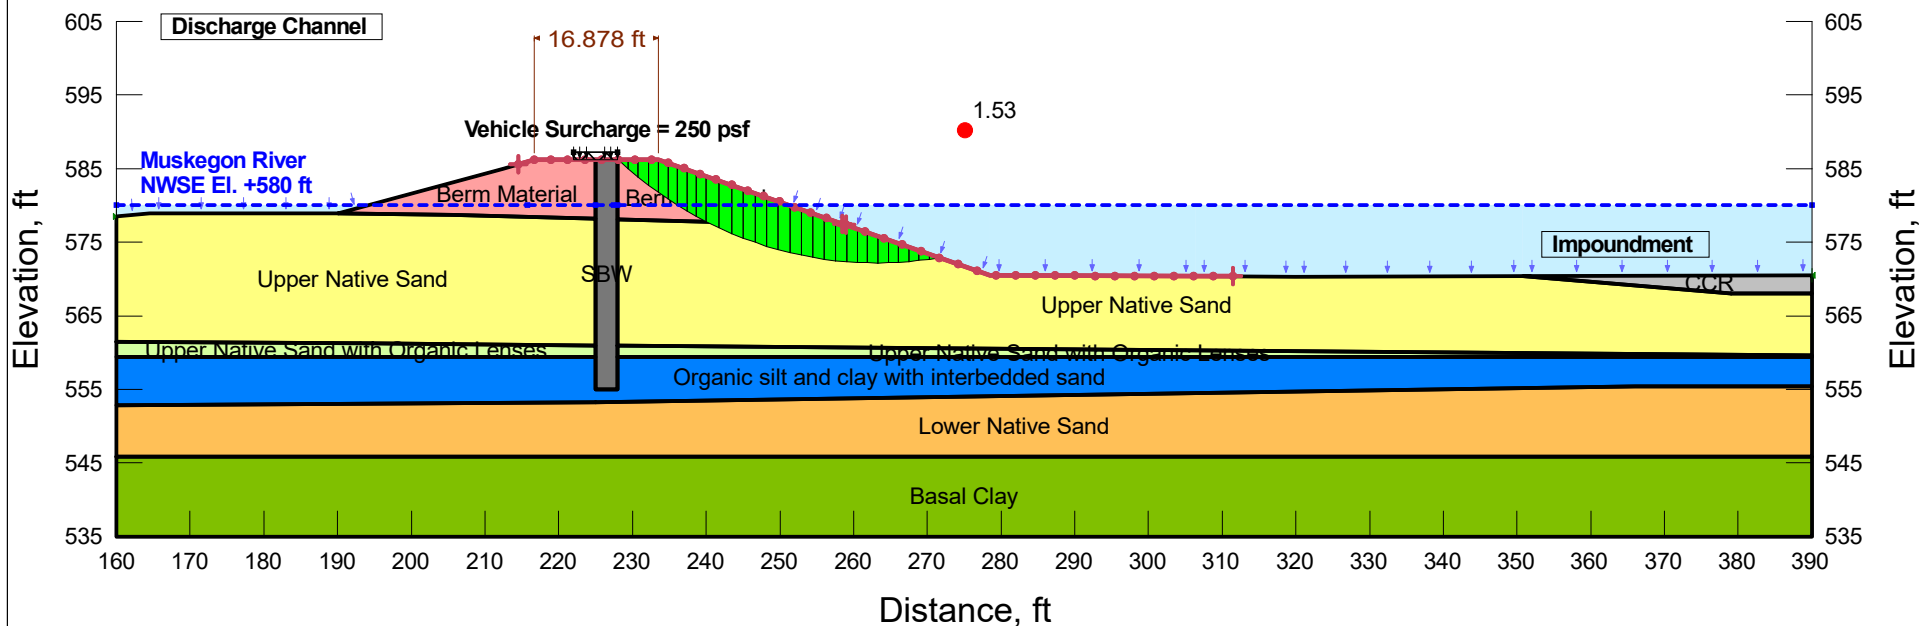
File Name: STA 16+50 - Stability.gsz
Method of Analysis: Spencer
Case Analyzed: 1 - Pond Side, NWSE, Long-Term
Minimum FS: 1.53

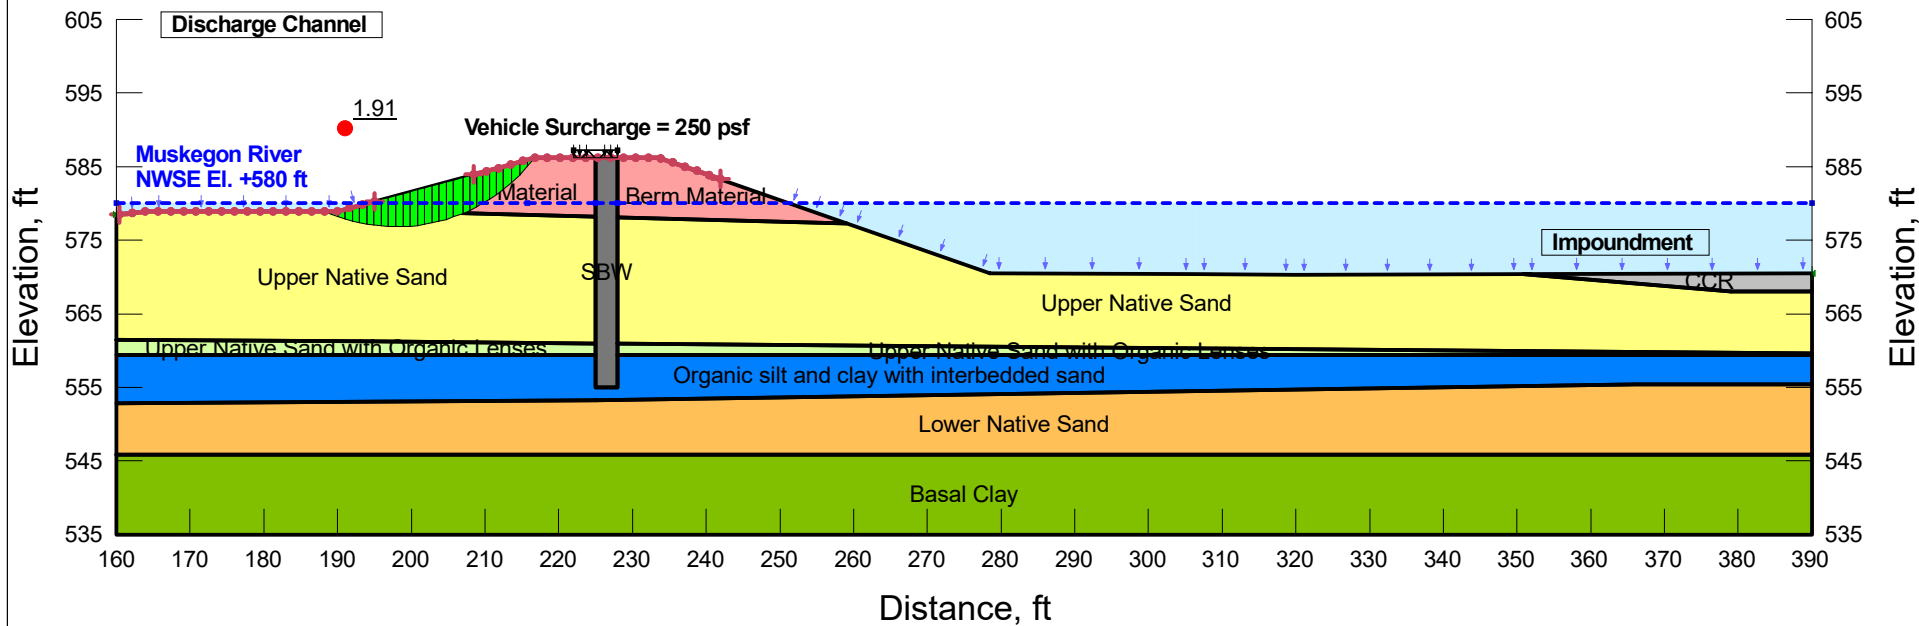
File Name: STA 16+50 - Stability.gsz
Method of Analysis: Spencer
Case Analyzed: 2 - River Side, NWSE, Long-Term
Minimum FS: 1.91

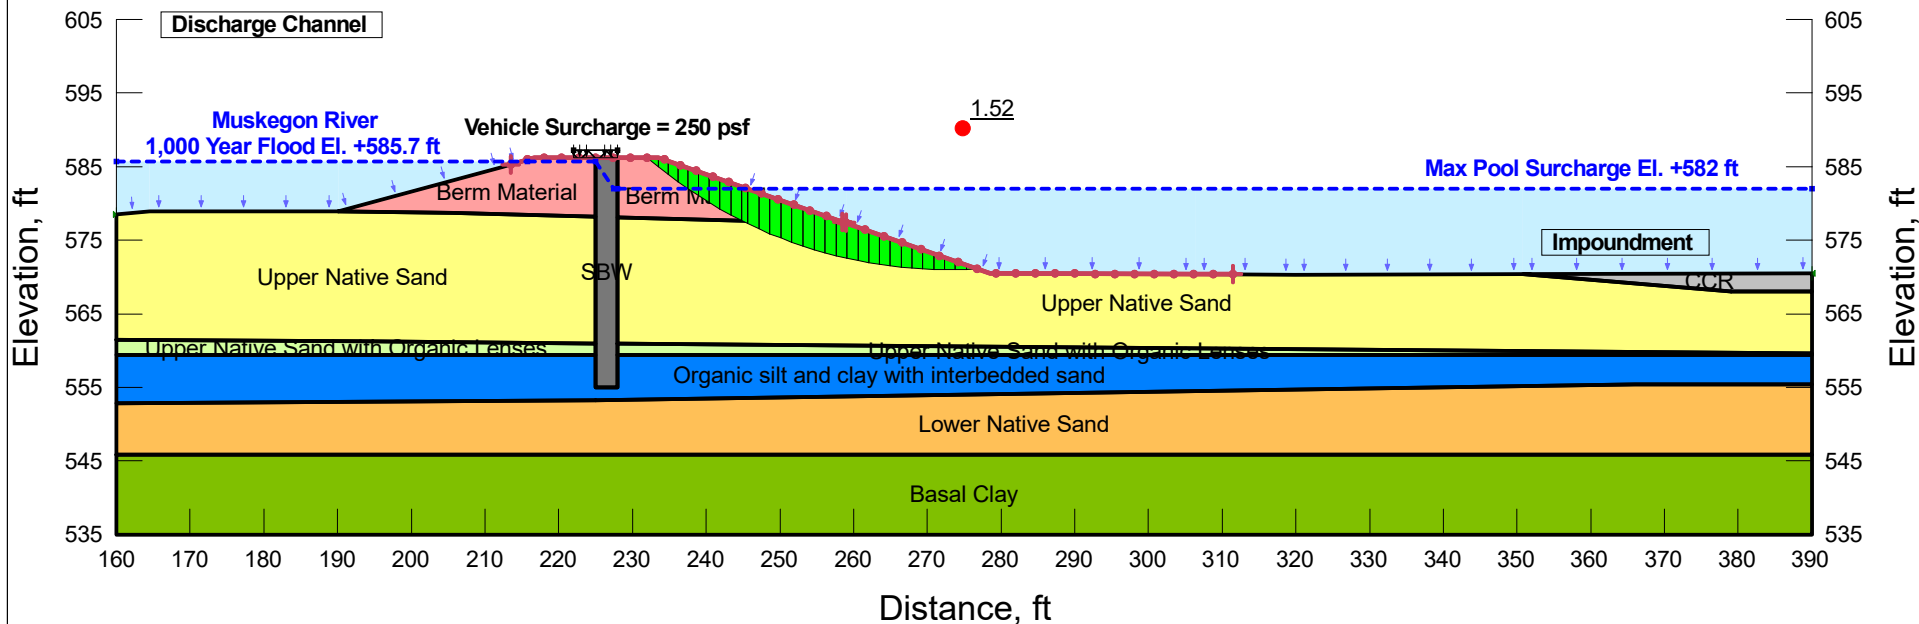
File Name: STA 16+50 - Stability.gsz
Method of Analysis: Spencer
Case Analyzed: 3 - Pond Side, 1000Yr Flood, Long-Term
Minimum FS: 1.52

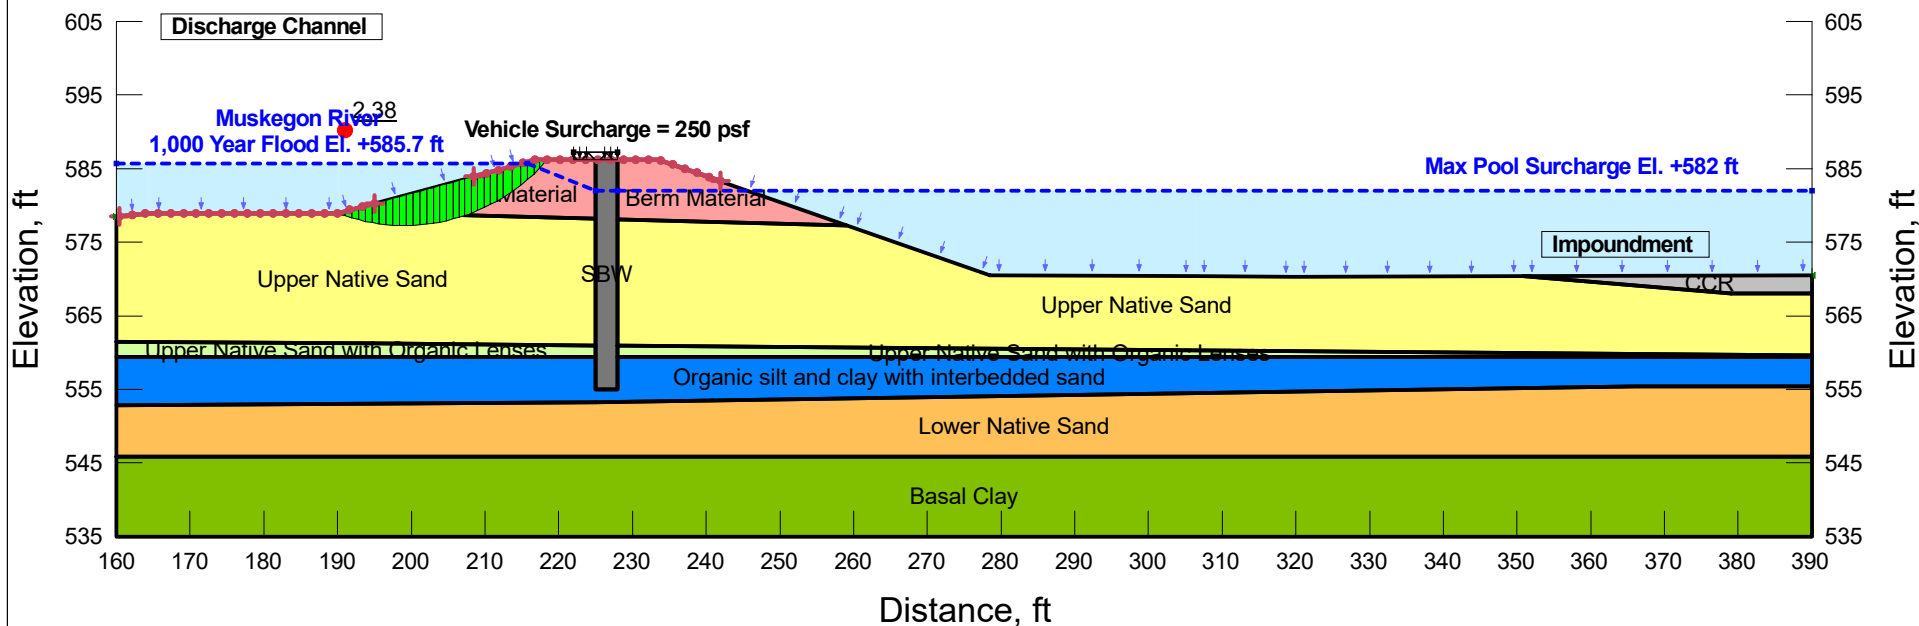
File Name: STA 16+50 - Stability.gsz
Method of Analysis: Spencer
Case Analyzed: 4 - River Side, 1000Yr Flood, Long-Term
Minimum FS: 2.38

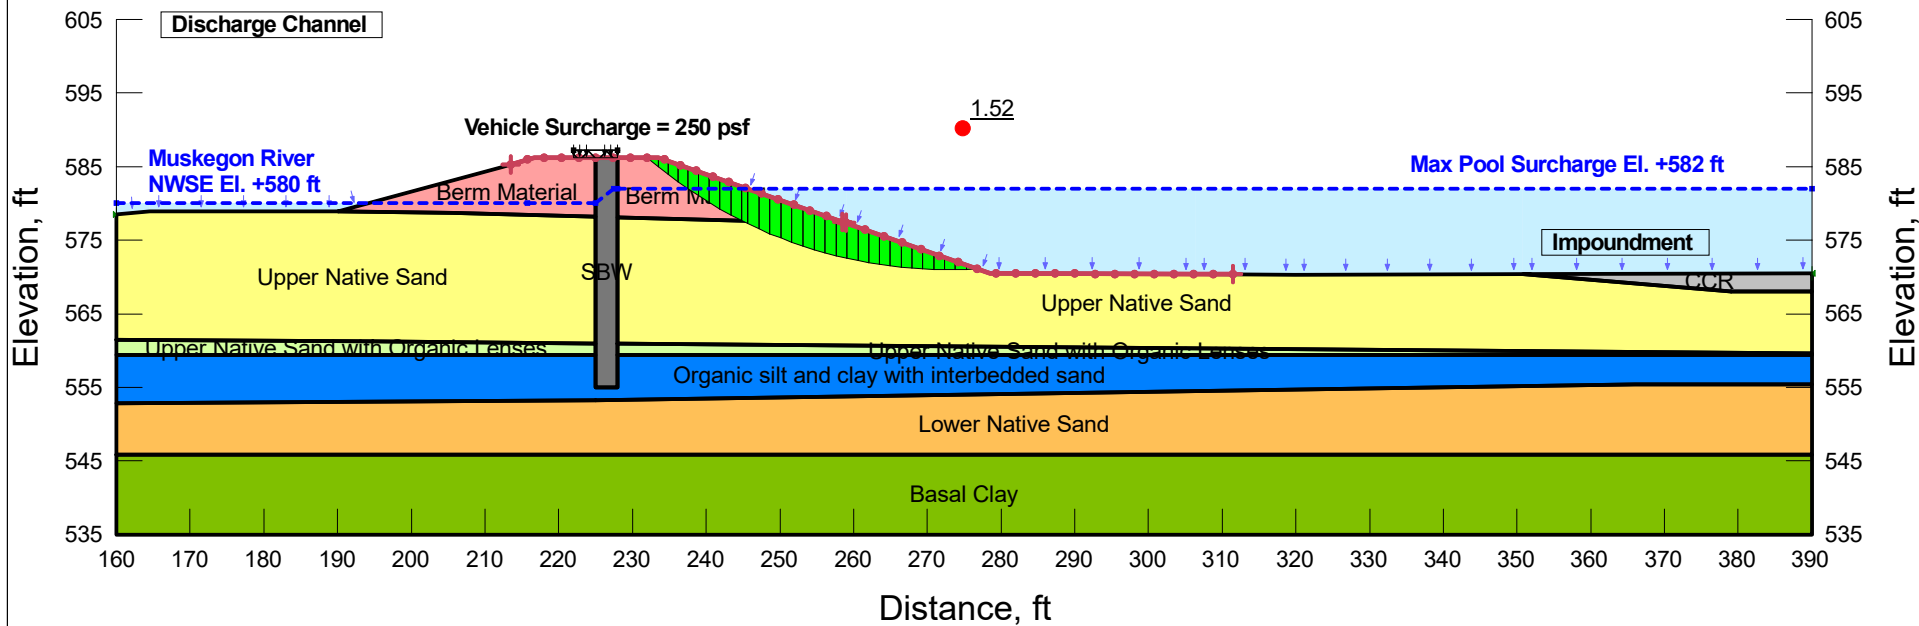
File Name: STA 16+50 - Stability.gsz
Method of Analysis: Spencer
Case Analyzed: 5 - Pond Side, Max Pool Surcharge, Long-Term
Minimum FS: 1.52

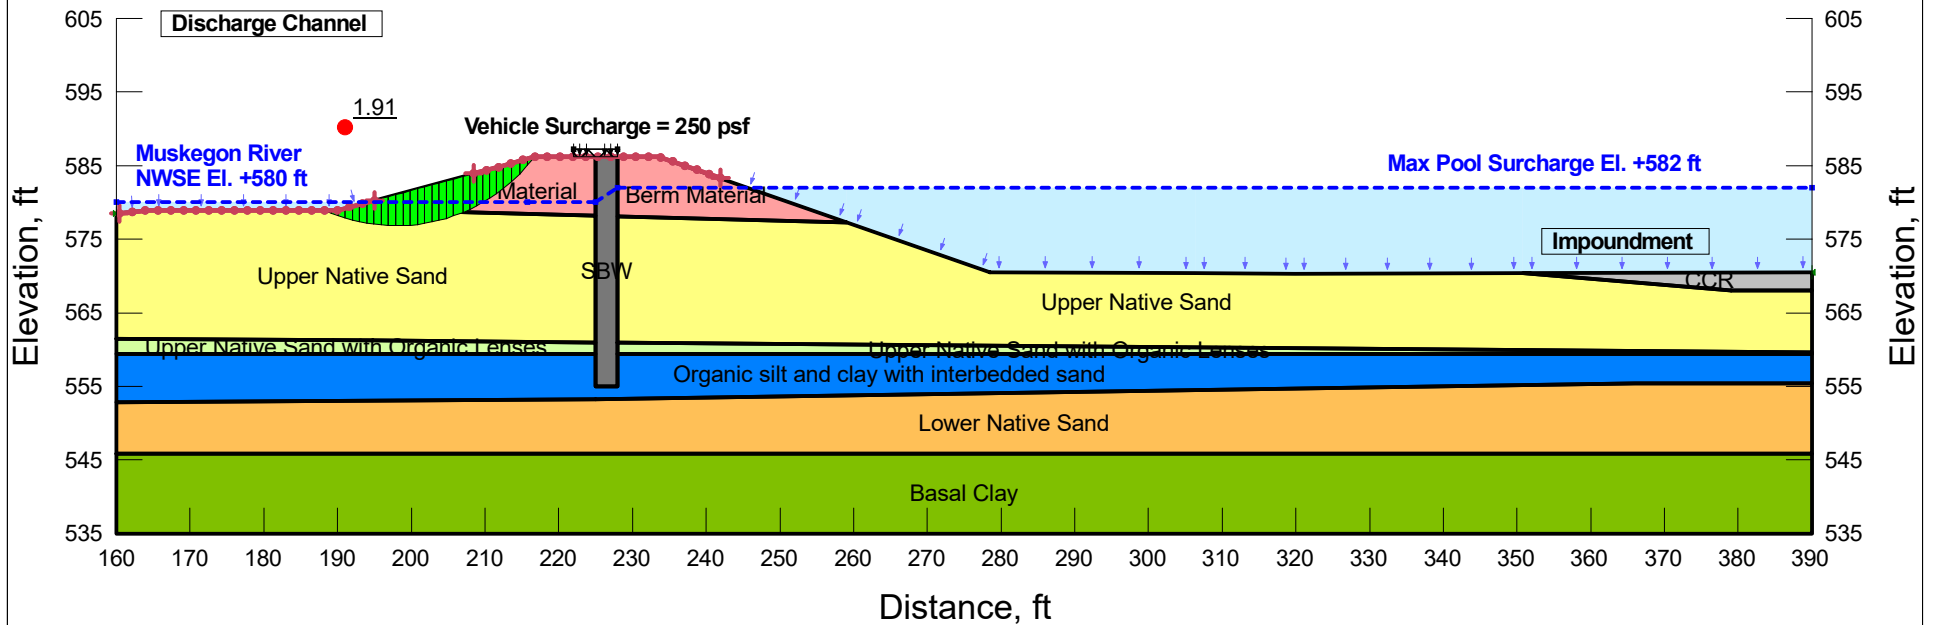
File Name: STA 16+50 - Stability.gsz
Method of Analysis: Spencer
Case Analyzed: 6 - River Side, Max Pool Surchage, Long-Term
Minimum FS: 1.91

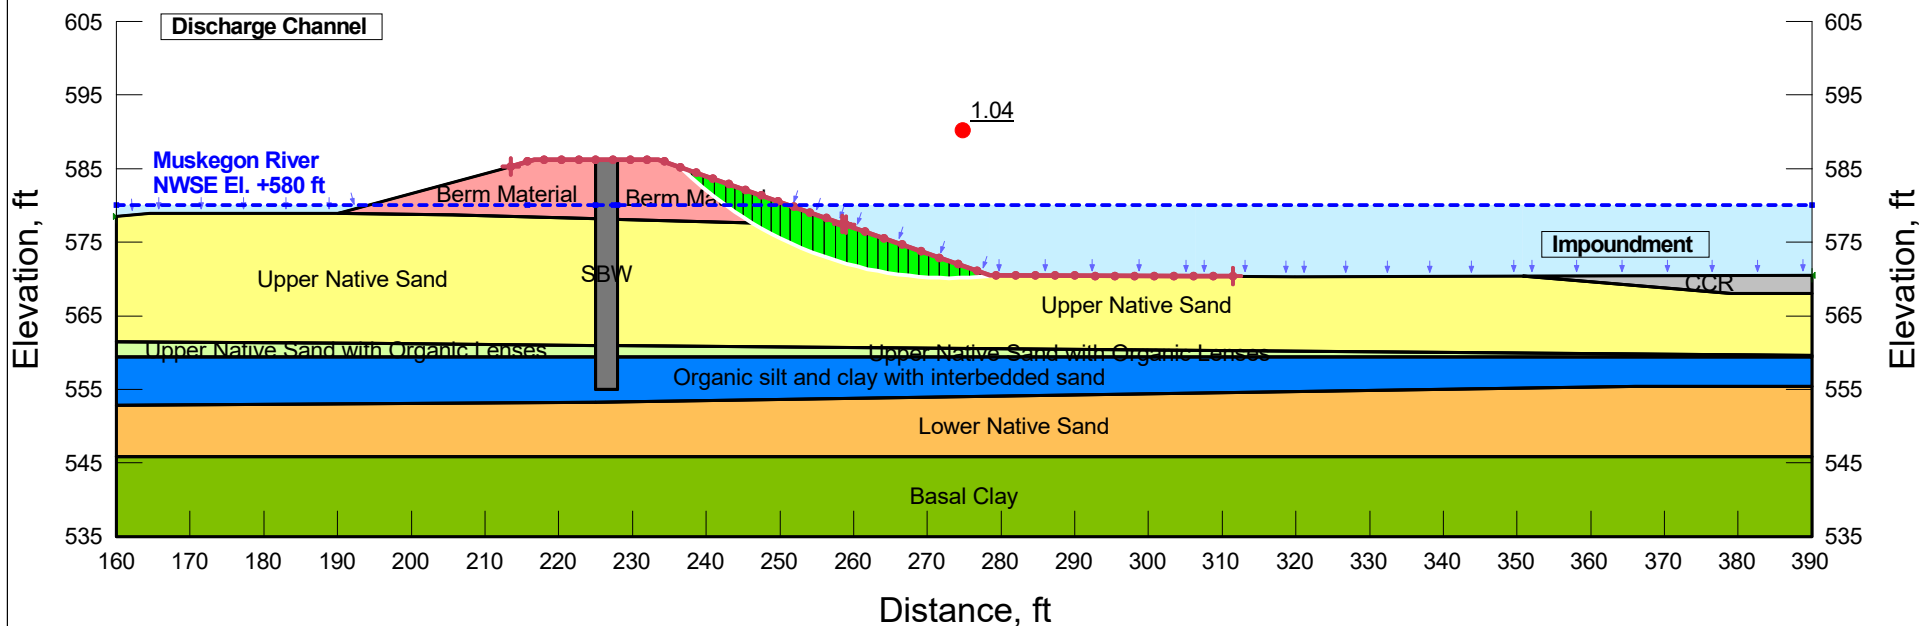
Seismic, 2475-year Return Period
Horizontal Seismic Coefficient = 0.079

File Name: STA 16+50 - Stability.gsz
Method of Analysis: Spencer
Case Analyzed: 7 - Pond Side, NWSE, Seismic-2475 year
Minimum FS: 1.04

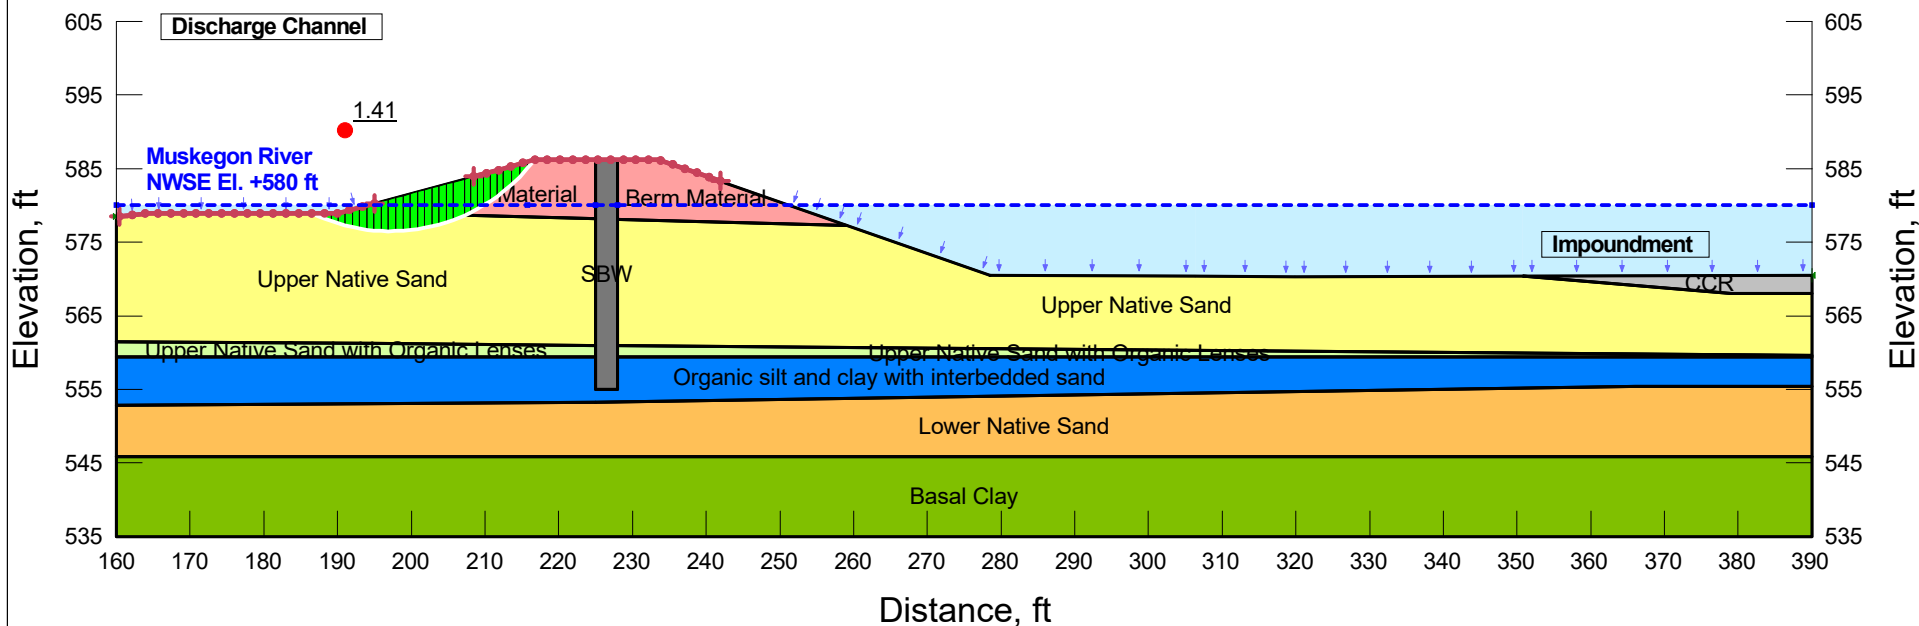
Seismic, 2475-year Return Period
Horizontal Seismic Coefficient = 0.079

File Name: STA 16+50 - Stability.gsz
Method of Analysis: Spencer
Case Analyzed: 8 - River Side, NWSE, Seismic-2475 year
Minimum FS: 1.41

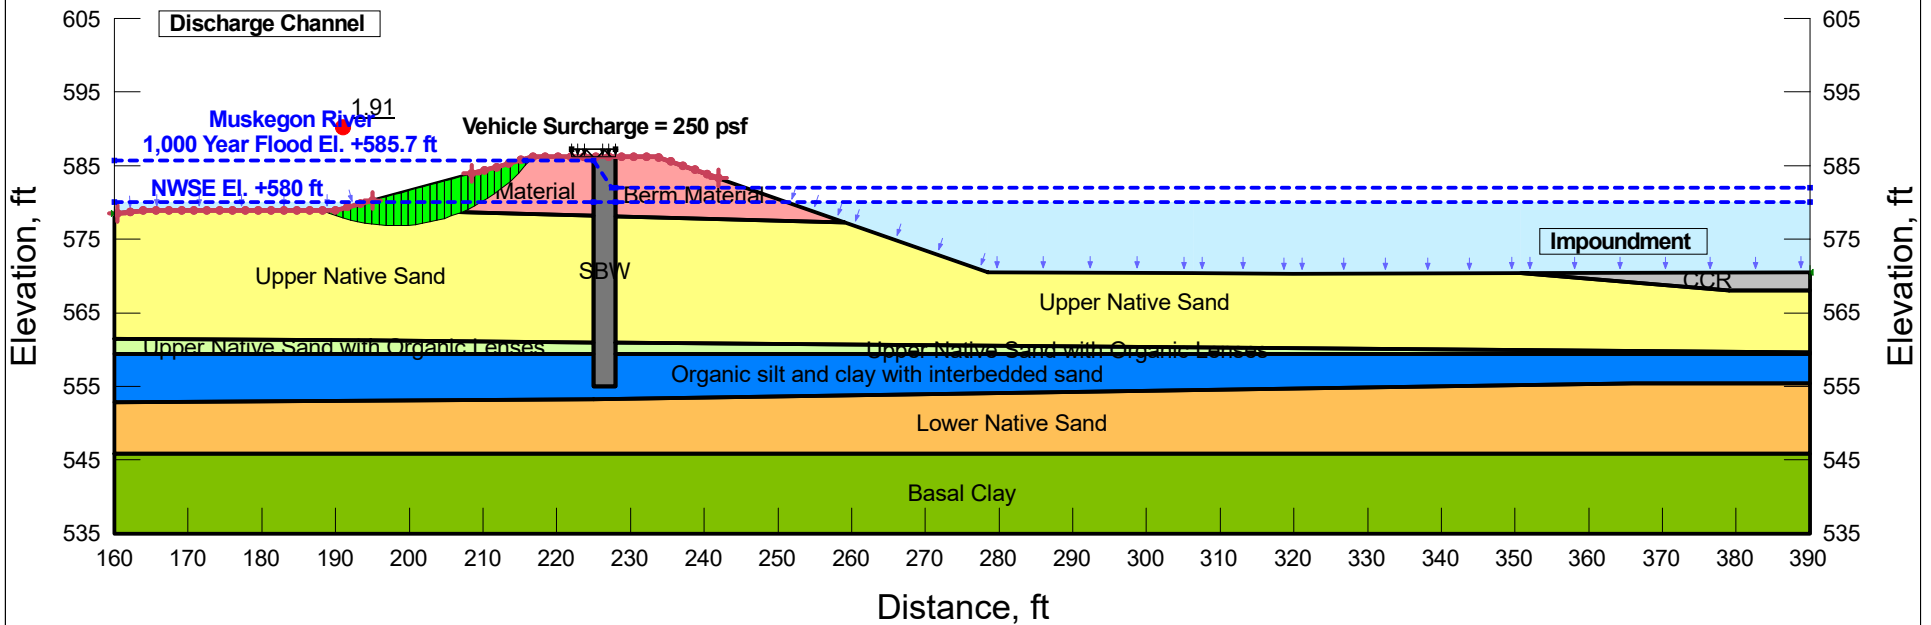
File Name: STA 16+50 - Stability.gsz
Method of Analysis: Spencer
Case Analyzed: 9 - River Side, Rapid Drawdown
Minimum FS: 1.91
