2023 Annual Inspection Report

For Compliance with the EPA Coal
Combustion Residuals (CCR) Rule
40 CFR §257.83(b)

Former B.C. Cobb Power Plant
Ponds 0-8 and Bottom Ash Pond

May 17, 2023

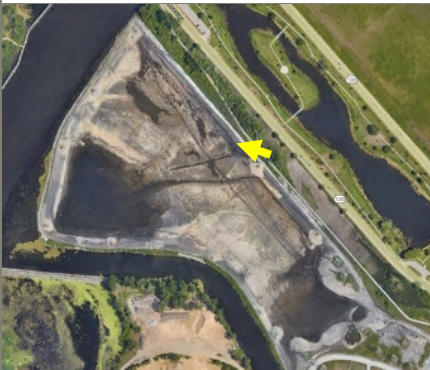
<p>Photograph No. 2</p> <p>Description: Interior slope of North Embankment. Note on-going interior slope reinforcement consisting of geotextile liner and rip rap.</p>

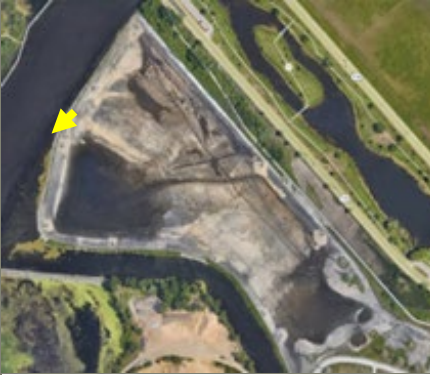
- The interior slope of the South Embankment was recently reinforced with stone rip-rap protection and seeding (Photo 6).
- The crest of the embankment consisted of a gravelly/soil surface (Photos 6 and 7).
- Rip-rap protects the exterior slope in one area near the outflow (Photo 7) due to previous erosion repair, which was in good condition.
- Vegetation is overgrown on the exterior slope.

<p>Photograph No. 6</p> <p>Description: Crest and interior slope of South Embankment with slope reinforcement almost complete. Seeding and mulching currently being installed.</p>

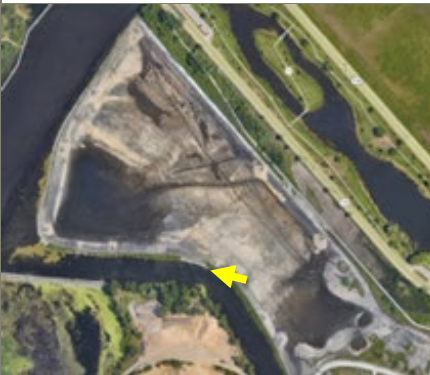
Client Name:	Site Location:	Photographic Log
Muskegon Environmental Redevelopment Group, LLC (MERG)	Ponds 0-8 and Bottom Ash Pond Former B.C. Cobb Power Plant Muskegon, Michigan	Project No. 10220433 Date: May 15, 2023
Photograph No. 9		
Description: NPDES outflow on exterior slope of South Embankment adjacent to Discharge Channel. Low flow of treated water exiting outflow.
