# CCR Removal Report

Supplement No. 2

Former B.C. Cobb Power Plant  
Bottom Ash Pond and Ponds 0-8

June 8, 2023

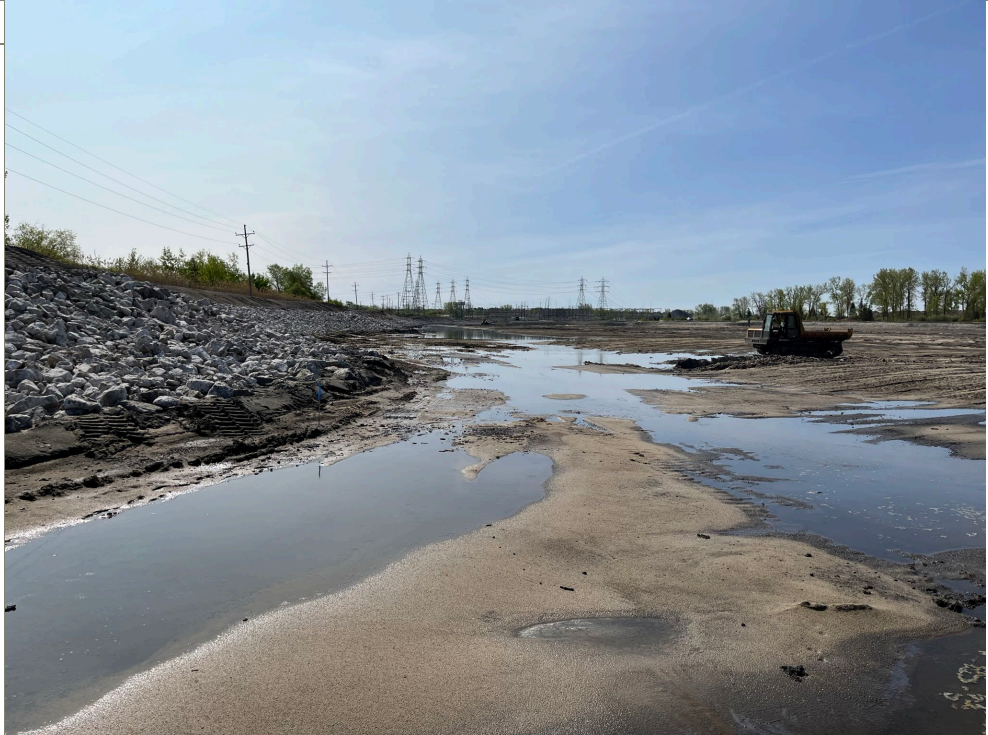
### Photograph No. 3

General area photo of excavation at B-series nodes. Note clean sand present and standing water from recent excavation.

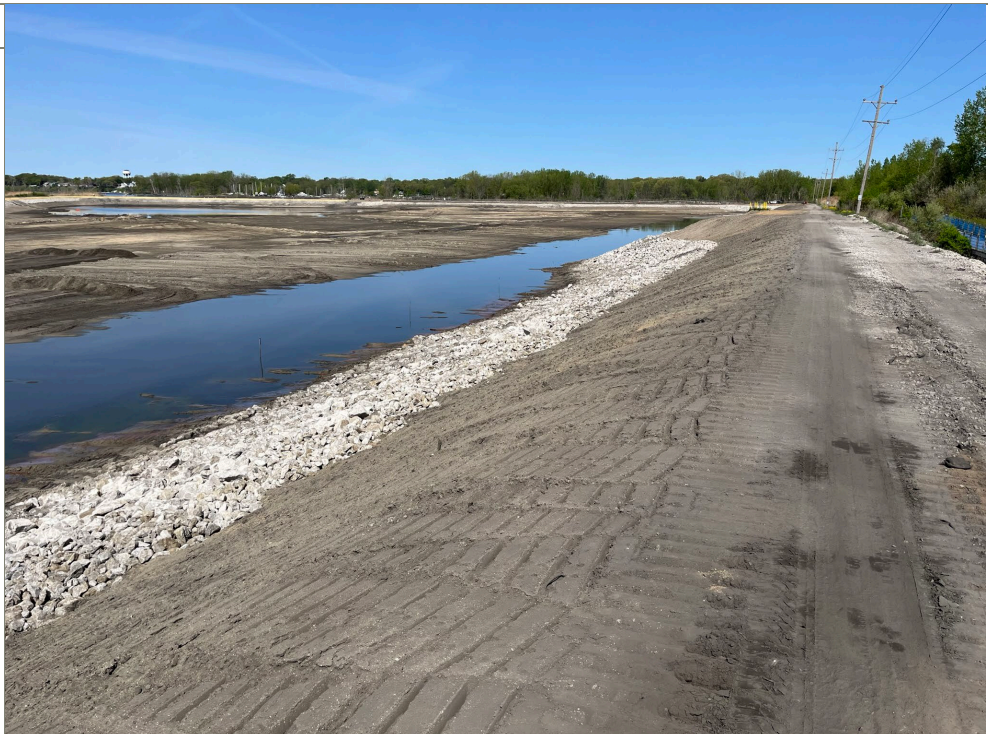
### Photograph No. 4

General area photo of North Embankment adjacent to B-series nodes. Note North Embankment repairs.

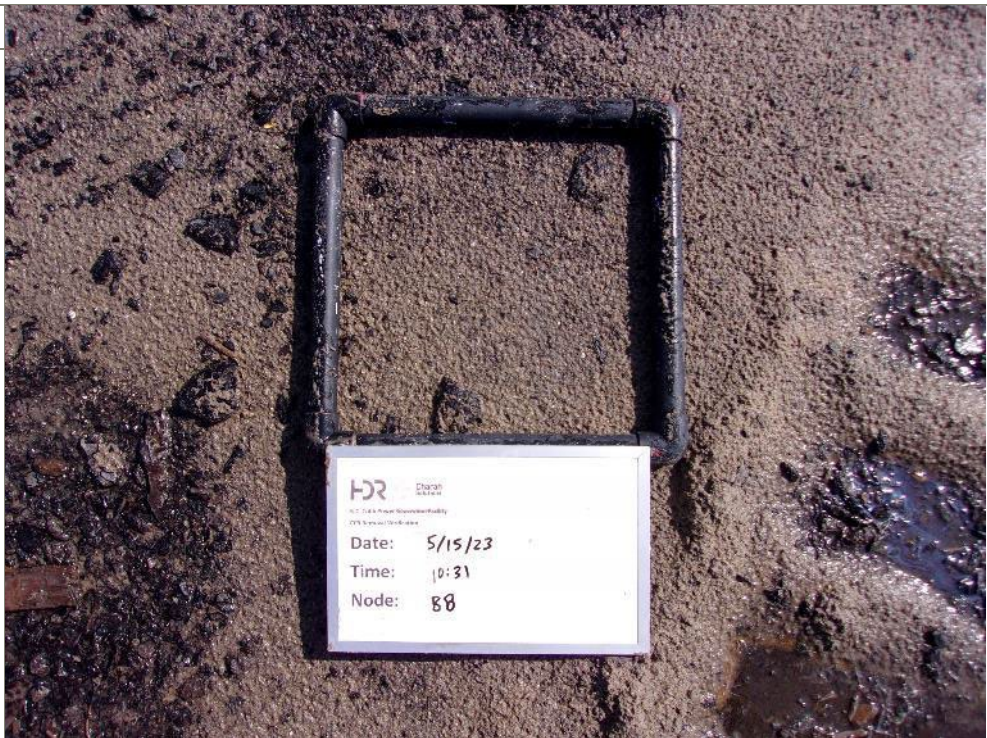
Node: B8R  HDR Microscopic Quantification Result: <1%		
<b>Photograph No. 8</b>

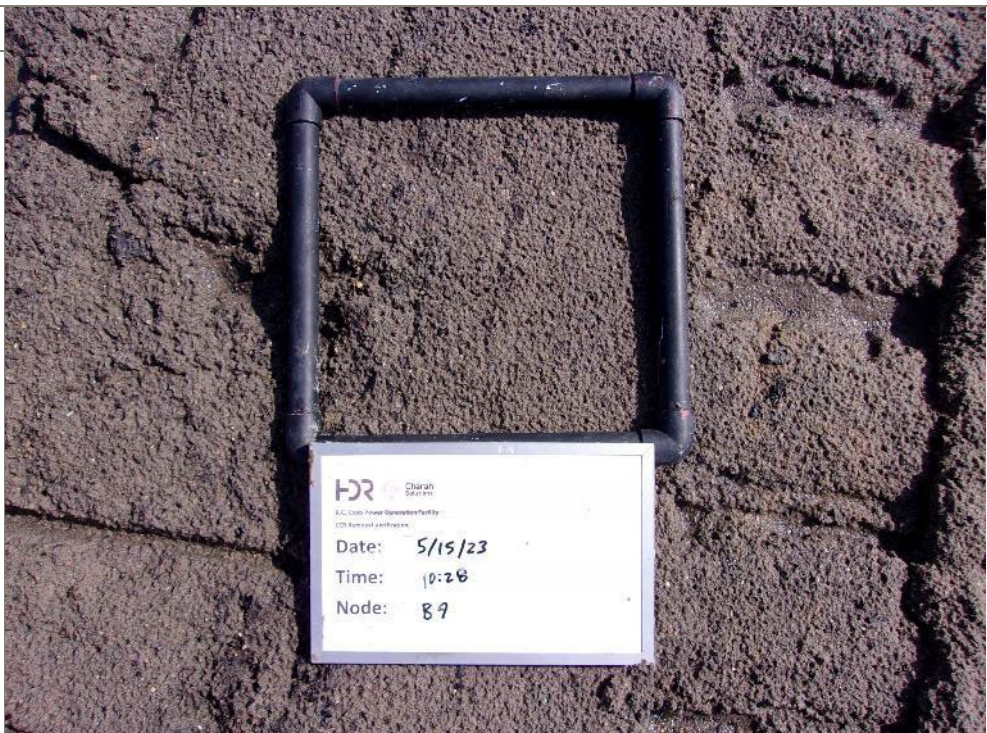
Node: B9R  HDR Microscopic Quantification Result: <1%

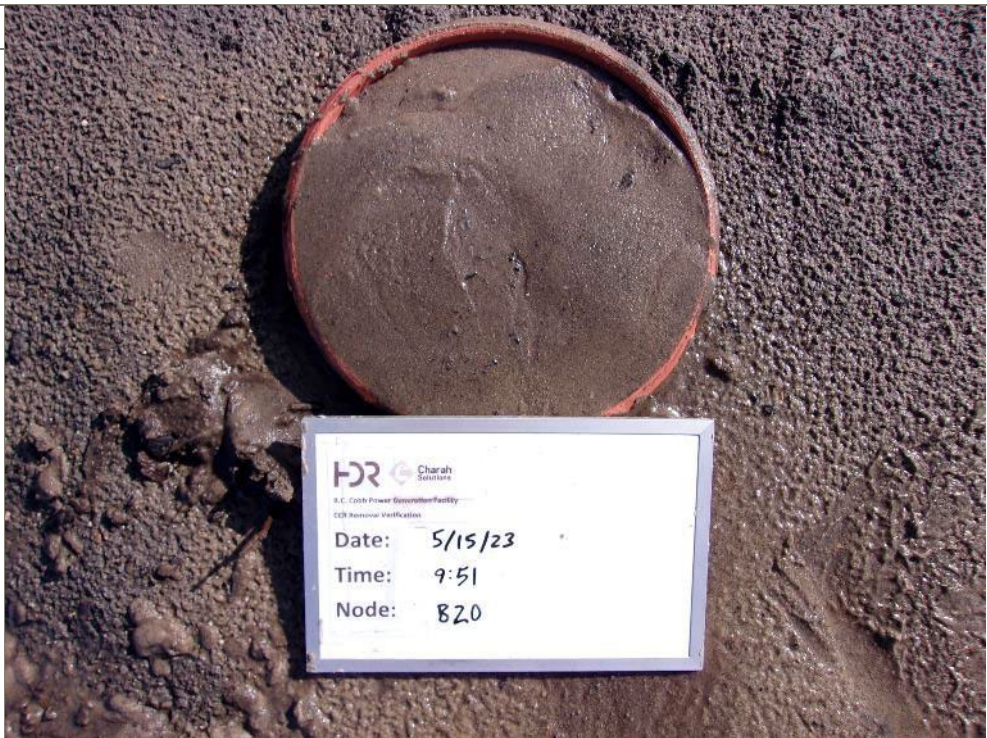
Node: B20R  HDR Microscopic Quantification Result: <1%		
Photograph No. 20

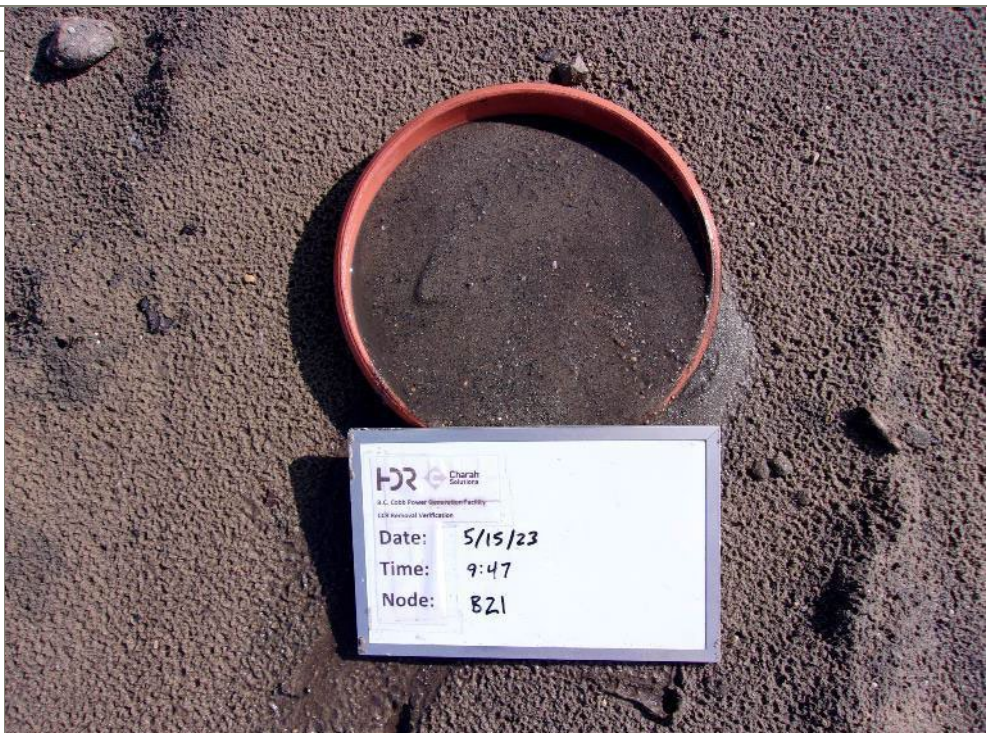
Node: B21R  HDR Microscopic Quantification Result: <1%

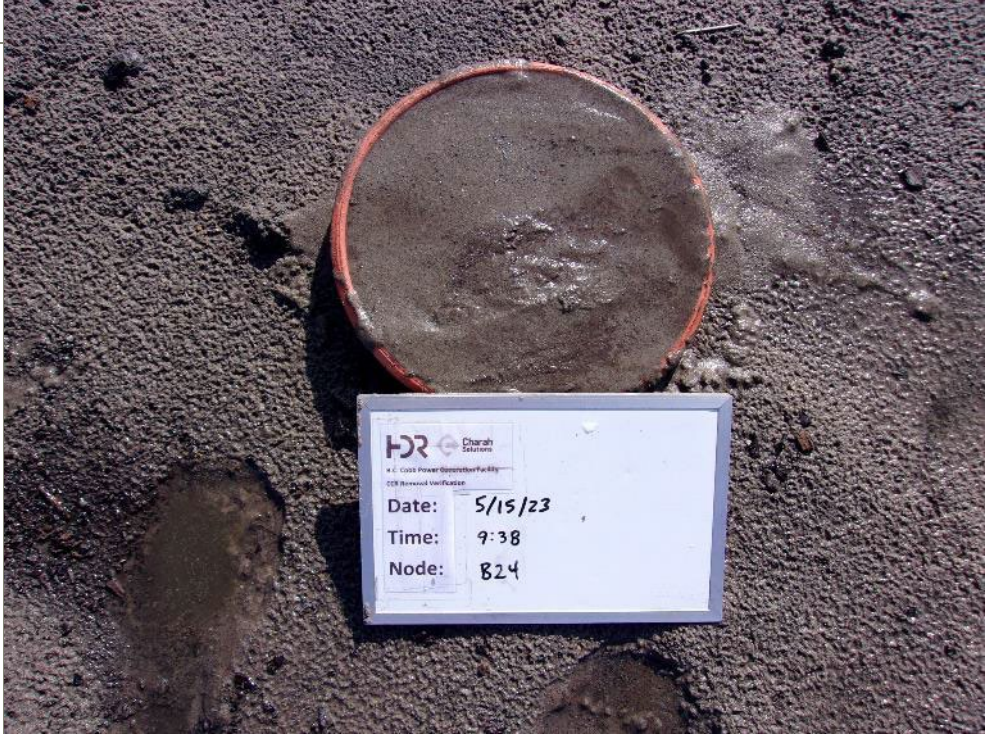
Node: B24R  HDR Microscopic Quantification Result: <1%		
<b>Photograph No. 24</b>

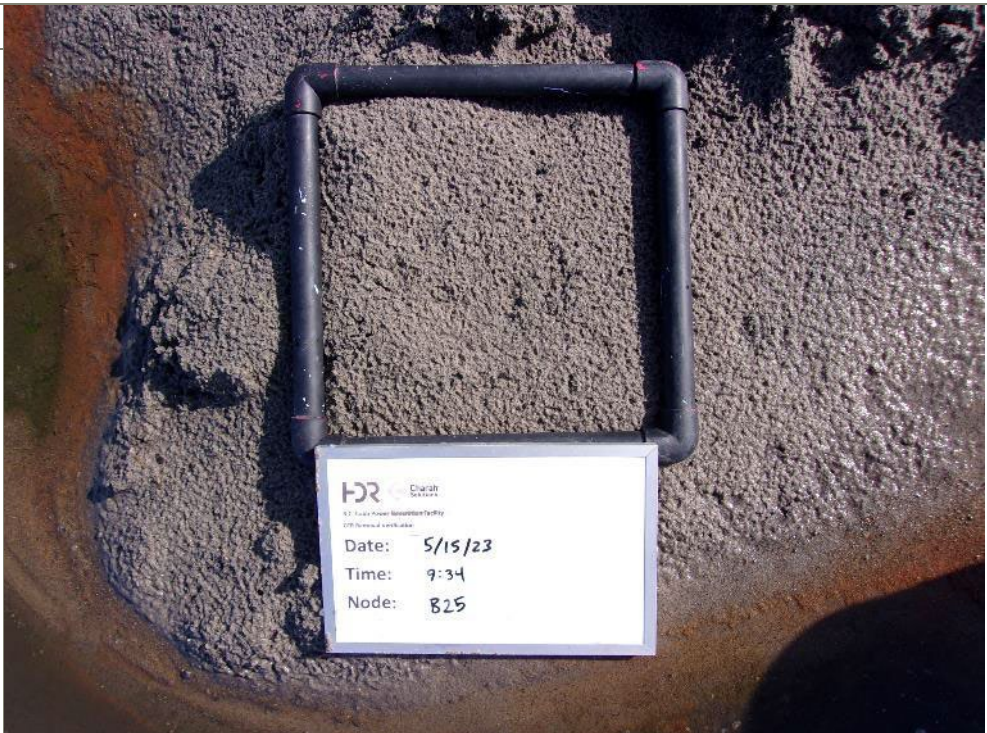
Node: B25R  HDR Microscopic Quantification Result: 2-3%

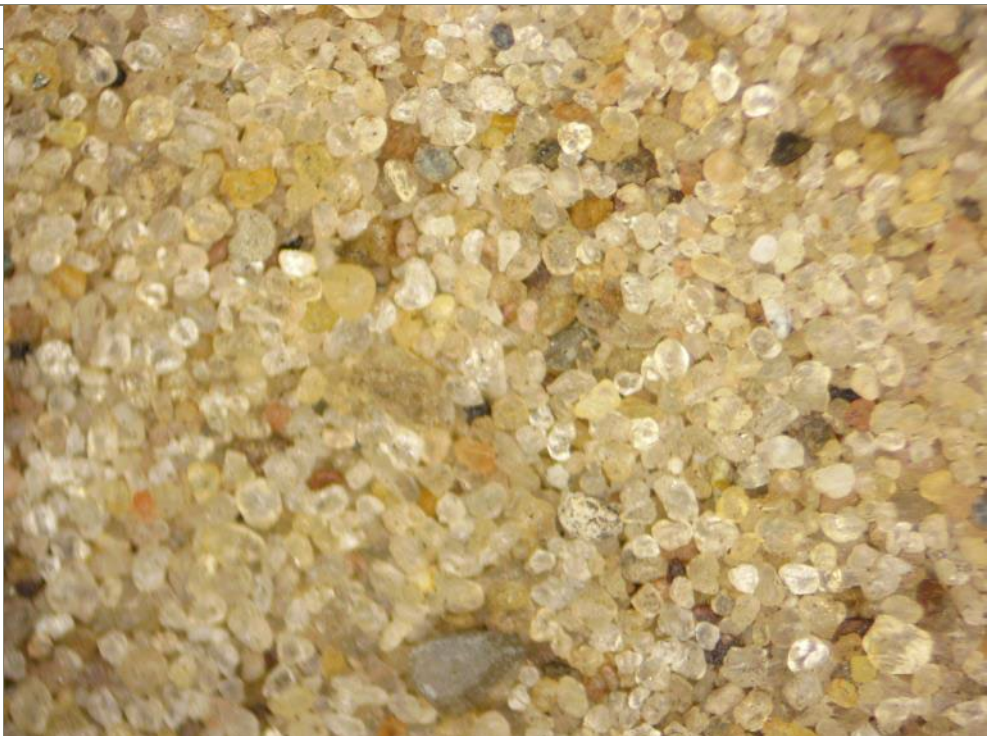
Node: B11R  HDR Microscopic Quantification Result: <1%  Note: Clean natural sand.		
Photograph No. 4

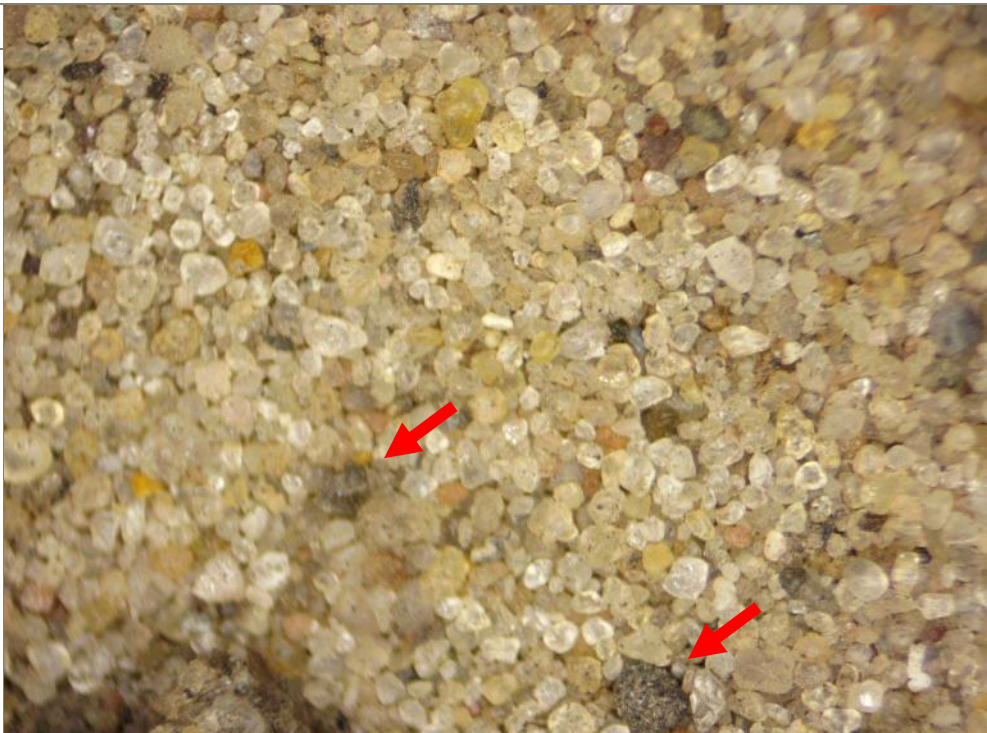
Node: B18R  HDR Microscopic Quantification Result: 2-3%  Note: Sporadic small CCR particles (red arrows) present mixed with clean sand.

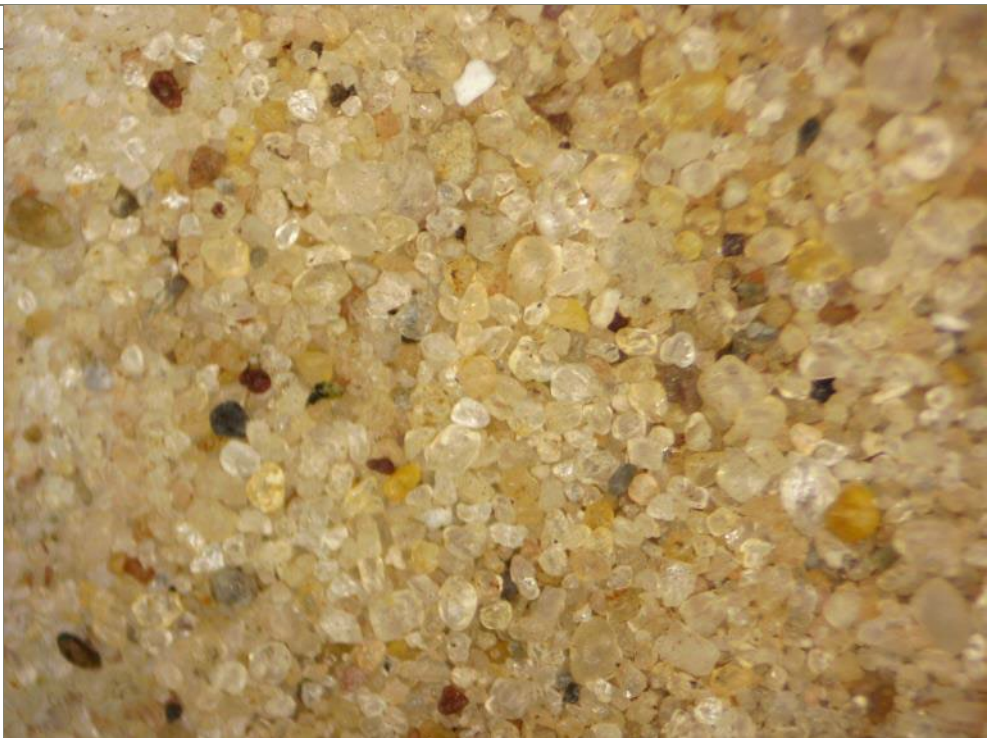
Node: B31R  HDR Microscopic Quantification Result: <1%  Note: Clean natural sand.		
<b>Photograph No. 8</b>

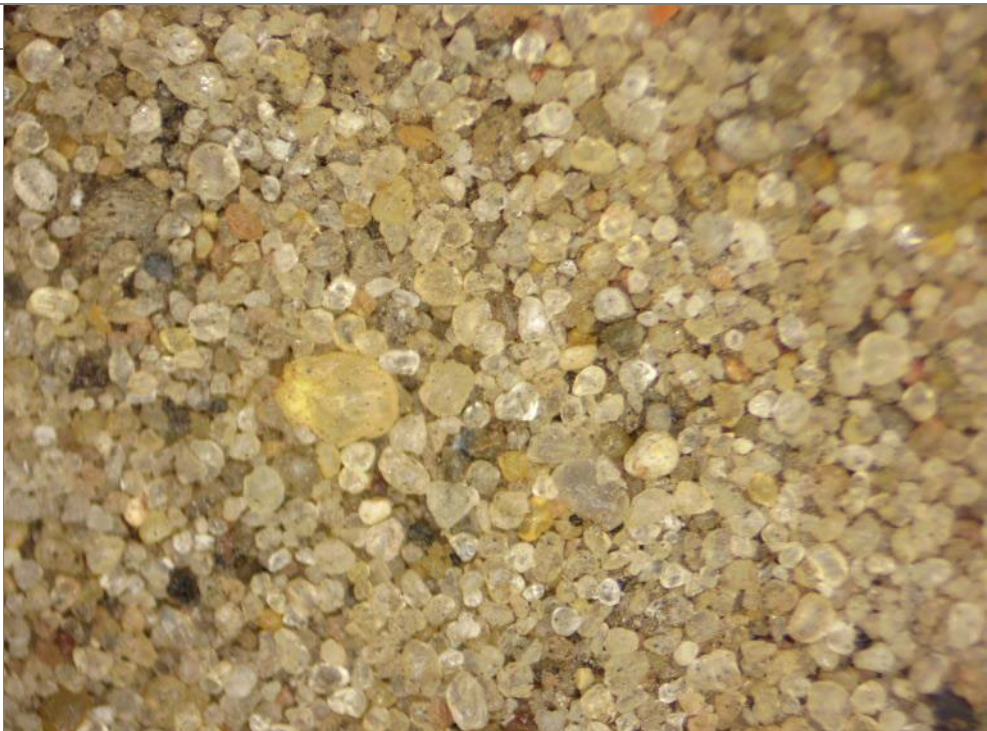
Node: B34R  HDR Microscopic Quantification Result: 2-3%  Note: Sporadic small CCR particles present mixed with clean sand.
