2024 Annual Inspection Report

For Compliance with the EPA Coal
Combustion Residuals (CCR) Rule
40 CFR §257.83(b)

Former B.C. Cobb Power Plant
Ponds 0-8 and Bottom Ash Pond

May 17, 2024

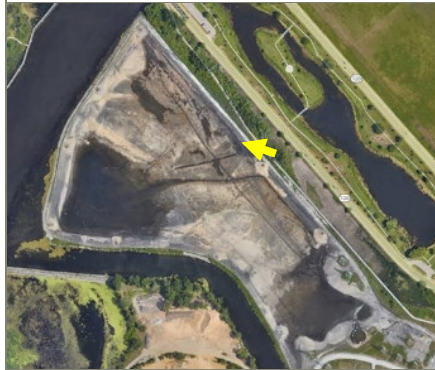
Photograph No. 1	
Description: Interior slope of North Embankment. Note interior slope reinforcement consisting of geotextile liner and rip rap installed in 2023.

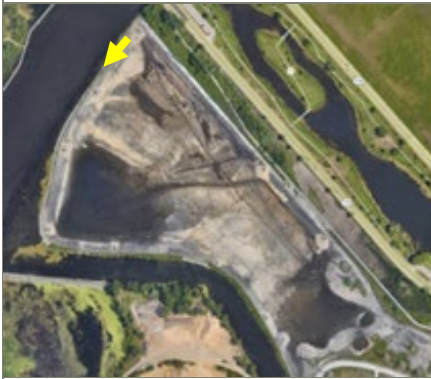
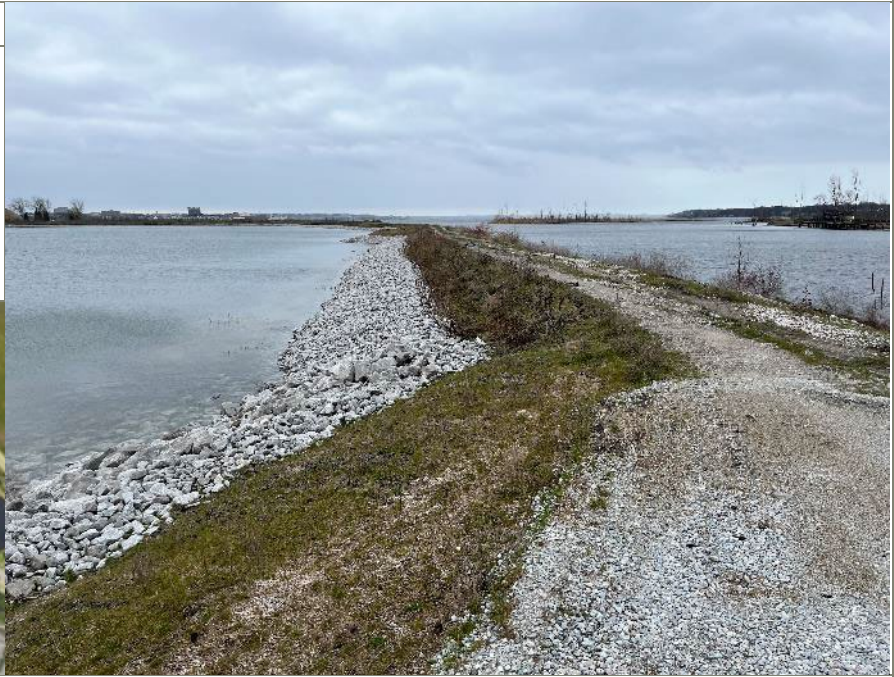
Photograph No. 3

- The interior slope of the West Embankment was recently reinforced with stone rip rap protection and seeding (Photo 3).
- Rip-rap protects the exterior slope, which was in good condition.
- Some minor vegetation overgrowth was observed on the exterior slope.

Description:
Interior slope and crest of West Embankment. Note interior slope reinforcement consisting of geotextile liner and rip rap installed in 2023.

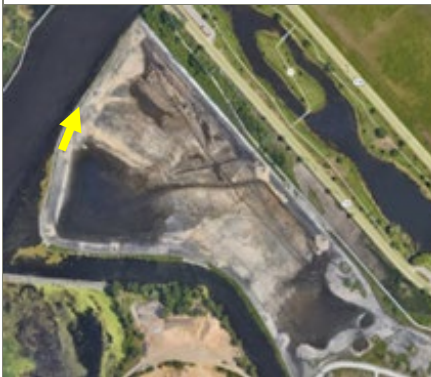
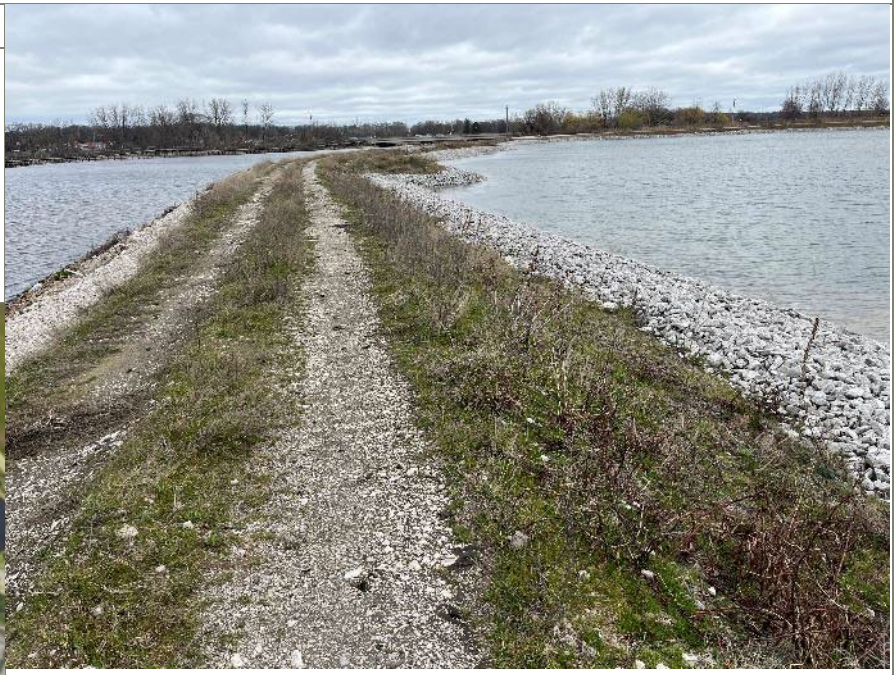
Photograph No. 4

Description:
Interior slope and crest of West Embankment.

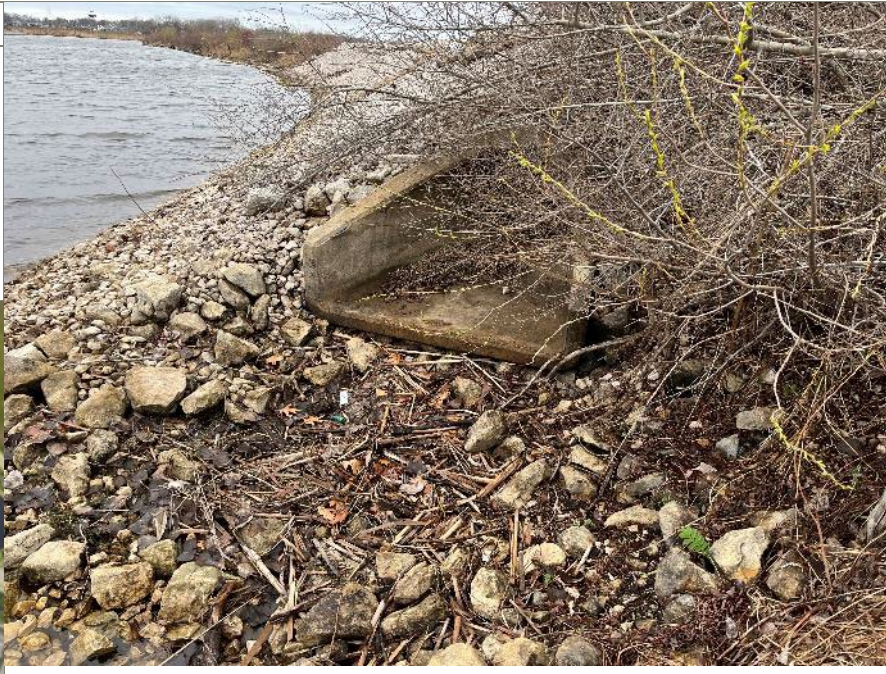
After the completion of the 2023 slope repairs, dewatering was stopped and there is no water currently exiting the outfall. Additionally, there was no evidence of settlement, sinkholes, or cracking in the area of the embankment above the pipes extending through the South Embankment.

Description: NPDES outflow on exterior slope of South Embankment adjacent to Discharge Channel. No flow of water exiting outflow.
