CCR Removal Report

Supplement No. 3

Former B.C. Cobb Power Plant
Bottom Ash Pond and Ponds 0-8

December 7, 2023

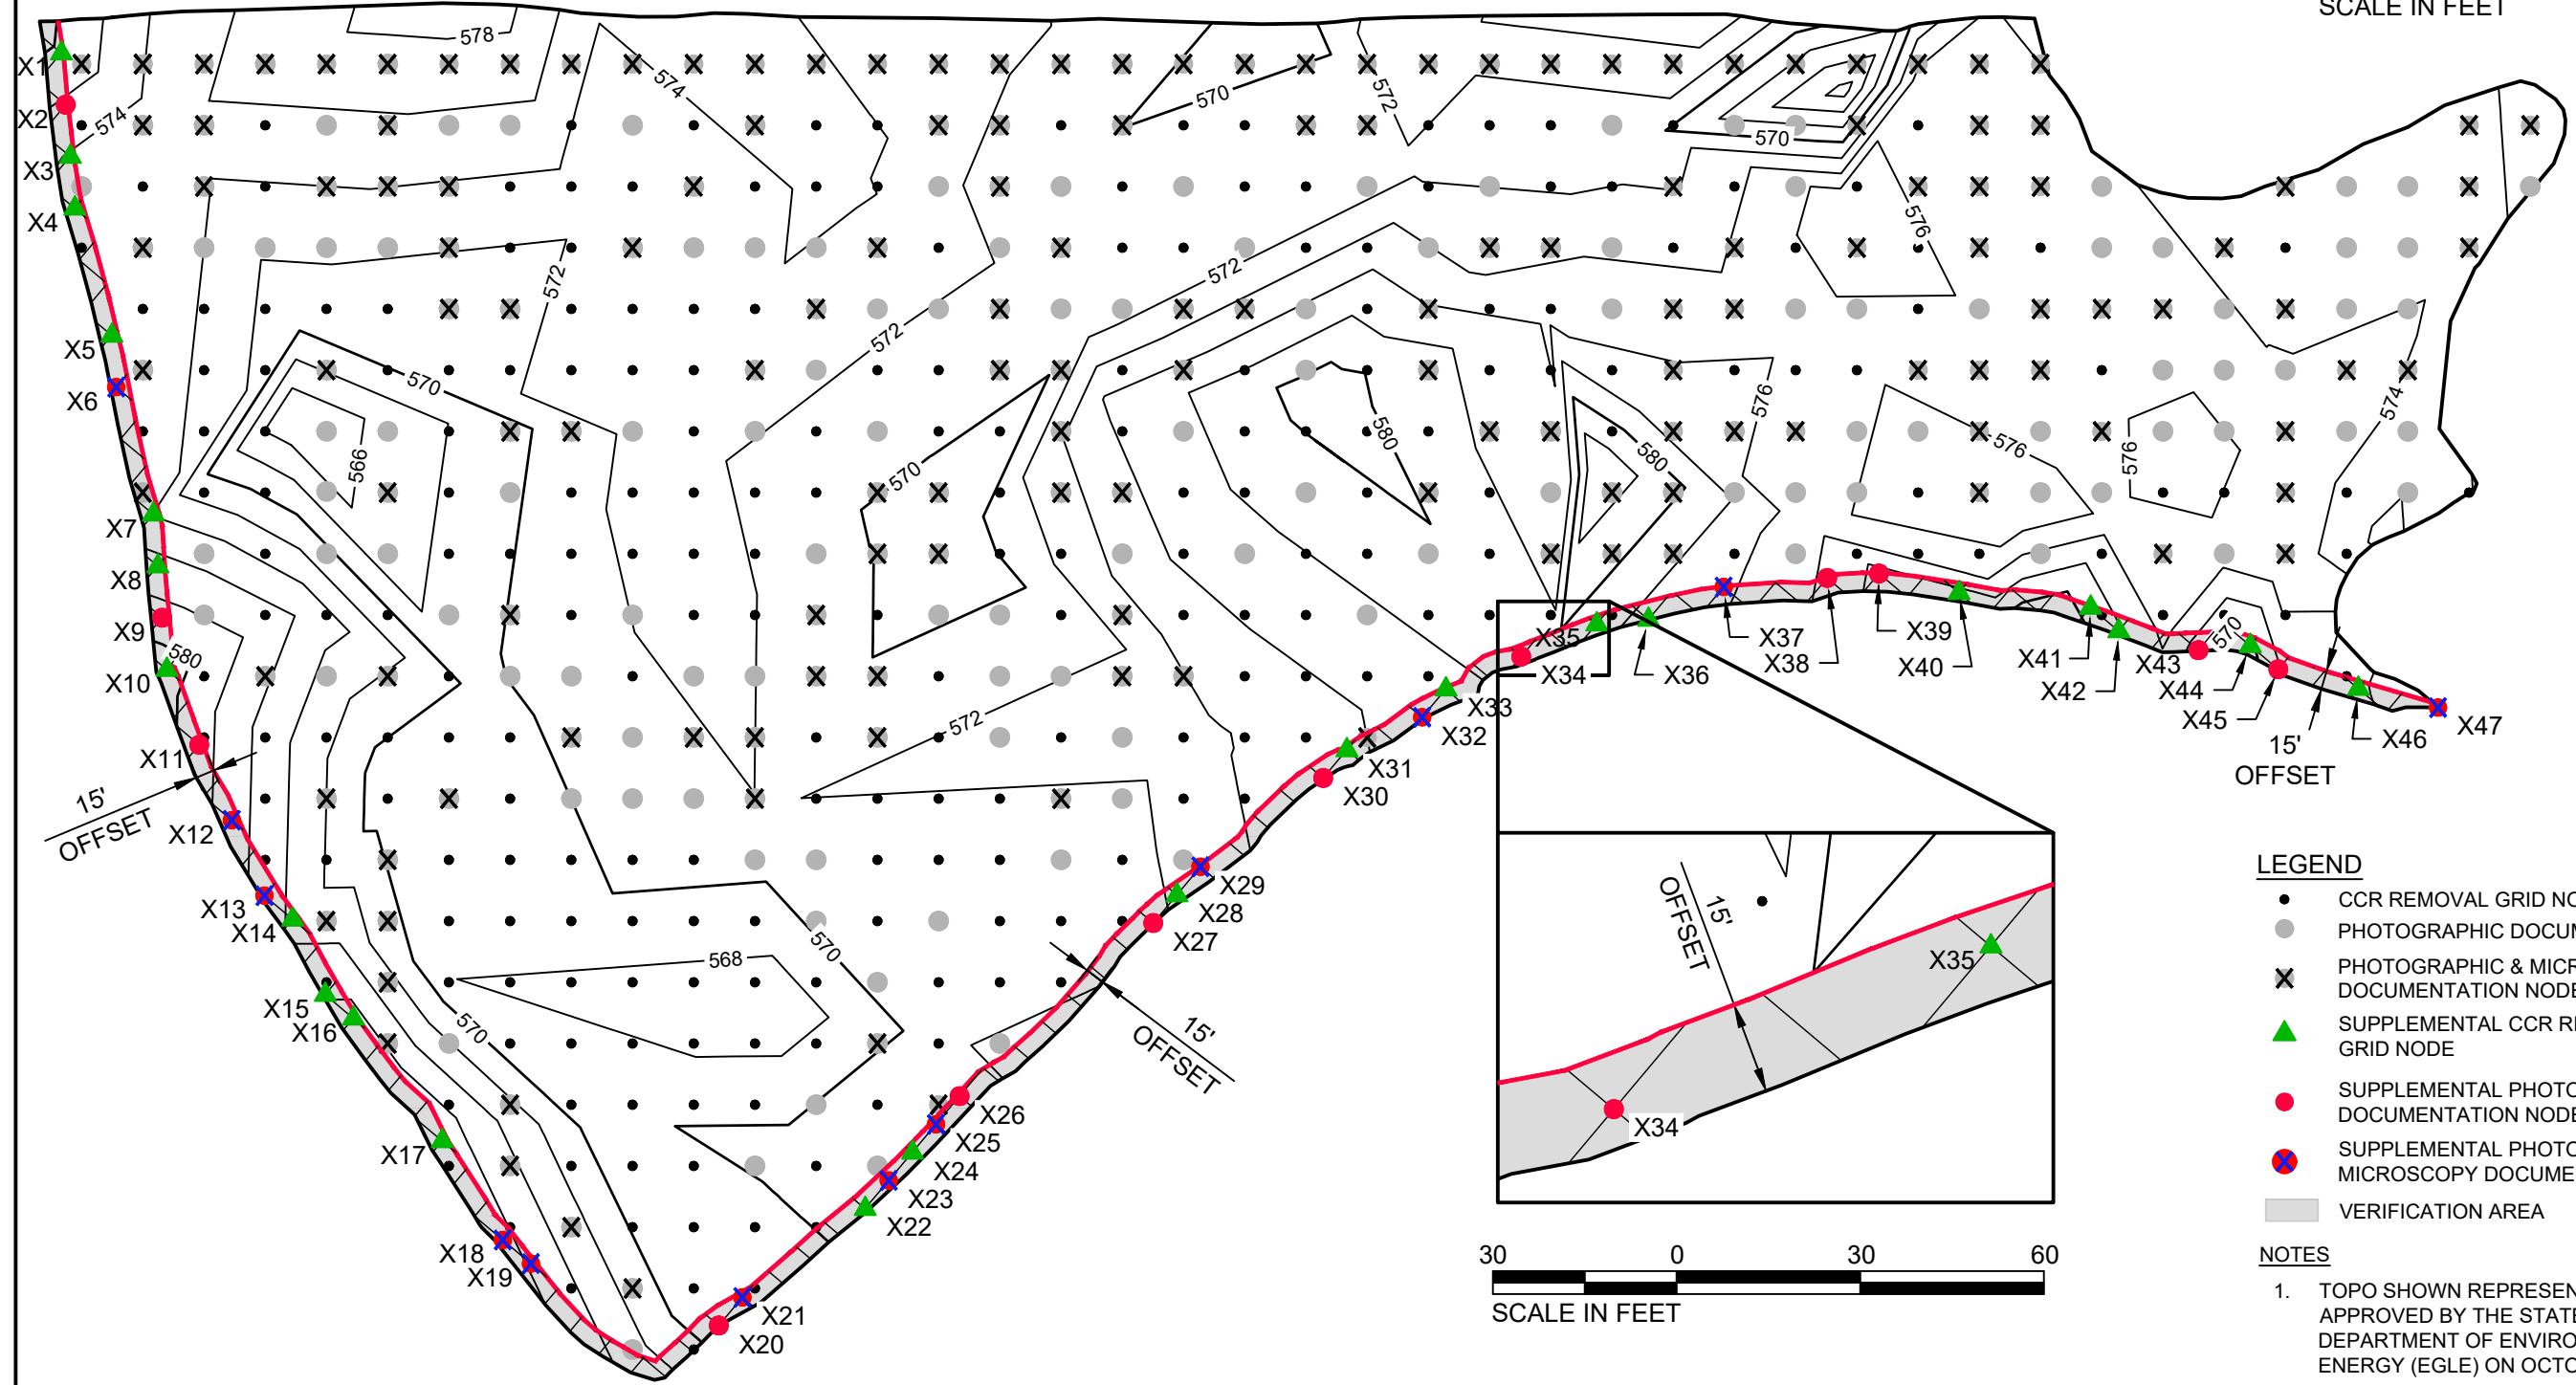
FIGURE
1

Through discussion with EGLE, a supplemental reverification was performed in the area adjacent to the Western and Southern Perimeter Embankments. A separate grid node system was developed for this reverification area and approved by EGLE¹. The sample nodes within this reverification area are referred to as the X-series nodes. The sample node locations where resampling was performed as part of the reverification presented herein are shown on Figure 1.

A separate grid system was developed for the reverification area presented herein, per direction from EGLE. Consistent with EGLE Sampling Strategies and Statistics Training Materials for Part 201 Cleanup Criteria (S3TM), a 30-foot grid was established across the verification area (15-ft offset from the edge of the excavation footprint along the toe of the western and southern perimeter embankments) as shown on Figure 1. According to the

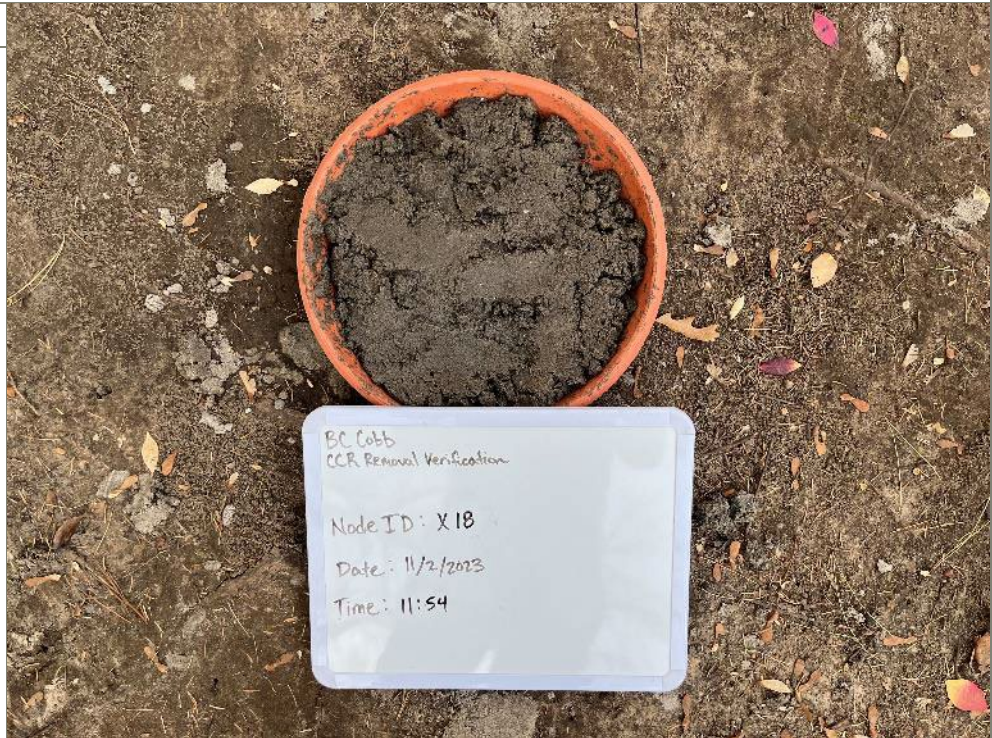
Photograph No. 7

Node: X18

HDR Microscopic Quantification Result:
1-2%

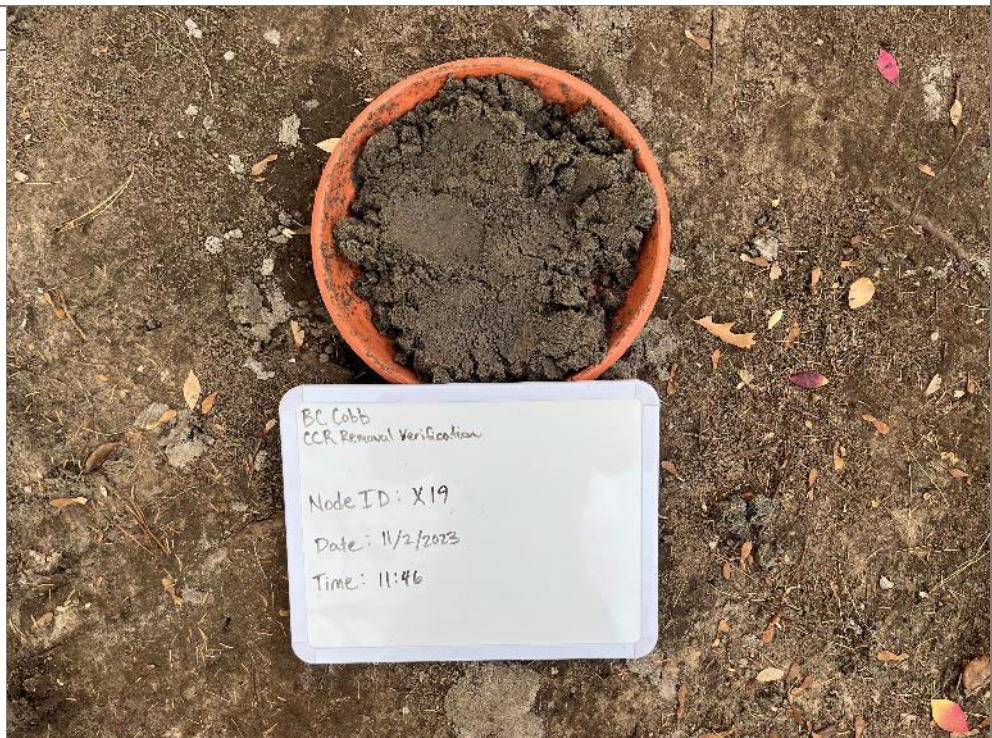
Photograph No. 8

Node: X19

HDR Microscopic Quantification Result:
<1%

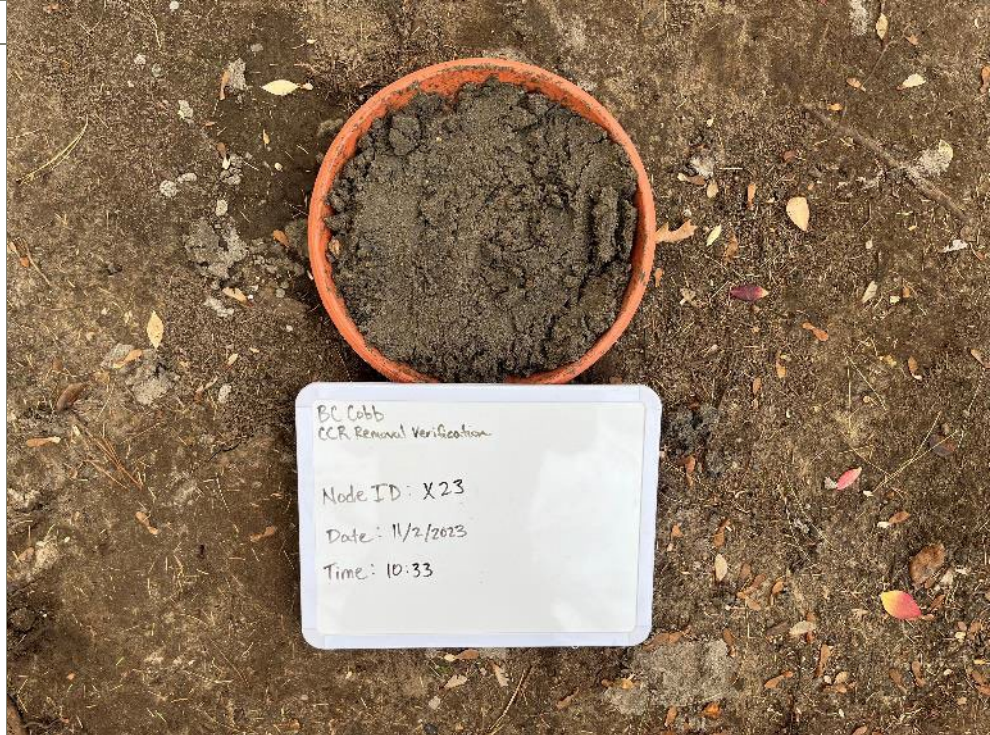
Photograph No. 11

Node: X23

HDR Microscopic Quantification Result:
2-3%

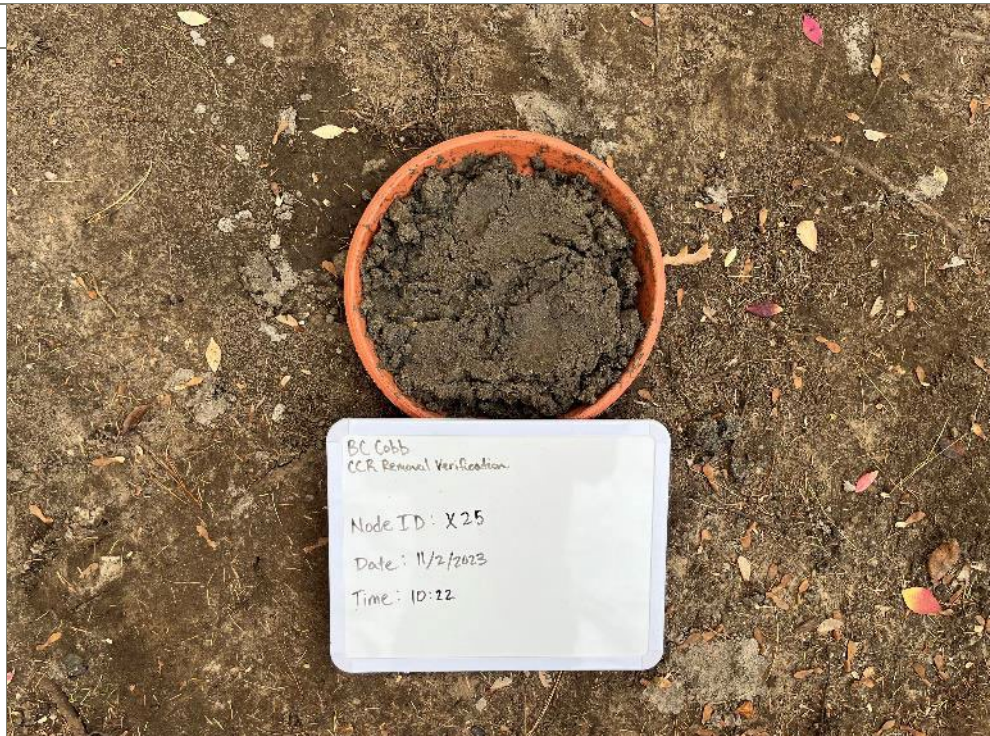
Photograph No. 12

Node: X25

HDR Microscopic Quantification Result:
<1%

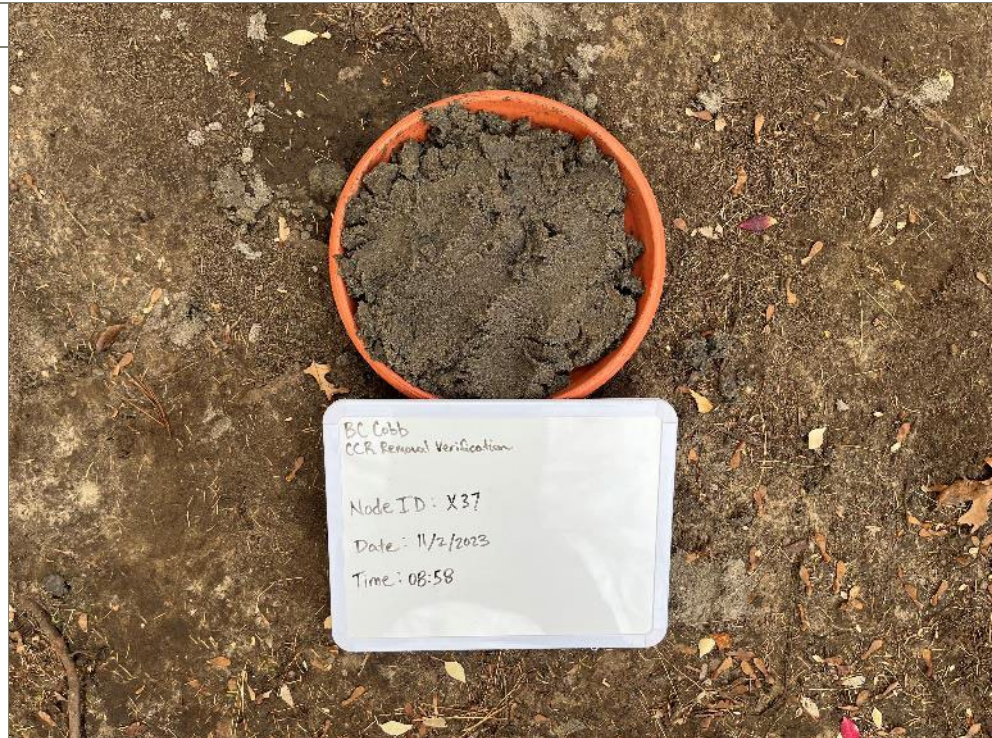
Photograph No. 19

Node: X37

HDR Microscopic Quantification Result:
<1%

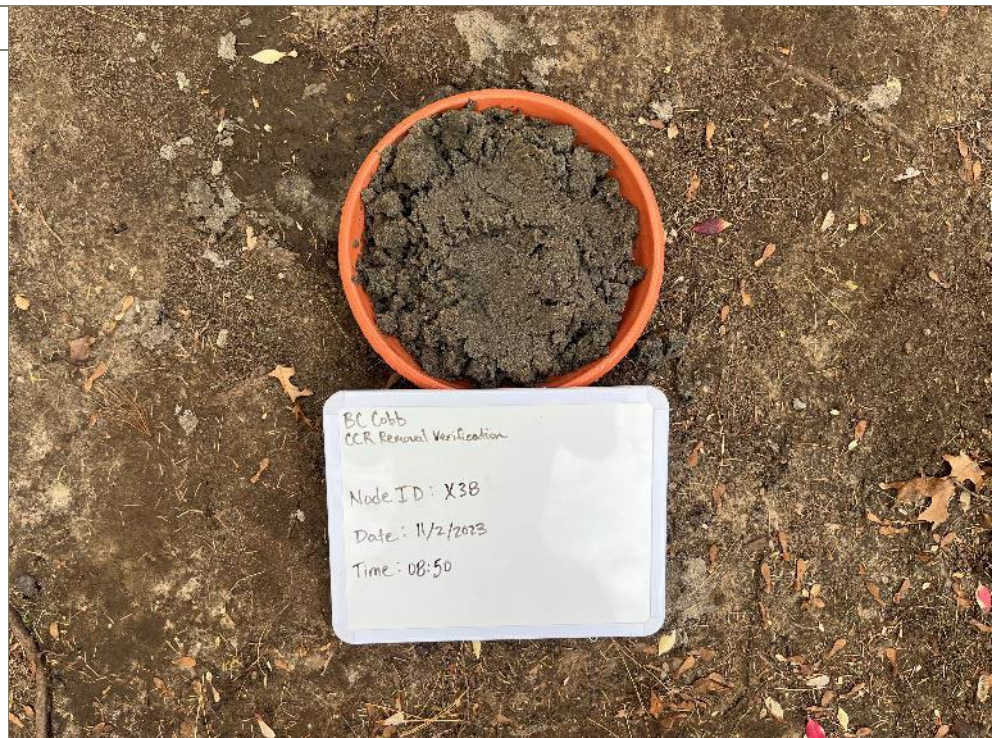
Photograph No. 20

Node: X38

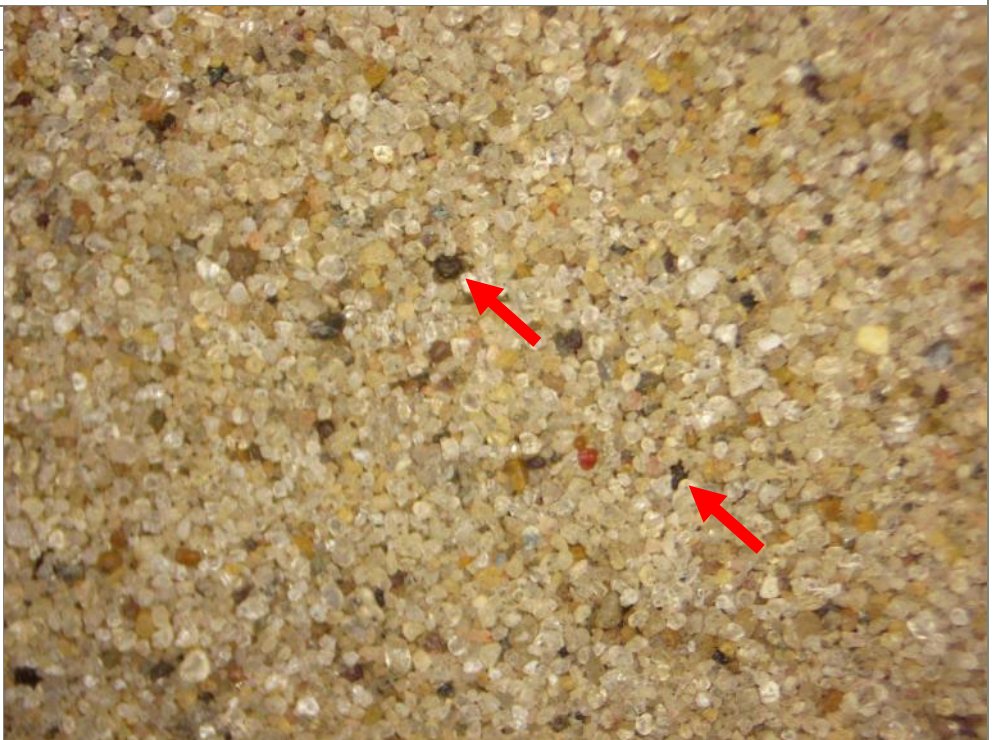
Photograph No. 2	
<p>Node: X18</p> <p>HDR Microscopic Quantification Result: 1-2%</p> <p>Note: Sporadic small CCR particles (red arrows) mixed with clean sand. Some dark particles appear to be natural sands.</p>

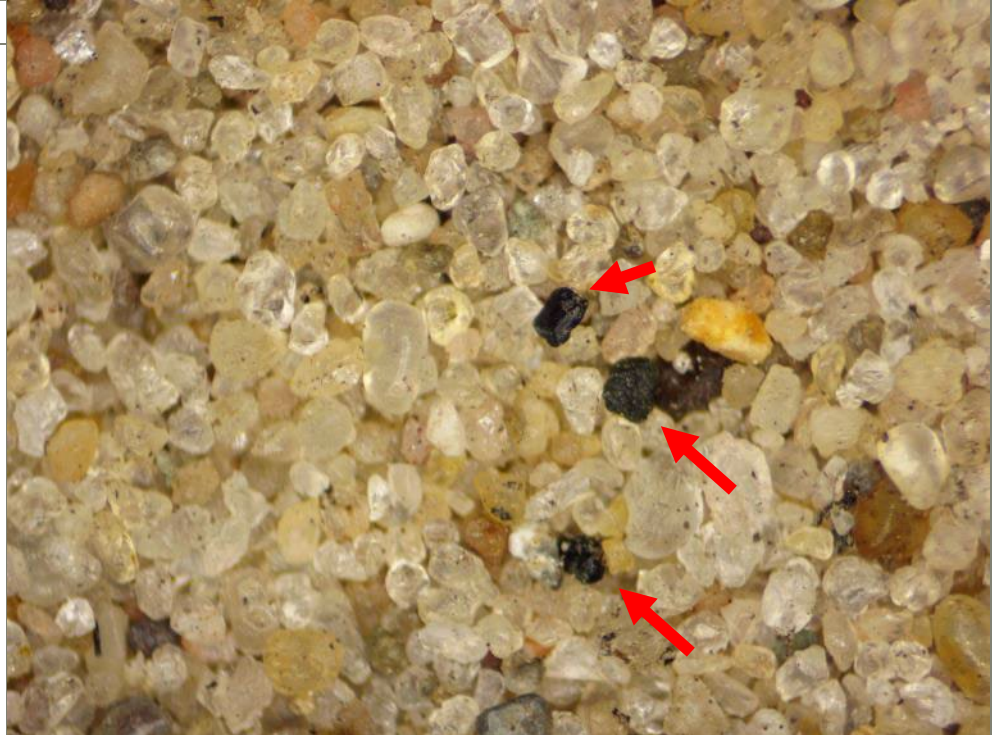
Photograph No. 3

Node: X29

HDR Microscopic Quantification Result:
1%

Note: Clean natural sands with sporadic CCR particles (red arrows).

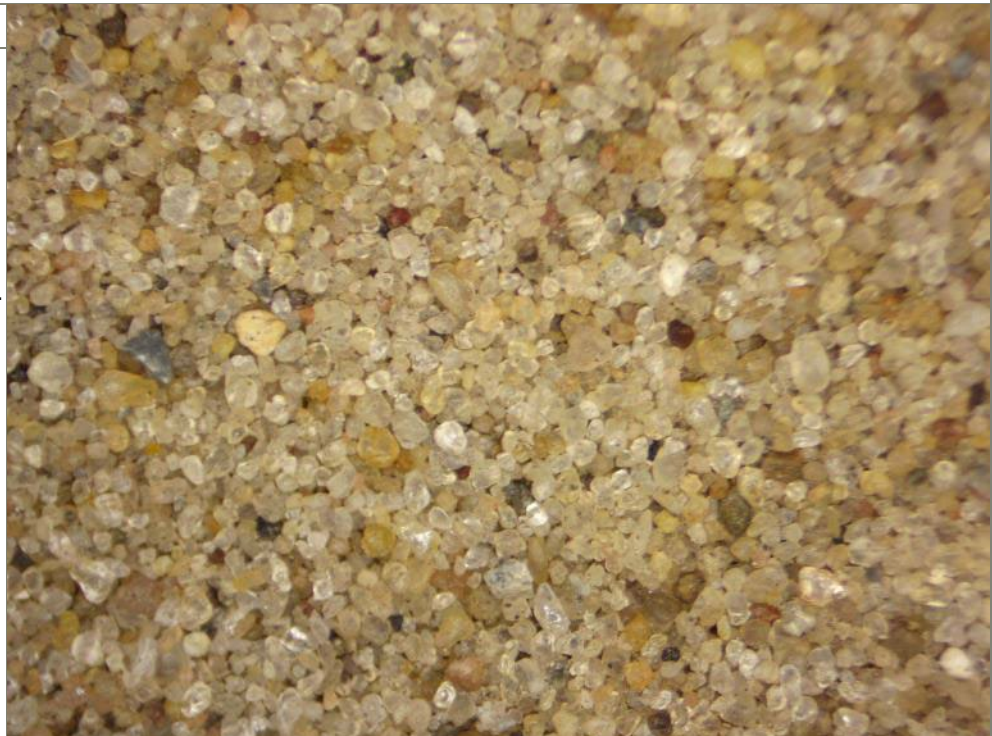
Photograph No. 4

Node: X37

HDR Microscopic Quantification Result:
<1%

Note: Clean natural sands.
