# 2025 Annual Inspection Report

For Compliance with the EPA Coal Combustion Residuals (CCR) Rule  
40 CFR §257.83(b)

Former B.C. Cobb Power Plant  
Ponds 0-8 and Bottom Ash Pond

May 15, 2025

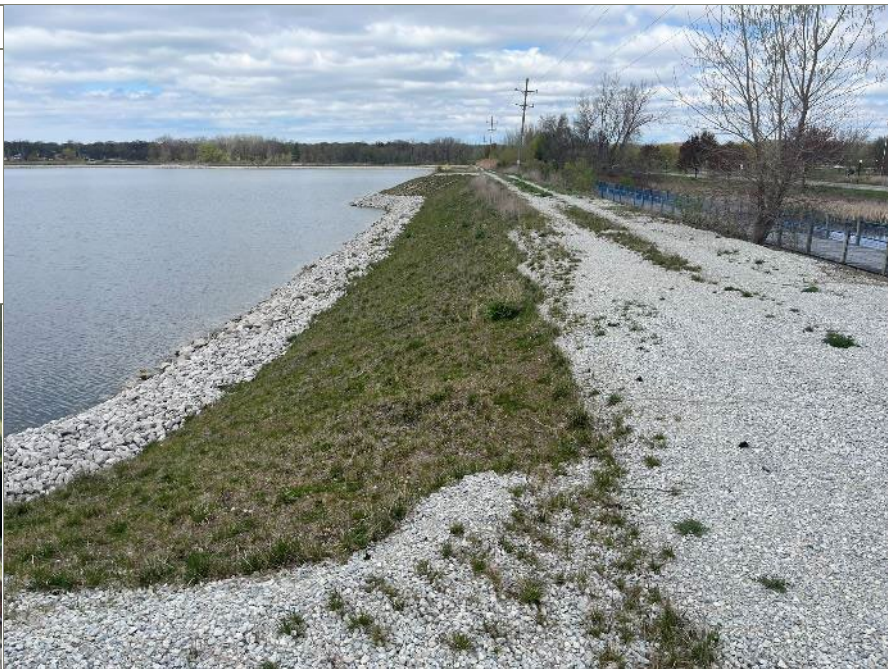
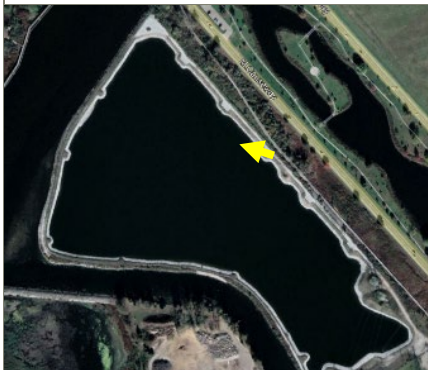
| Client Name: | | Site Location: | Photographic Log |
|---|--|---|---|
| <b>Photograph No. 1</b> | | | |

The North Embankment separates the impoundment to the south and the North Causeway (M-120) and Muskegon Lakeshore Trail to the north. The North Embankment appeared to be in good condition (Photos 1 and 2) and no evidence of movement, settlement, cracking, distress, erosion, seepage, animal burrows or other adverse conditions was observed in the crest and interior and exterior slopes, except as noted herein.

| Client Name: | | Site Location: | Photographic Log |
|---|--|---|---|
| Description:<br>Interior slope of North Embankment. | | | |

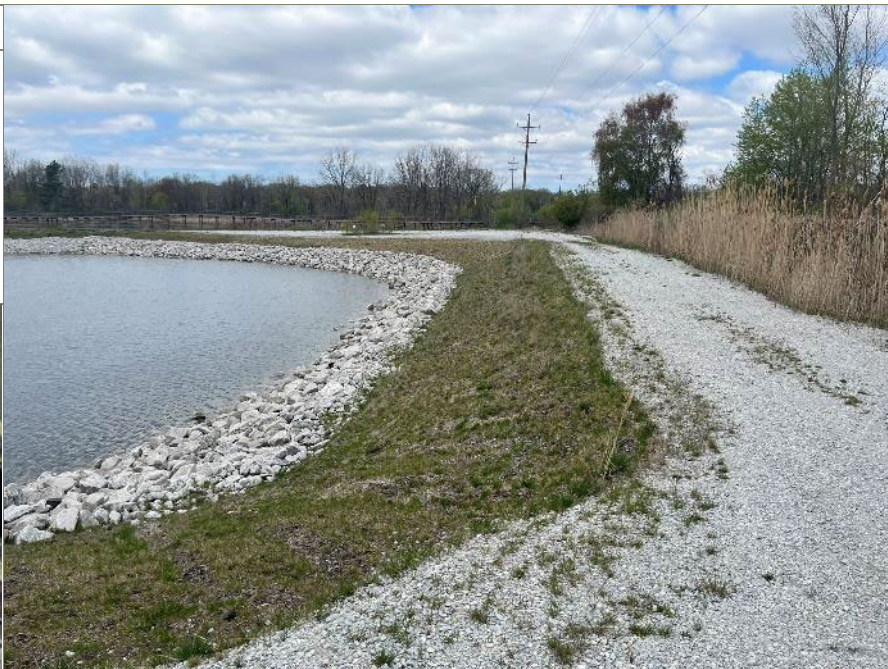
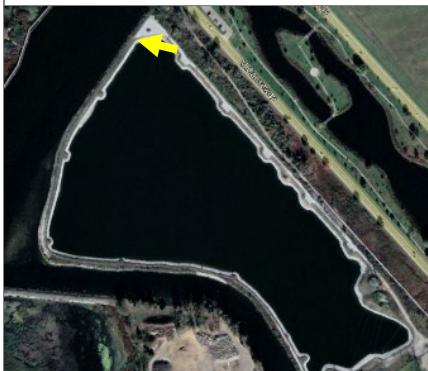
| Client Name: | | Site Location: | Photographic Log |
|---|--|---|---|
| <b>Photograph No. 2</b> | | | |

- Vegetation overgrowth was observed on the exterior slope.

| Client Name: | | Site Location: | Photographic Log |
|---|--|---|---|
| Description:<br>Interior slope of North Embankment. | | | |

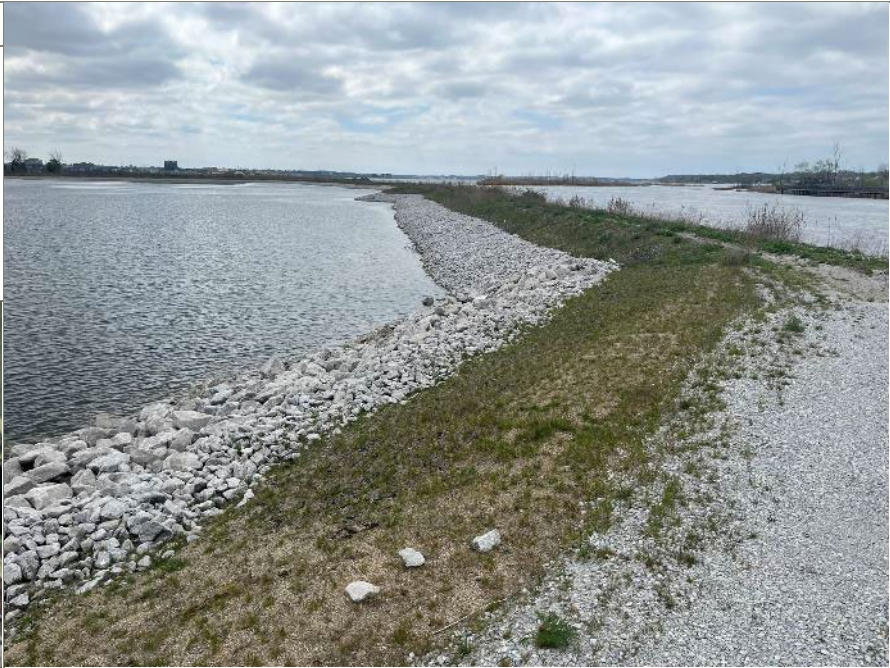
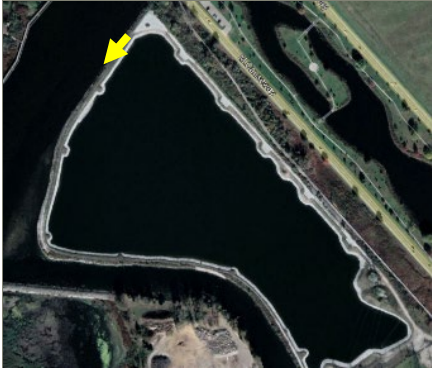
| Client Name: | Site Location: | Photographic Log |
|---|---|---|
| <b>Photograph No. 3</b> | | |

- The interior slope of the West Embankment was recently reinforced with stone rip rap protection and seeding (Photo 3).
- Rip-rap protects the exterior slope, which was in good condition.
- Some minor vegetation overgrowth was observed on the exterior slope.

| Client Name: | Site Location: | Photographic Log |
|---|---|---|
| Description:<br>Interior slope of West<br>Embankment. | | |

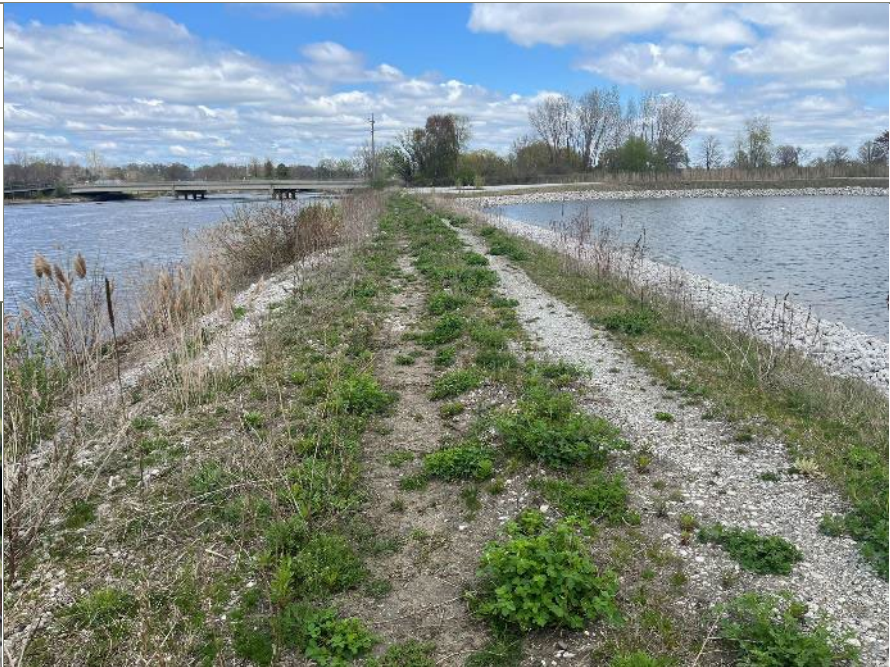
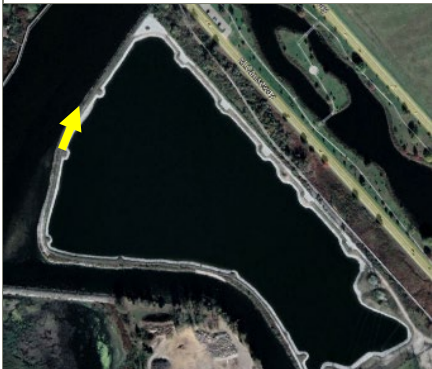
| Client Name: | Site Location: | Photographic Log |
|---|---|---|
| <b>Photograph No. 4</b> | | |

The West Embankment separates the impoundment to the east and the Muskegon River to the west. The West Embankment appeared to be in good condition (Photos 3 and 4) and no evidence of movement, settlement, cracking, distress, erosion, seepage, animal burrows or other adverse conditions was observed in the crest and interior and exterior slopes, except as noted herein.

| Client Name: | Site Location: | Photographic Log |
|---|---|---|
| Description:<br>Crest of West Embankment. | | |

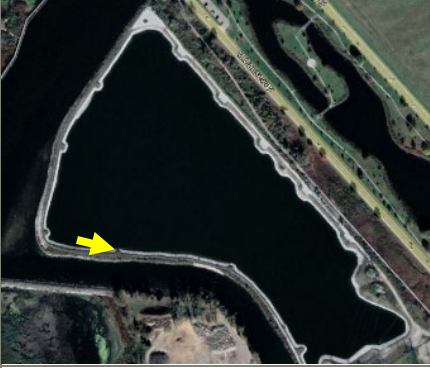
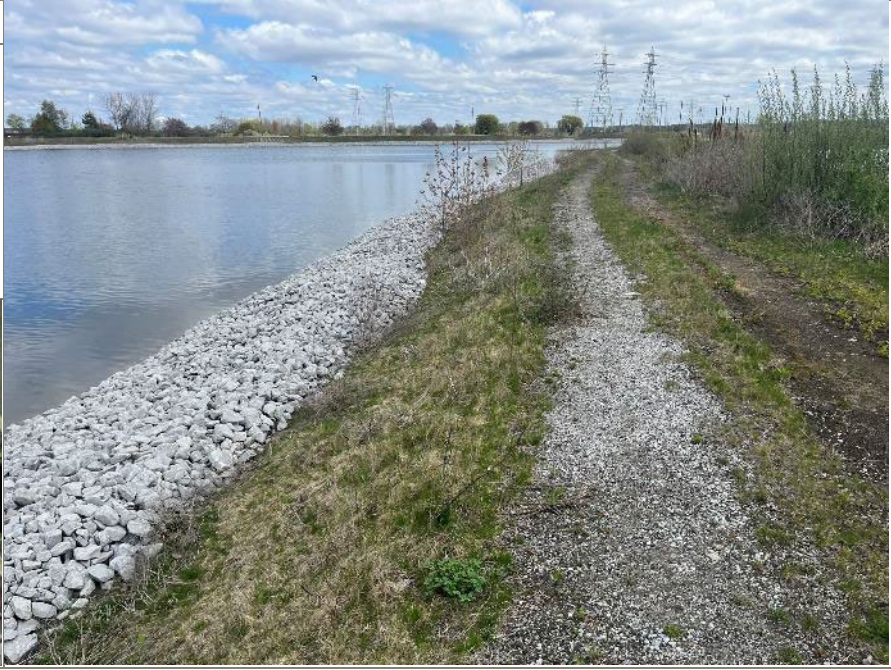
- The interior slope of the South Embankment was reinforced with stone rip-rap protection and seeding in 2023 (Photo 5).
- The crest of the embankment consisted of a gravelly/soil surface (Photos 5 and 6).
- Rip-rap protects the exterior slope in one area near the outflow (Photo 7) due to previous erosion repair, which was in good condition.
- Vegetation is overgrown on the exterior slope.

| Client Name: | Site Location: | Photographic Log |
|---|---|---|
| <p><b>Photograph No. 5</b></p> <p>Description:<br/>Crest and interior slope of South Embankment.</p> | | |

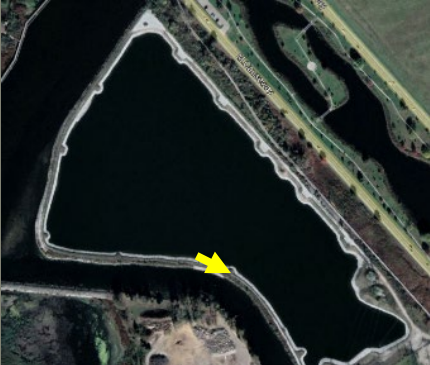
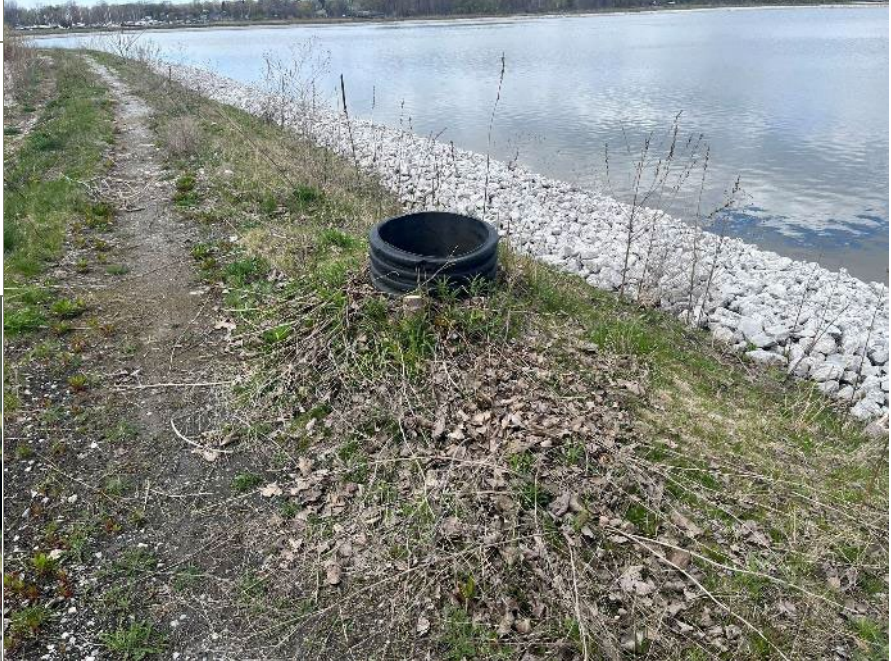
| Client Name: | Site Location: | Photographic Log |
|---|---|---|
| <p><b>Photograph No. 6</b></p> <p>Description:<br/>Dewatering inlet in crest of South Embankment connecting to NPDES outfall. Connection appeared in good condition.</p> | | |

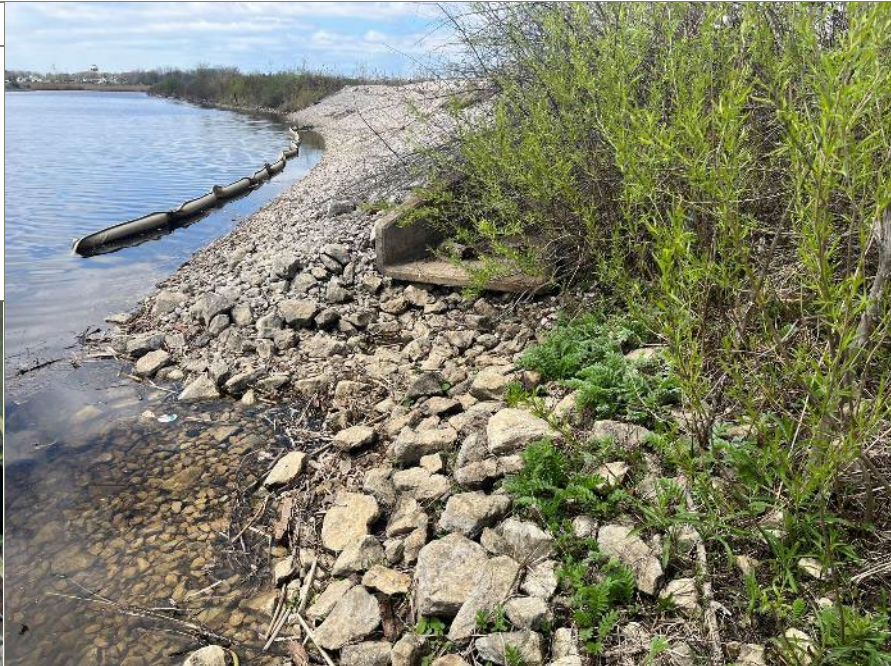
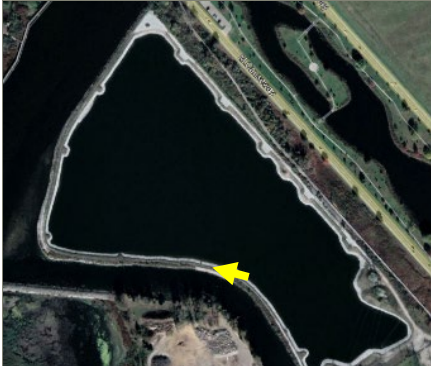
| Client Name: | Site Location: | Photographic Log |
|---|---|---|
| <b>Photograph No. 7</b> | | |

Prior to decommissioning the impoundment system, the pond network discharged from Pond 4 through the South Embankment via one 24-inch diameter HDPE outflow pipe to the permitted NPDES outflow (Photo 7) which was installed with a concrete headwall and endwall. There is no water currently exiting the outfall. Additionally, there was no evidence

of settlement, sinkholes, or cracking in the area of the embankment above the pipes extending through the South Embankment.

| Client Name: | Site Location: | Photographic Log |
|---|---|---|
| Description:<br>NPDES outflow on exterior slope of South Embankment adjacent to Discharge Channel. No flow of water exiting outflow. | | |
