## CCR Removal Report

Former B.C. Cobb Power Plant  
Bottom Ash Pond and Ponds 0-8

September 19, 2022

*Prepared by:*  
HDR MICHIGAN, Inc.  
5405 Data Court  
Ann Arbor, Michigan 48108

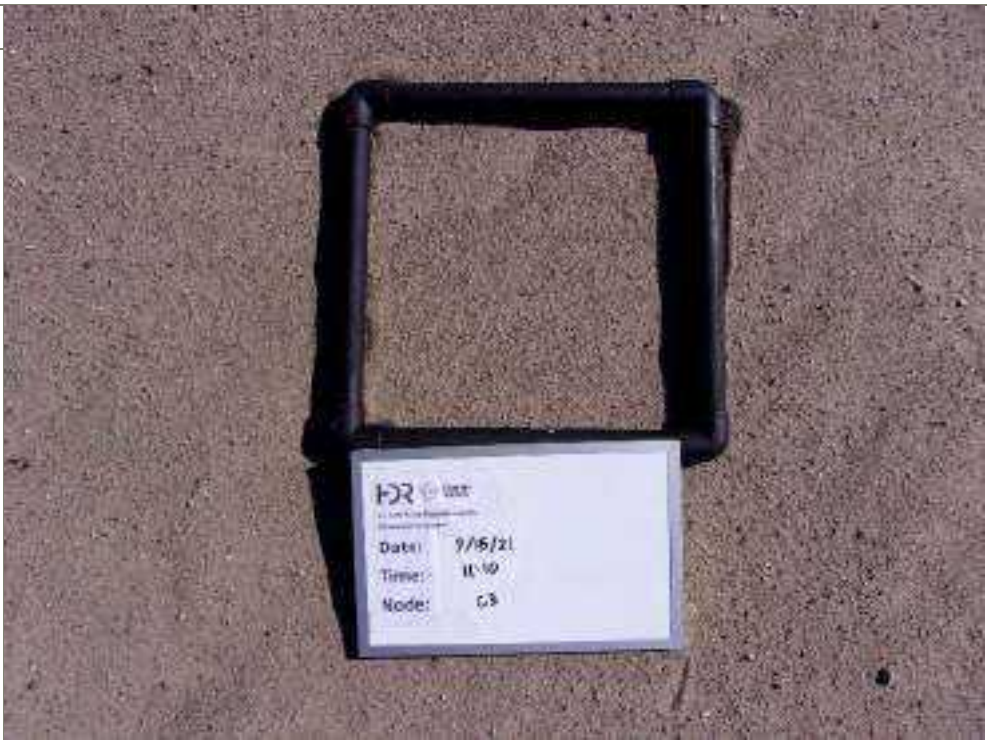
Client Name:	Site Location:	Node Photographic Log
Muskegon Environmental Redevelopment Group, LLC (MERG)	Former B.C. Cobb Power Plant Bottom Ash Pond and Ponds 0-8 Muskegon, Michigan	HDR Project No. 10220433
<p><b>Photograph No. 21</b></p> <p>Node: C3</p> <p>HDR Microscopic Quantification Result: 1-2%</p>

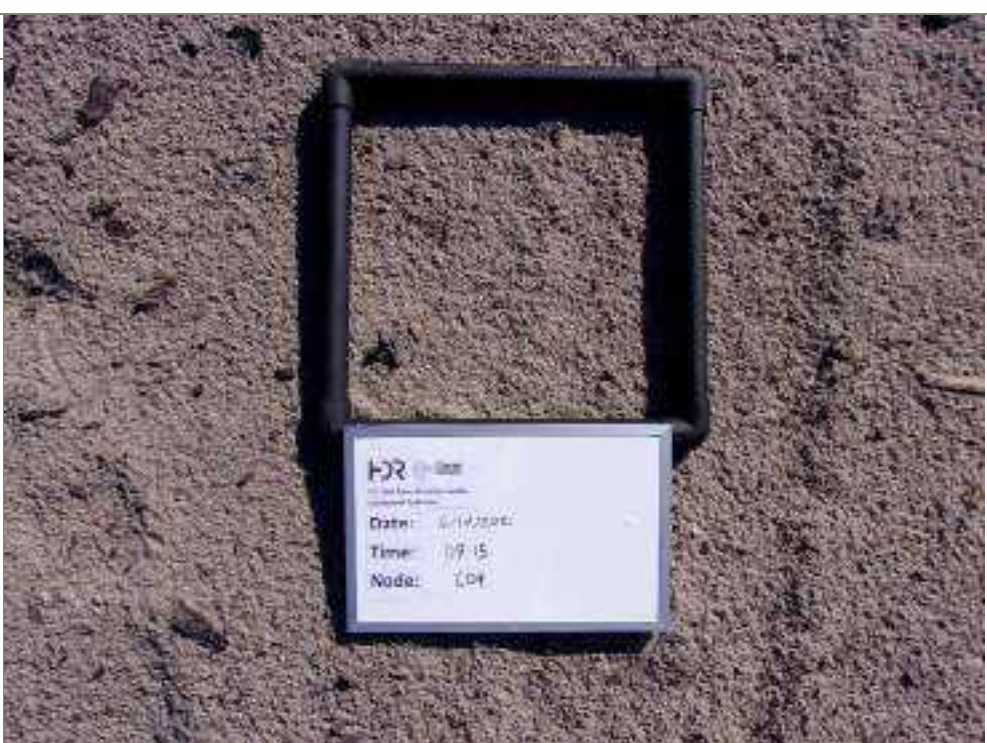
<p><b>Photograph No. 22</b></p> <p>Node: C4</p> <p>HDR Microscopic Quantification Result: 2-3%</p>

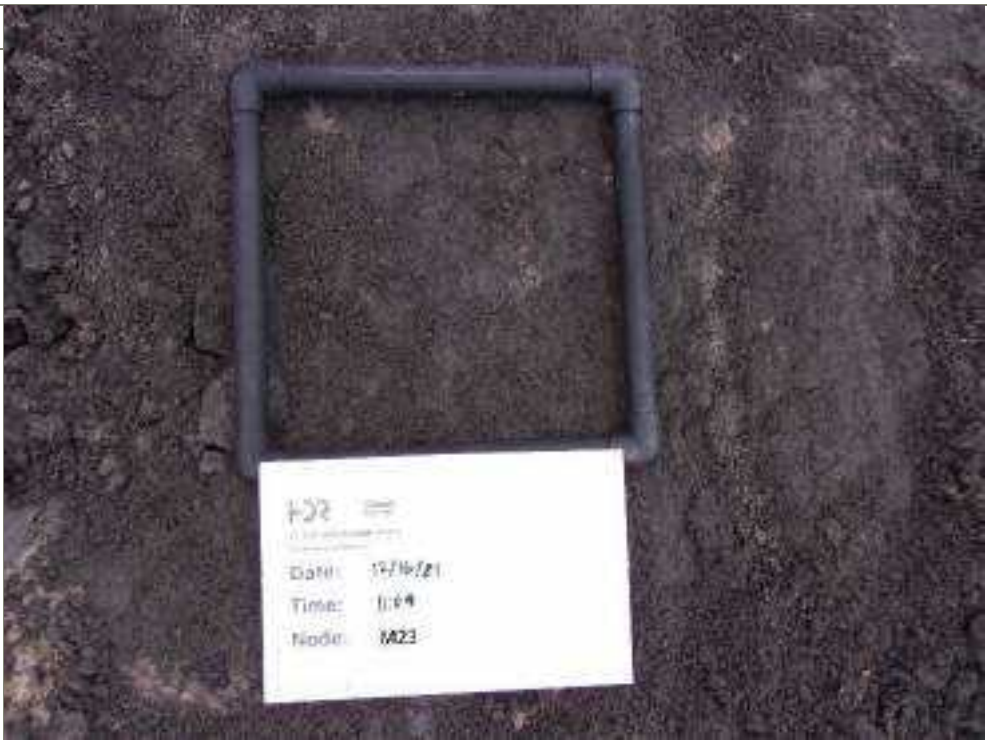
Client Name:	Site Location:	Node Photographic Log
Muskegon Environmental Redevelopment Group, LLC (MERG)	Former B.C. Cobb Power Plant Bottom Ash Pond and Ponds 0-8 Muskegon, Michigan	HDR Project No. 10220433
<p><b>Photograph No. 226</b></p> <p>Node: M23</p> <p>HDR Microscopic Quantification Result: 80-90%</p>

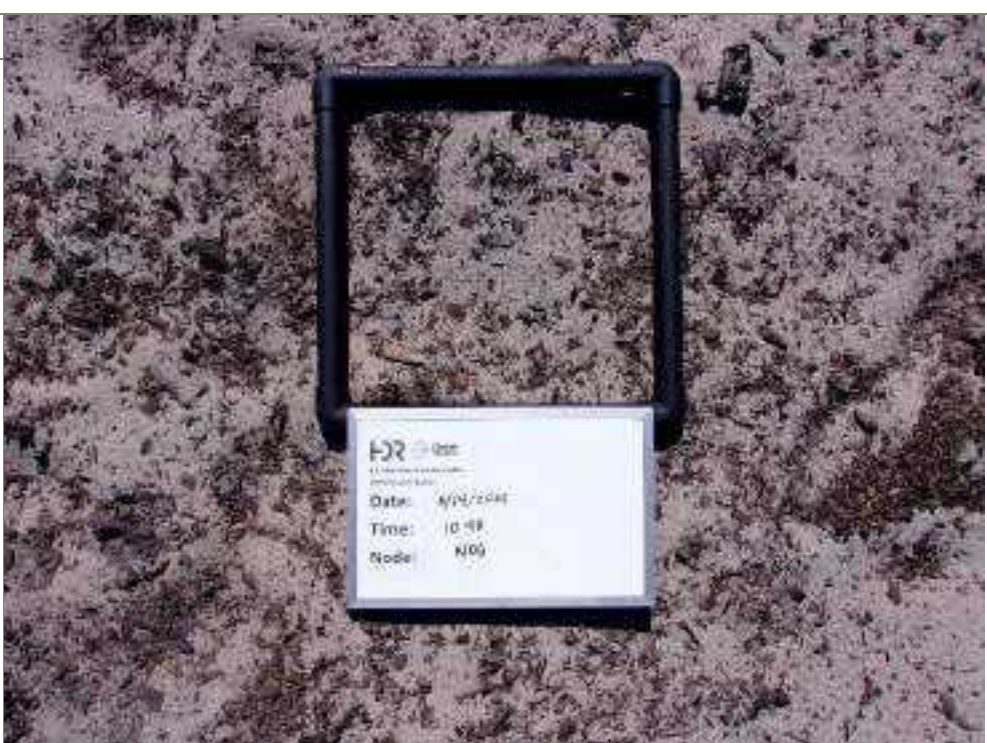
<p><b>Photograph No. 227</b></p> <p>Node: N6</p> <p>HDR Microscopic Quantification Result: 20-25%</p>

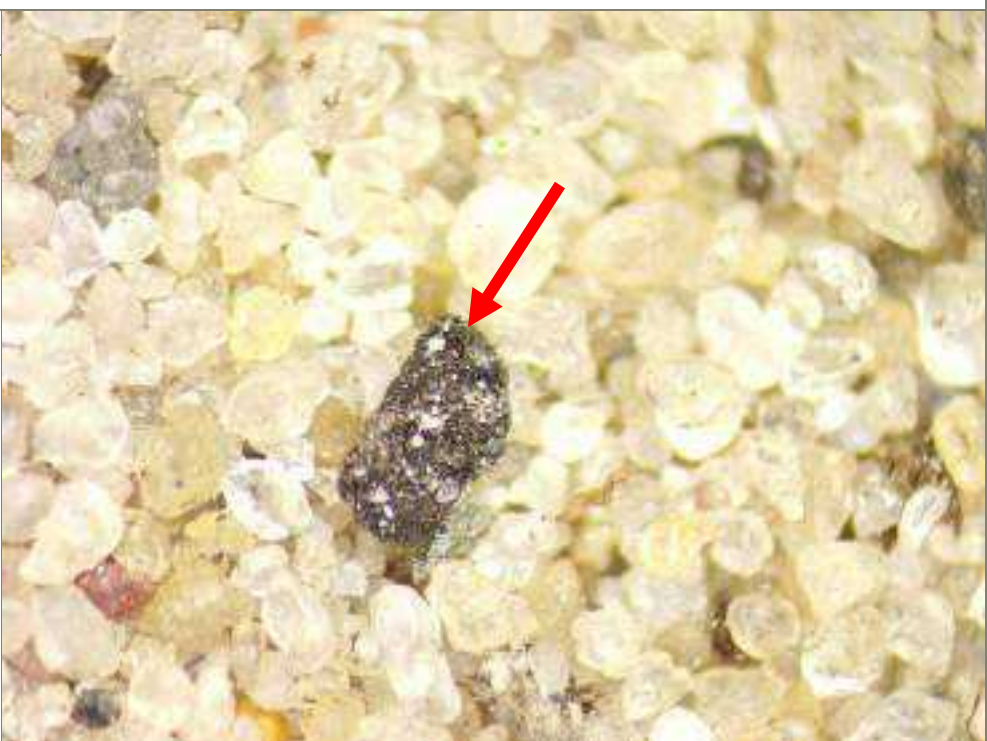
<p><b>Photograph No. 6</b></p> <p>Node: B21</p> <p>HDR Microscopic Quantification Result: &lt;1%</p> <p>Note: Very clean sand with light colored and transparent quartz. Red arrow indicates CCR particle.</p>

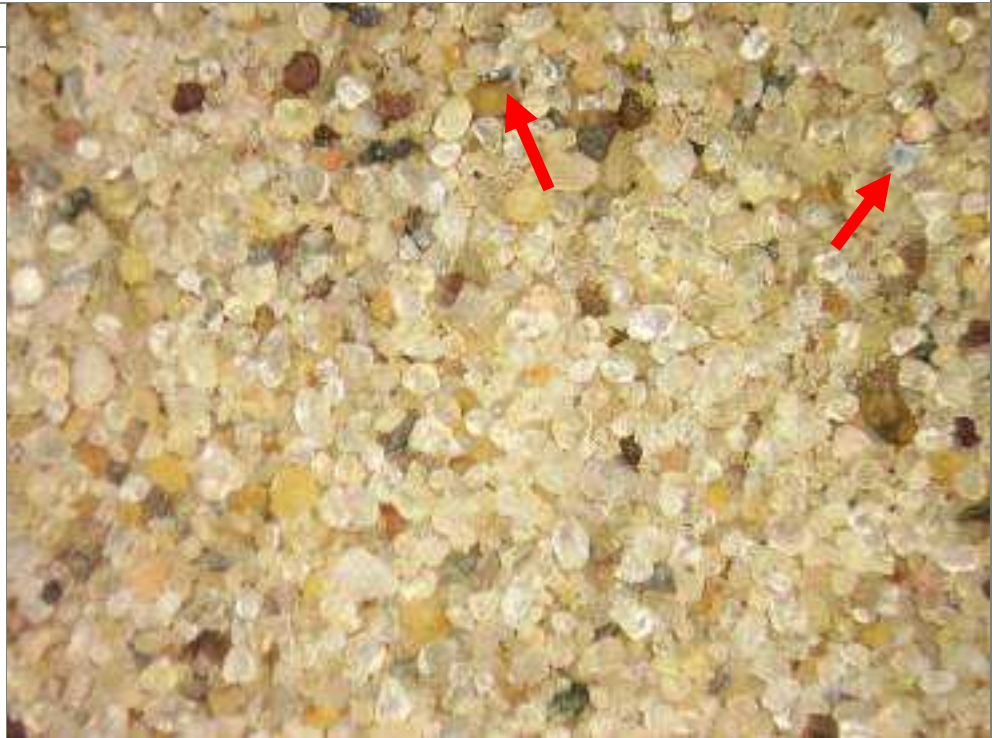
Note: Clean sand, small  
white/gray slag like  
material present (red  
arrows) but scarce.

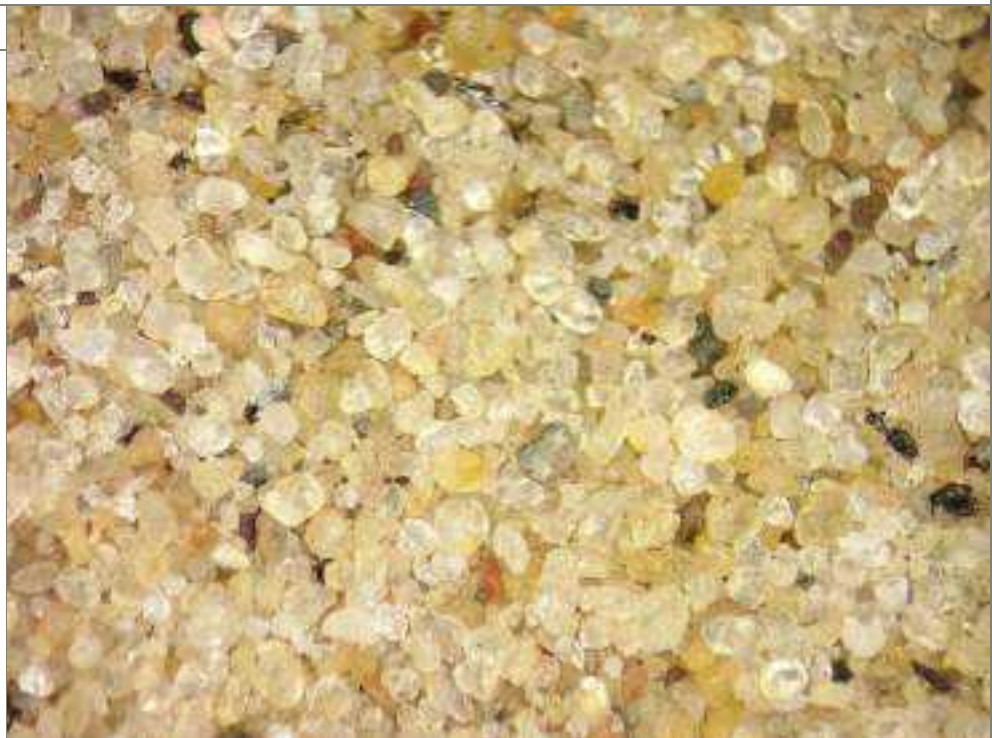
**Photograph No. 8**

Node: D6

Note: Clean sand with  
various organic material  
present. Scarce CCR  
present.

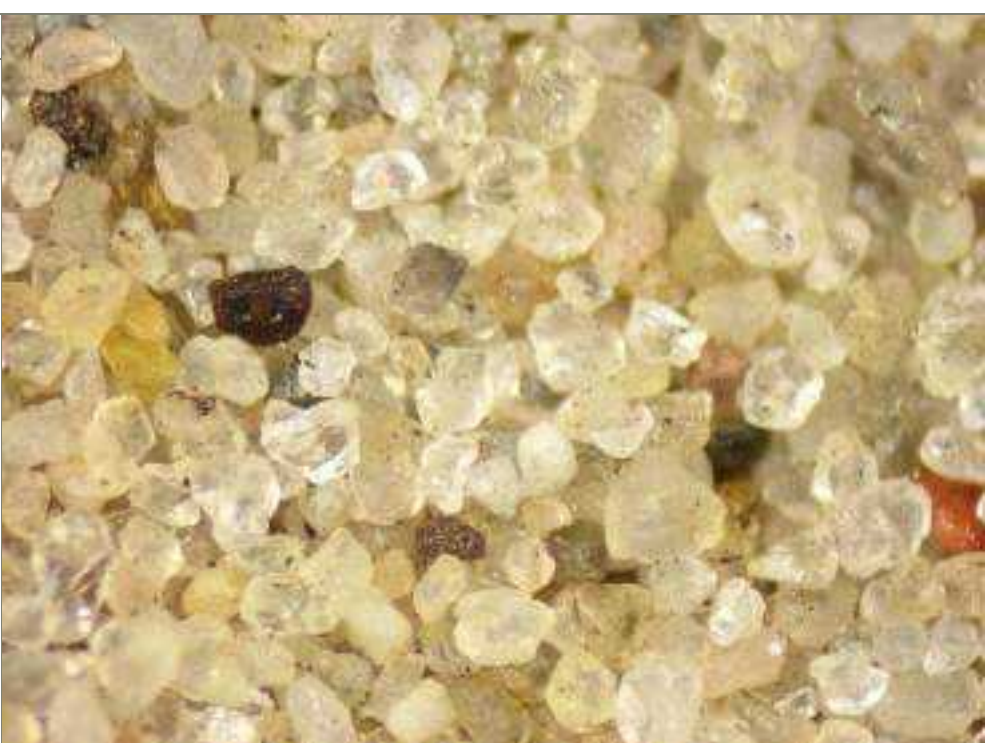
<p><b>Photograph No. 22</b></p> <p>Node: U10</p> <p>HDR Microscopic Quantification Result: &lt;1%</p> <p>Note: Clean sand particles.</p>

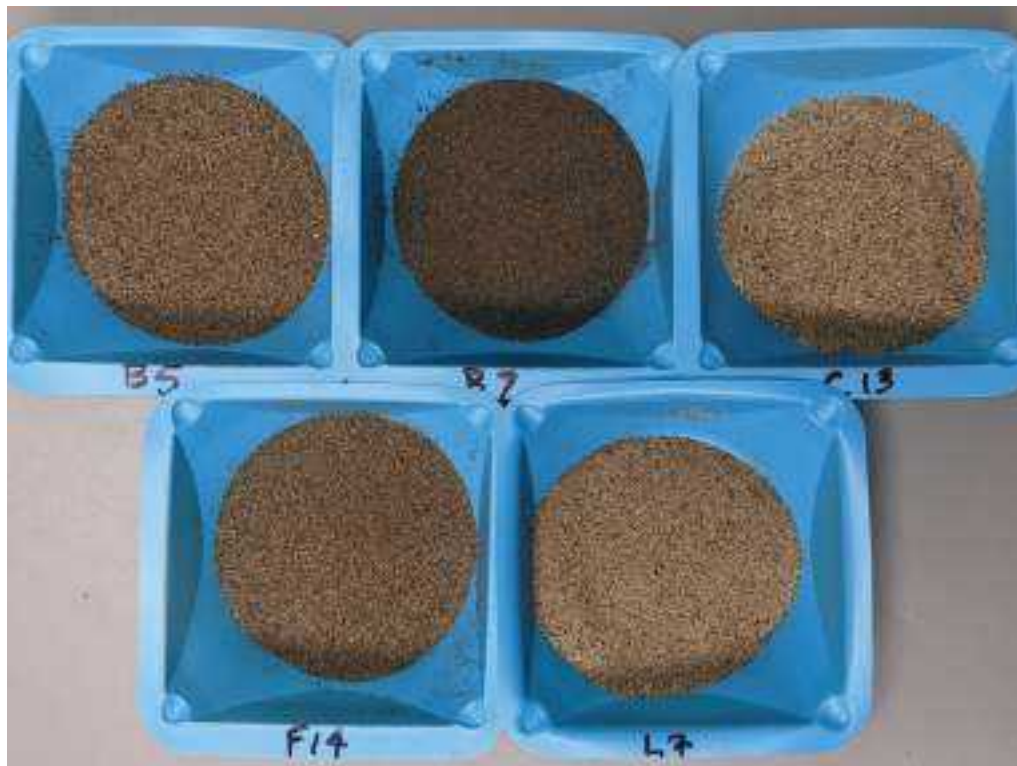
**Fig. 1** Top photograph shows the samples received for examination. Bottom photograph shows a ~35 gram portion of each labeled sample.

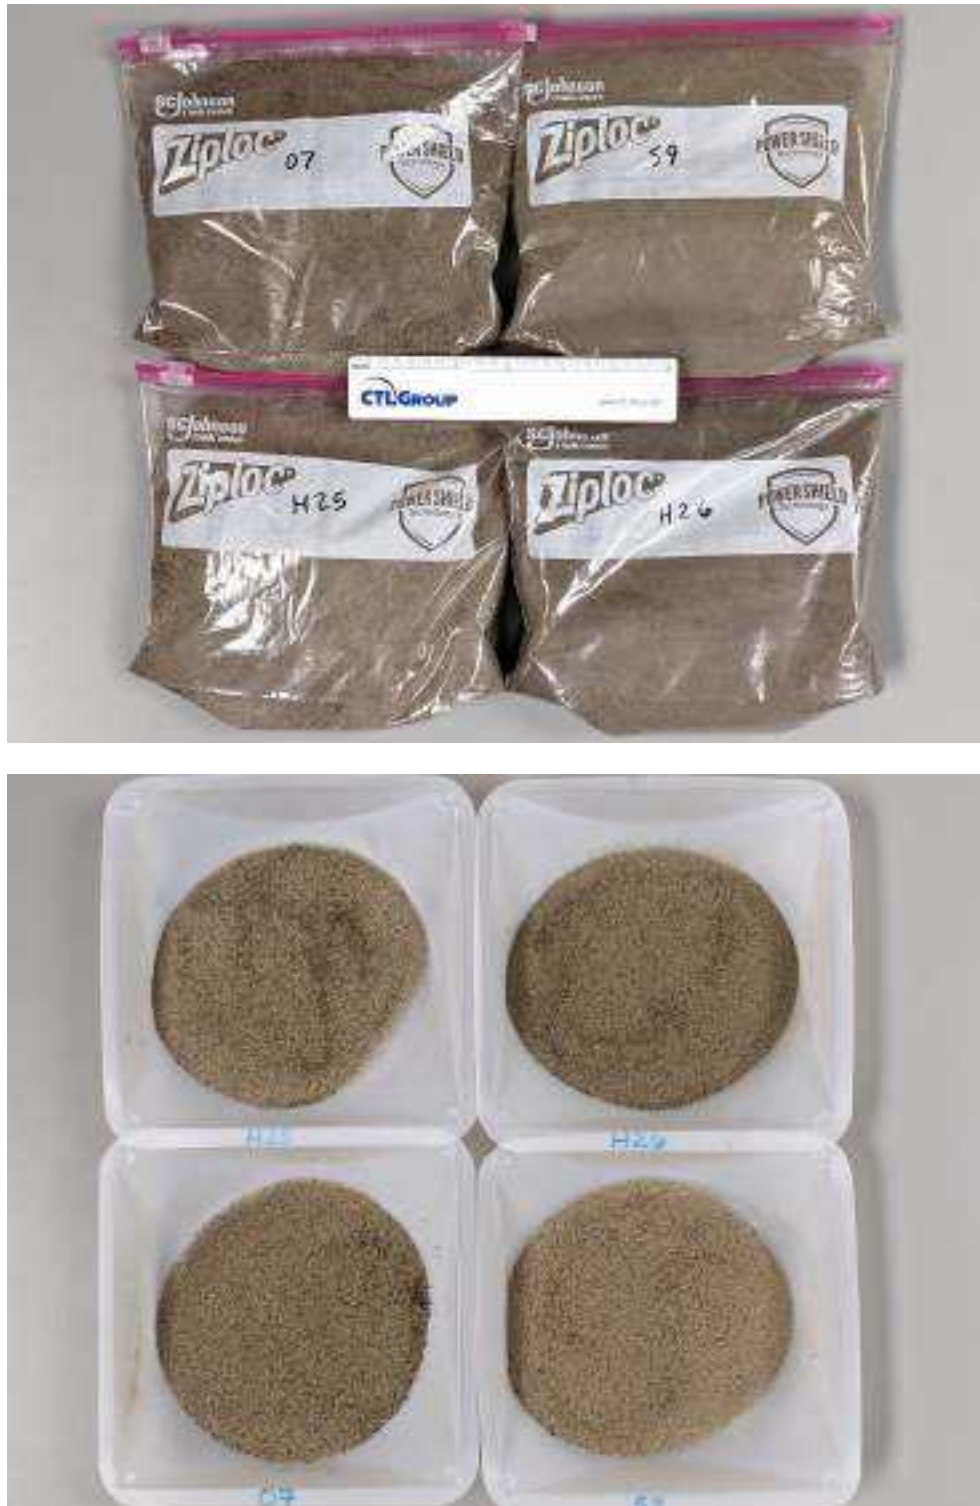
Fig. 1 Top photograph shows the samples received for examination.  
Bottom photograph shows the 35 to 38 gram test specimens.

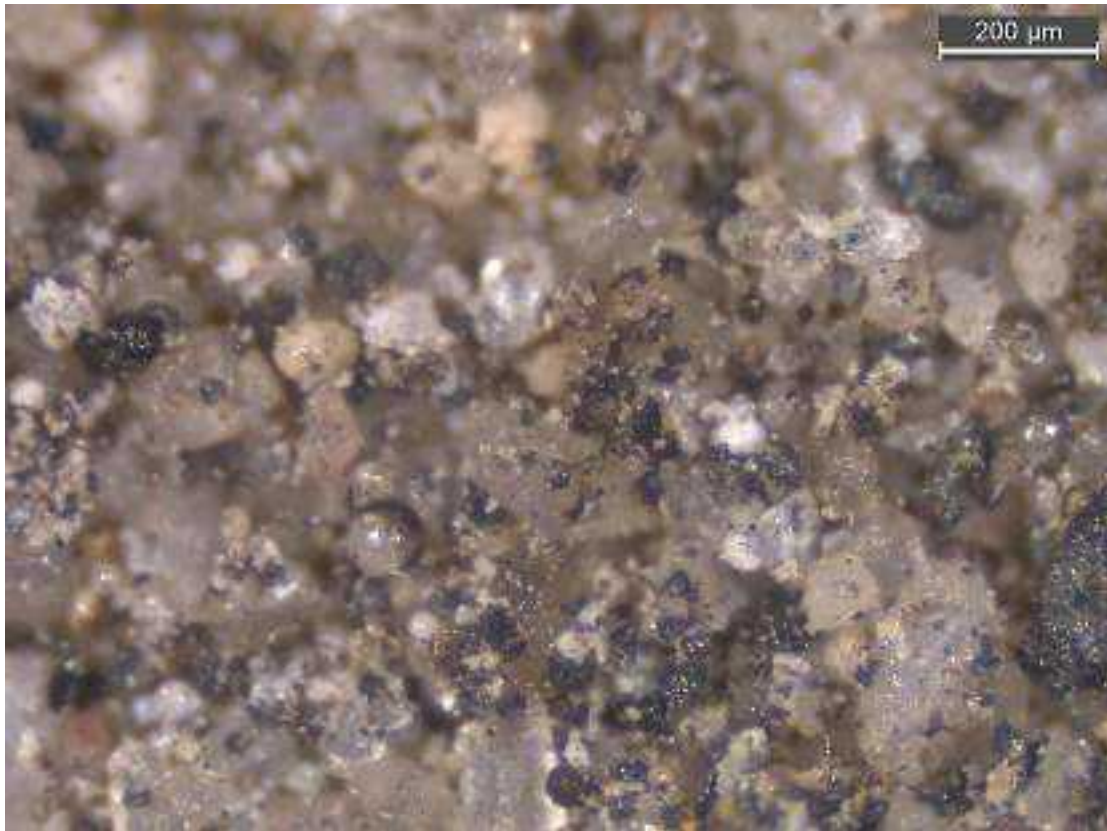
**Fig. 6 Sample O7 Fines (minus No. 100 sieve). Black particles and spherical white particles are CCR.**

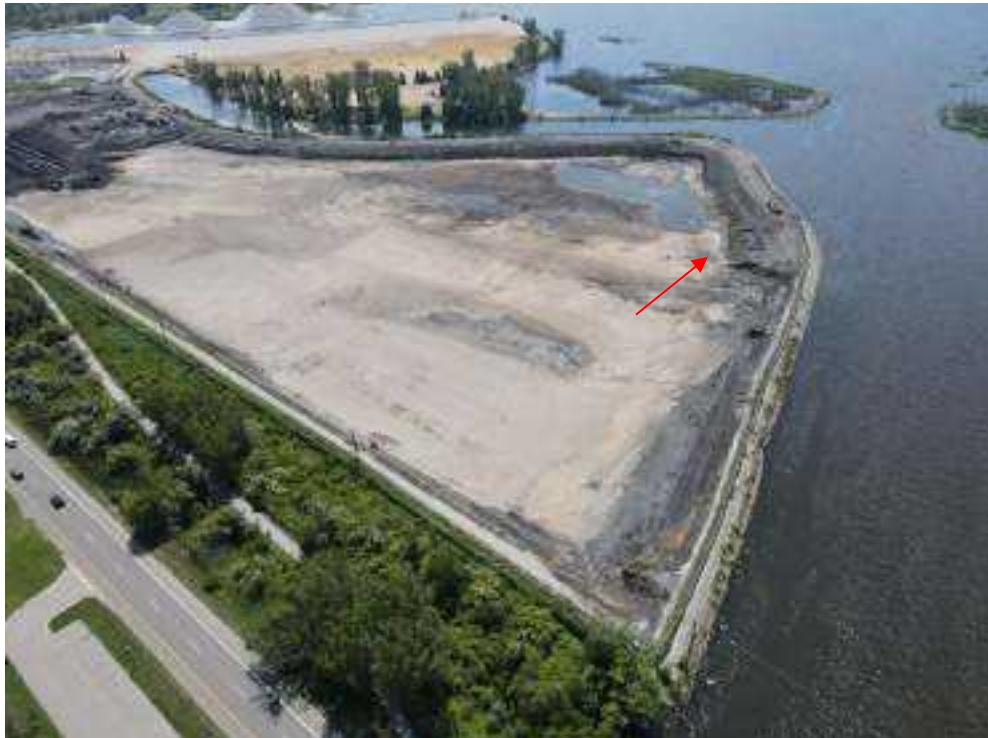
This memorandum provides the review and recommendation of the current proposed excavation planned adjacent to the western perimeter embankment adjacent to former CCR Ponds 2 and 3. HDR understands that Muskegon Environmental Redevelopment Group LLC (MERG) has removed CCR across Ponds 2 and 3 and is currently at, or slightly below, design excavation grade (El. 576 to 578) adjacent to the western perimeter berm (approximate area identified by red arrow in image below).

MERG indicated that CCR is still present at the current excavation bottom elevation, which is at, or slightly below, the originally proposed excavation grade. MERG has requested HDR to provide guidance on the minimum elevation that could be safely excavated without impacting the stability of the perimeter berm.

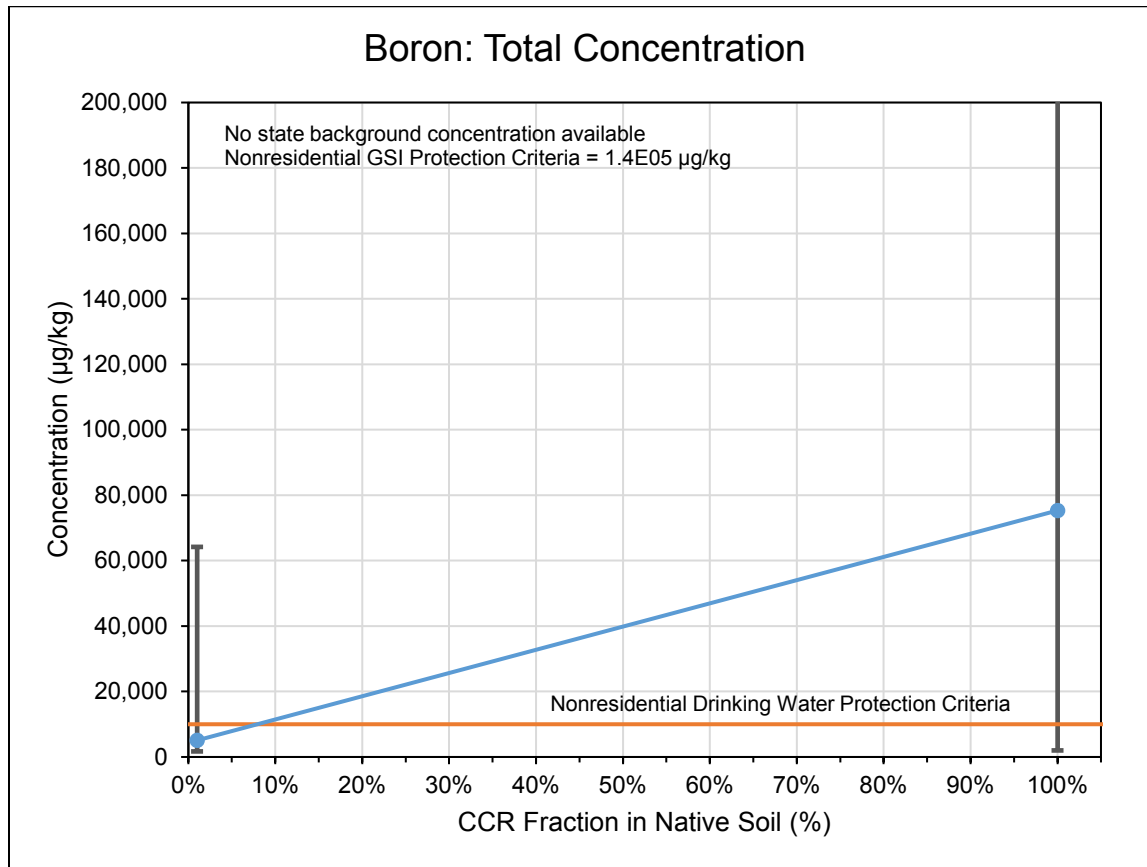
**Figure 4 – Boron Concentrations in CCR and Native Soils**

Orange line shows Nonresidential Drinking Water Protection criteria for boron in soil (10,000 µg/kg).  
Blue line shows average metals concentrations in CCR and native soil connected by a trend line to allow comparison.  
Error bars show maximum and minimum concentrations measured in all 64 CCR and 48 underlying native soil samples.
