# Structural Stability and Safety Factor Assessment

For Compliance with the EPA Coal  
Combustion Residuals (CCR) Rule  
40 CFR §257.73(d)  
40 CFR §257.73(e)

Former B.C. Cobb Power Plant  
Ponds 0-8 and Bottom Ash Pond

June 29, 2021

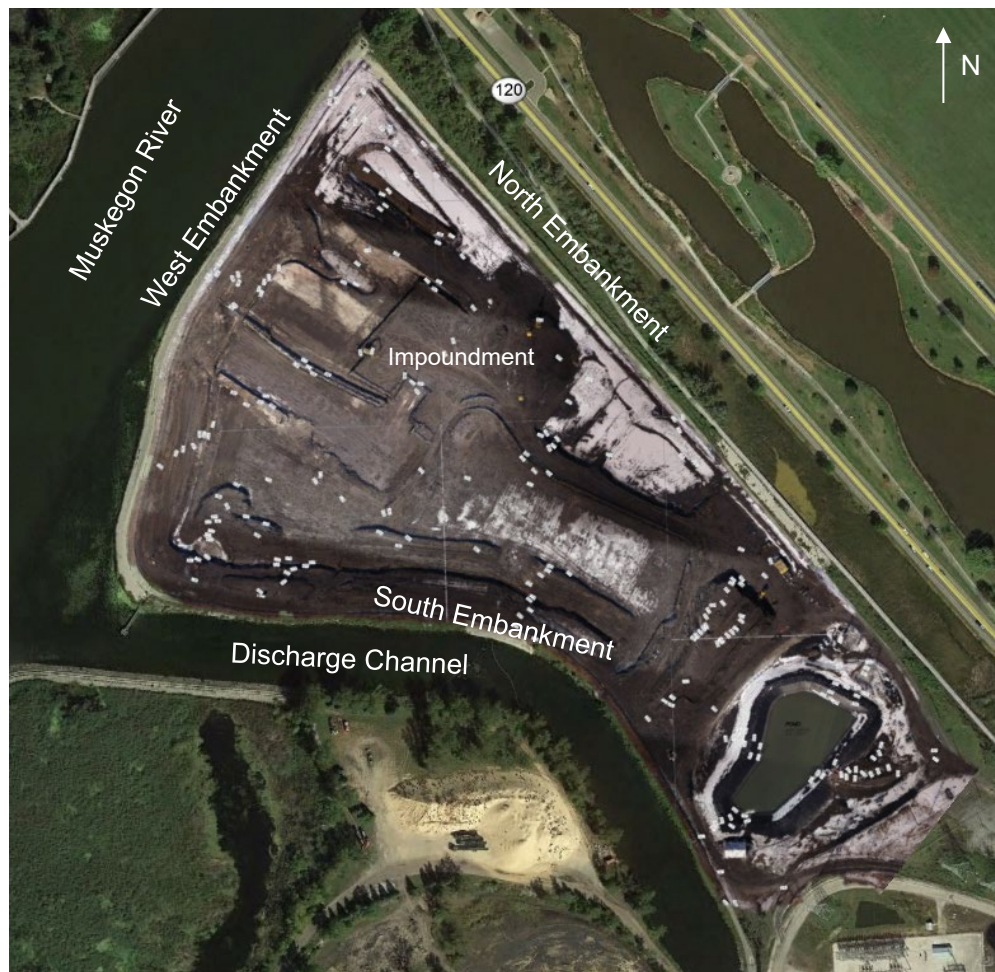
**Figure 2. Aerial Image of Impoundment During Excavation**

Figure 2 presents an aerial view of the CCR impoundment as of February 2021, displaying the ongoing excavation of Ponds 0-8 and the Bottom Ash Pond as well as the terminology of the embankment sections used in this report.

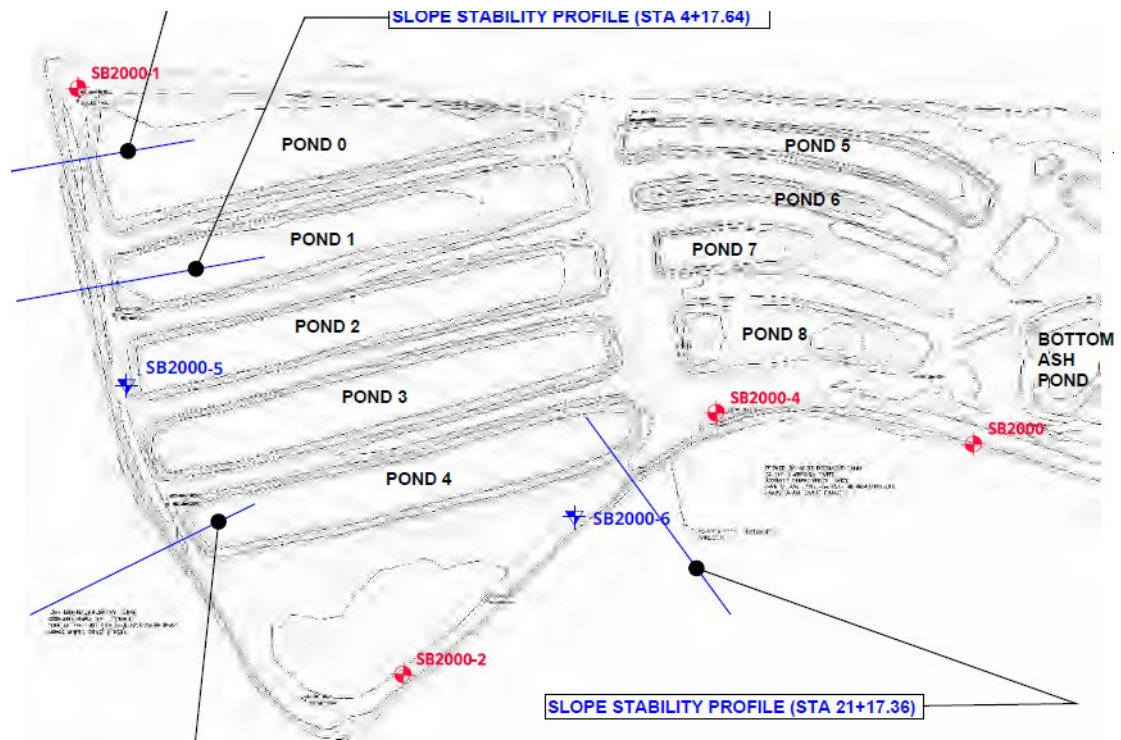
**Figure 3. Approximate Boring Locations**

The approximate locations of the borings performed by SME are shown on Figure 3 of SME 2020 (Ref. [18]) and also in Figure 3 below. The boring logs are provided in Attachment 1.

The recent boring logs prepared by SME 2020 indicate that the foundation of the perimeter embankments (top of the natural sands encountered in the borings) ranges from approximately El. 573 to 582 feet. The foundation material is comprised primarily by alternating layers of granular material (i.e. sand, silty sand, sandy silt) from the foundation surface to depths of approximately 25 to 33 feet (approximately El. 543 to 547 feet ) below the original foundation grade where it is underlain by cohesive material consisting of silty clay and lean clay. Traces of silt and gravel, organic clay, peat, and organic matter were observed in the alternating sand and silt layers.

Field density tests performed on the granular material (Standard Penetration Test (SPT) blow counts) indicated that the granular soils ranged from very loose to dense, with blow counts ranging from 0 to 41 blows per foot. Undrained shear strengths obtained from field estimates with a hand penetrometer or torvane in the cohesive soils ranged from 400 psf (soft) to 2,100 psf (stiff). Moisture contents in the cohesive soils ranged between 22 and 79 percent.

The previous subsurface investigation documentation along with the history of no instability in the foundation material indicates that the foundation is competent and stable. The assessment of abutment stability required by the CCR Final Rule is not applicable, as the embankments are continuous.
