2022 Annual Inspection Report

For Compliance with the EPA Coal Combustion Residuals (CCR) Rule
40 CFR §257.83(b)

Former B.C. Cobb Power Plant
Ponds 0-8 and Bottom Ash Pond

May 26, 2022

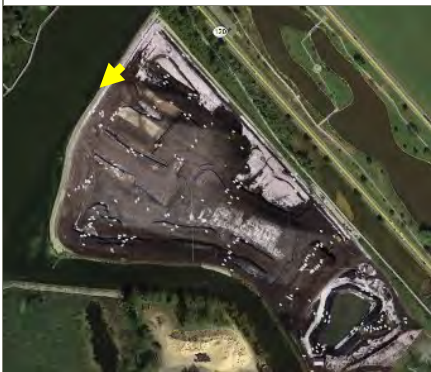
| Client Name: | Site Location: | Photographic Log |
|---|--|--|
| Photograph No. 5 | | |

- Rip-rap protects the exterior slope (Photo 5), which was in good condition.
- Some minor vegetation overgrowth was observed on the exterior slope (Photo 5).

| Client Name: | Site Location: | Photographic Log |
|---|--|--|
| Description: Exterior slope of West Embankment adjacent to Muskegon River. Note vegetation on exterior slope. | | |

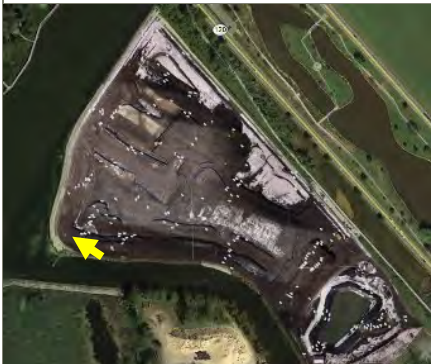
| Client Name: | Site Location: | Photographic Log |
|---|--|--|
| Photograph No. 6 | | |

| Client Name: | Site Location: | Photographic Log |
|---|--|--|
| Description: Interior slope of South Embankment adjacent to Discharge Channel. Note rip-rap protected monitoring wells at top left of photo. | | |
