2023 Annual Inspection Report

For Compliance with the EPA Coal
Combustion Residuals (CCR) Rule
40 CFR §257.83(b)

Former B.C. Cobb Power Plant
Ponds 0-8 and Bottom Ash Pond

May 17, 2023

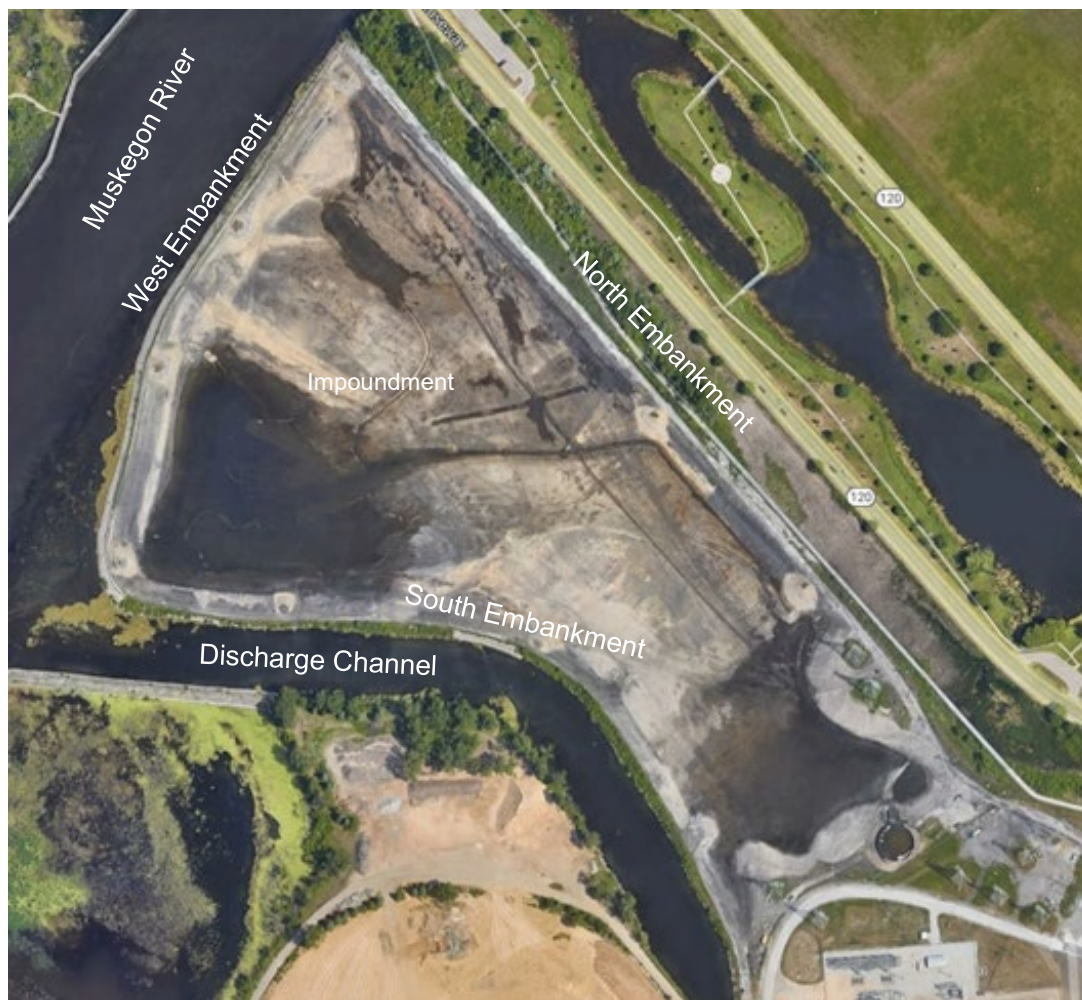
Figure 3. B.C. Cobb Site Terminology

The visual inspection was conducted in accordance with the CCR Final Rule to identify signs of distress or malfunction of the CCR unit and appurtenant structures and consisted of observations of features and conditions readily discernible by external visual inspection through reasonable efforts. Relevant photographs with the corresponding photograph locations are provided in Appendix A and the Inspection Checklist Form is provided in Appendix B. A discussion of the embankment conditions is presented in the following subsections and the terminology describing the embankment sections is shown in Figure 3.
