# CCR Removal Report

Supplement No. 2

Former B.C. Cobb Power Plant  
Bottom Ash Pond and Ponds 0-8

June 8, 2023

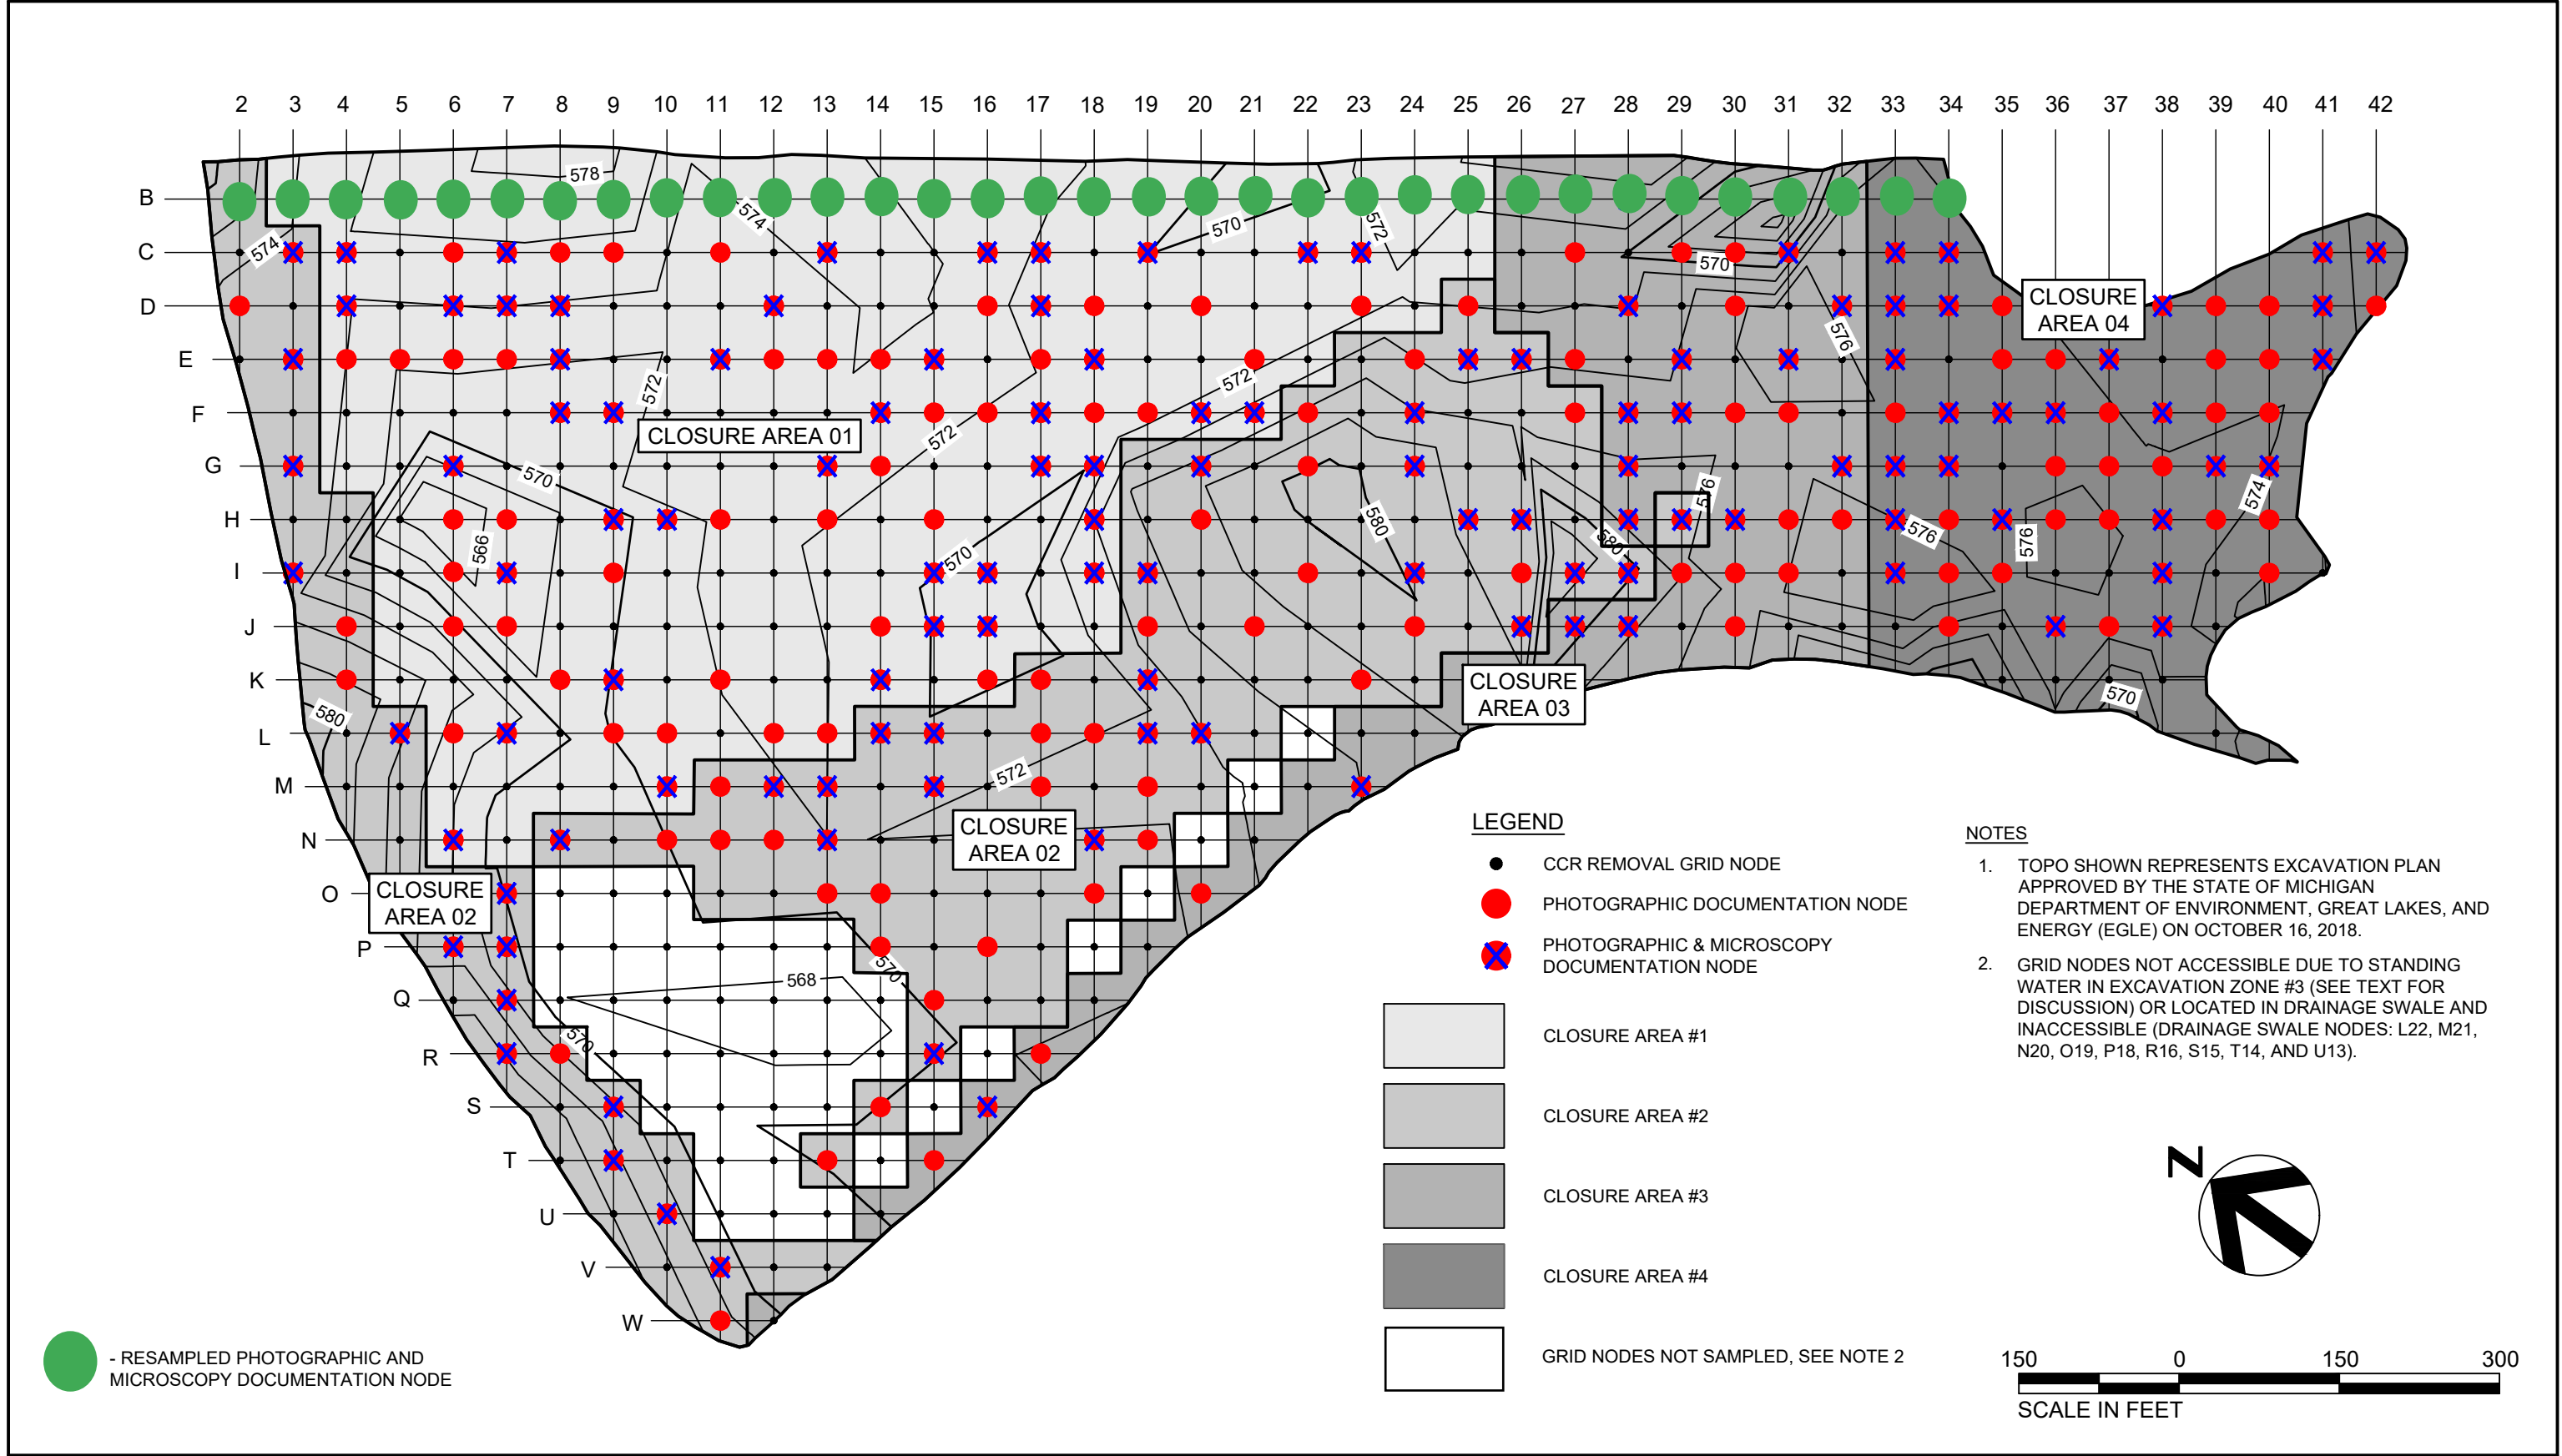
SAMPLE NODE LAYOUT

Further information about the original sampling of the B-series nodes is presented in the CCR Removal Report (Ref. [2]) and Supplement No. 1 (Ref. [3]). The B-series node locations where resampling was performed to collect the follow-up samples are shown on Figure 1.

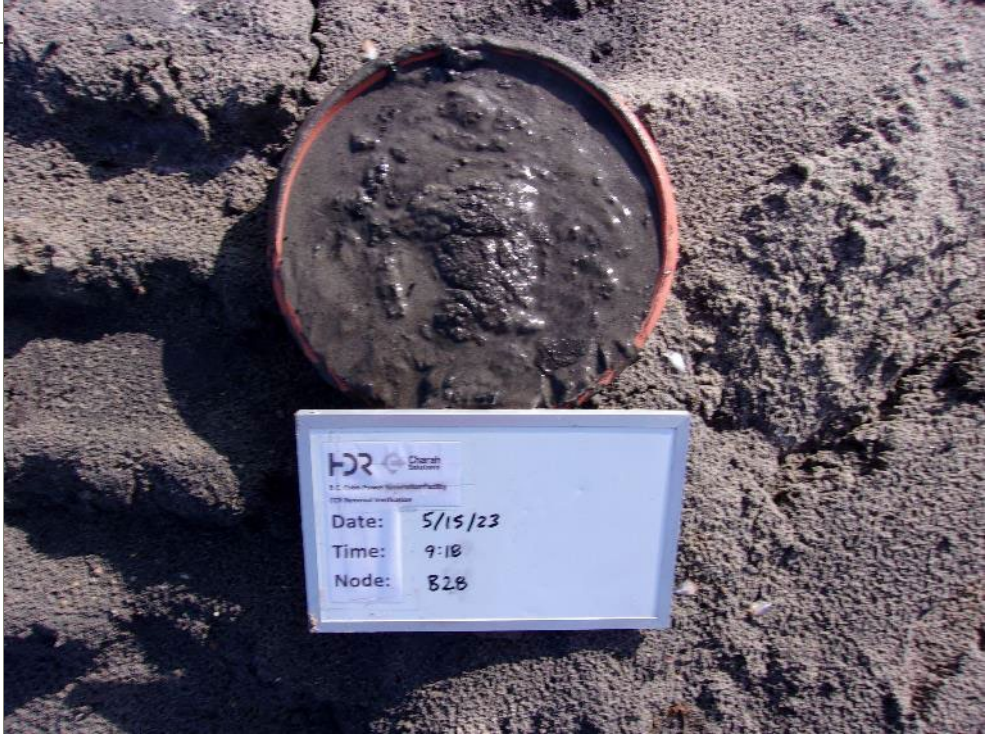
Node: B28R  HDR Microscopic Quantification Result: 1-2%		
<b>Photograph No. 28</b>	 	
Node: B29R  HDR Microscopic Quantification Result: 2-3%

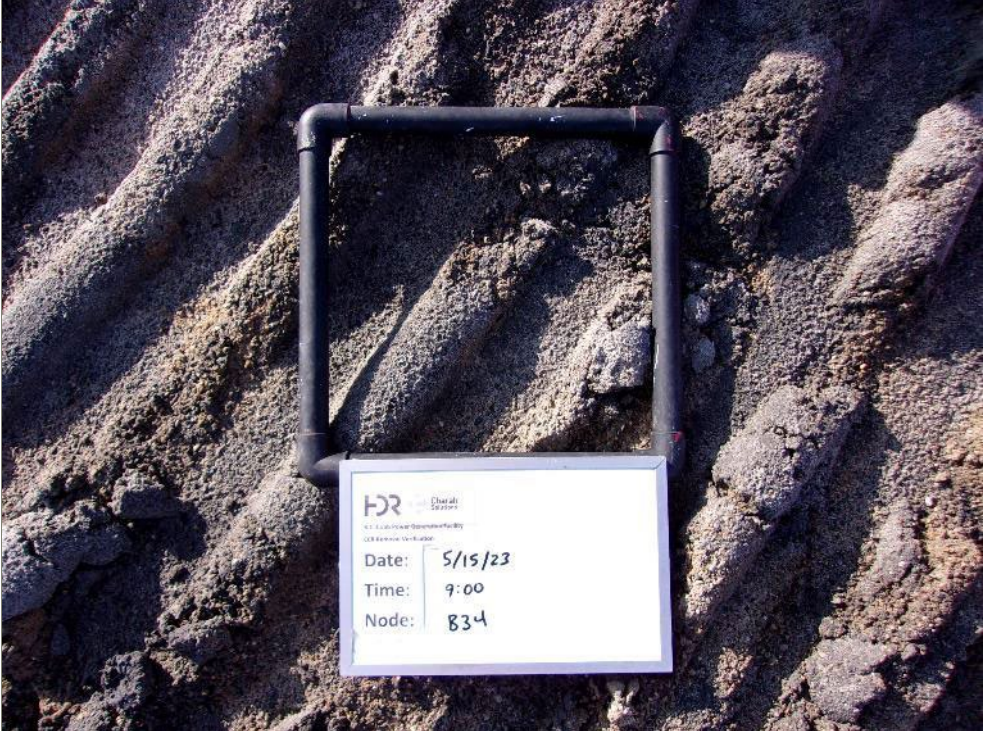
Client Name:	Site Location:	Node Photographic Log
Muskegon Environmental Redevelopment Group, LLC (MERG)	Former B.C. Cobb Power Plant Bottom Ash Pond and Ponds 0-8 Muskegon, Michigan	HDR Project No. 10220433
<div data-bbox="175 384 423 415"> <b>Photograph No. 33</b> </div> <div data-bbox="131 457 399 615"> Node: B34R   HDR Microscopic Quantification Result:  2-3% </div>

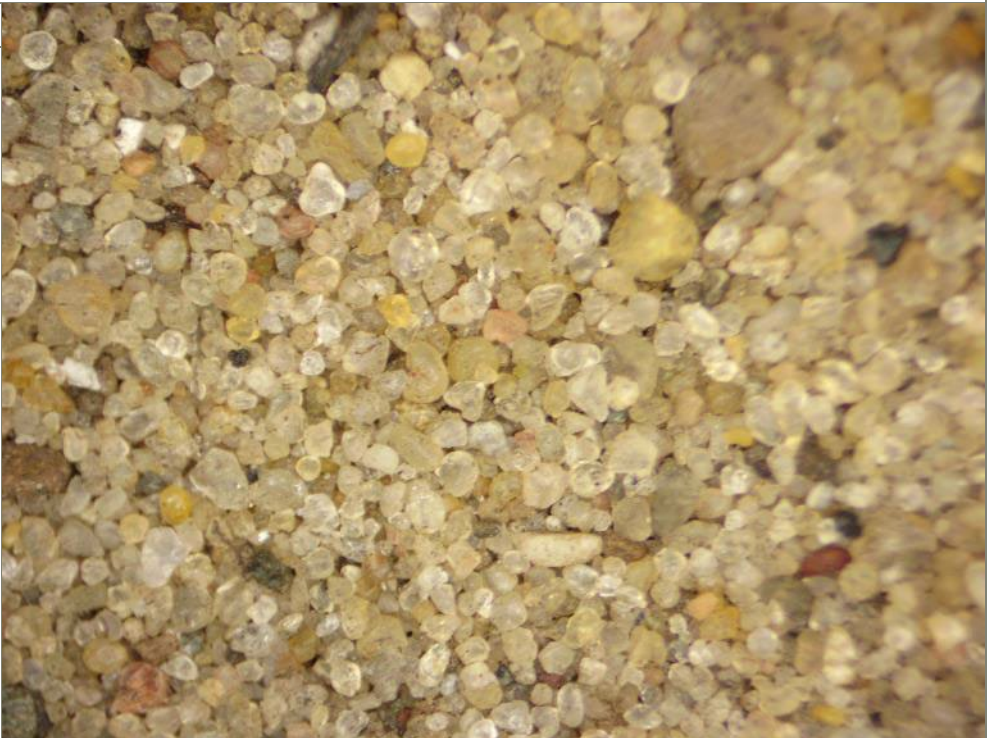
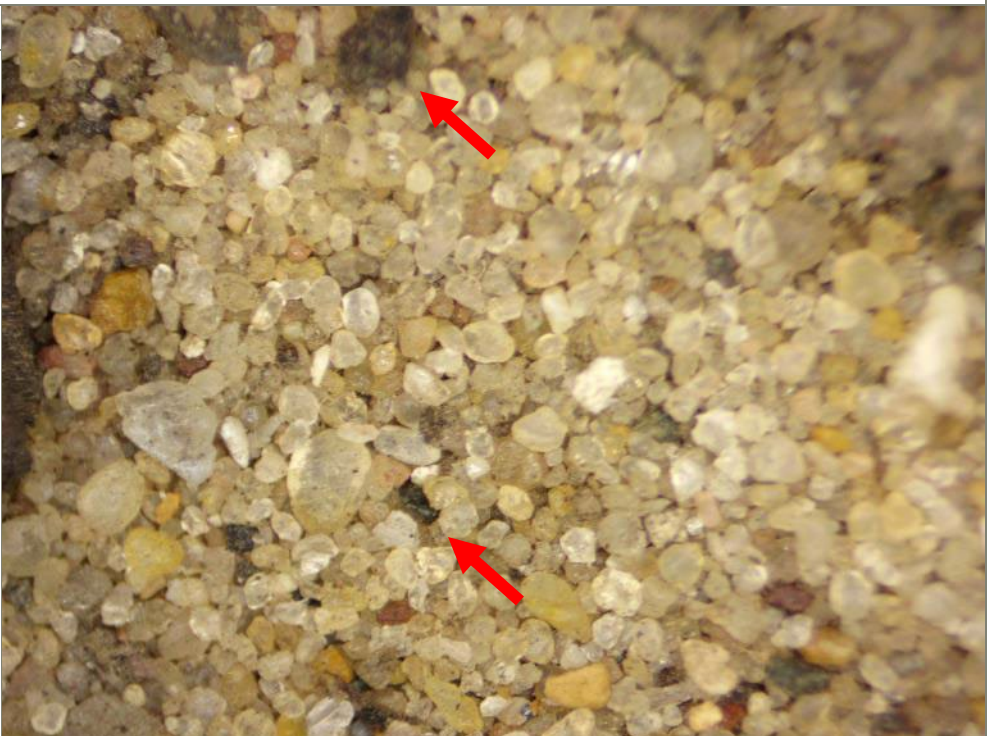
Client Name:	Site Location:	Microscopic Photographic Log
Muskegon Environmental Redevelopment Group, LLC (MERG)	Former B.C. Cobb Power Plant Bottom Ash Pond and Ponds 0-8 Muskegon, Michigan	HDR Project No. 10220433
<div data-bbox="180 384 412 415"><b>Photograph No. 1</b></div> <div data-bbox="131 457 464 741"> <p>Node: B2R</p> <p>HDR Microscopic Quantification Result: 1-2%</p> <p>Note: Light colored and transparent quartz. Scarce CCR present.</p> </div>		
<div data-bbox="180 1161 412 1192"><b>Photograph No. 2</b></div> <div data-bbox="131 1234 464 1518"> <p>Node: B10R</p> <p>HDR Microscopic Quantification Result: 2-3%</p> <p>Note: Sporadic small CCR particles (red arrows) mixed with clean sand.</p> </div>

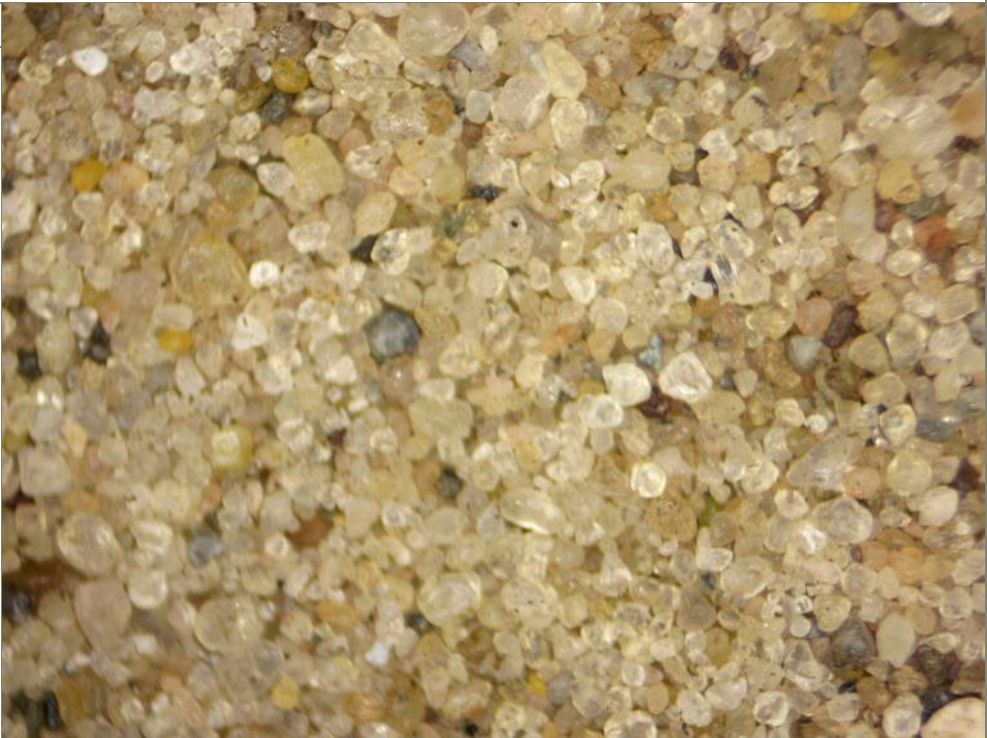
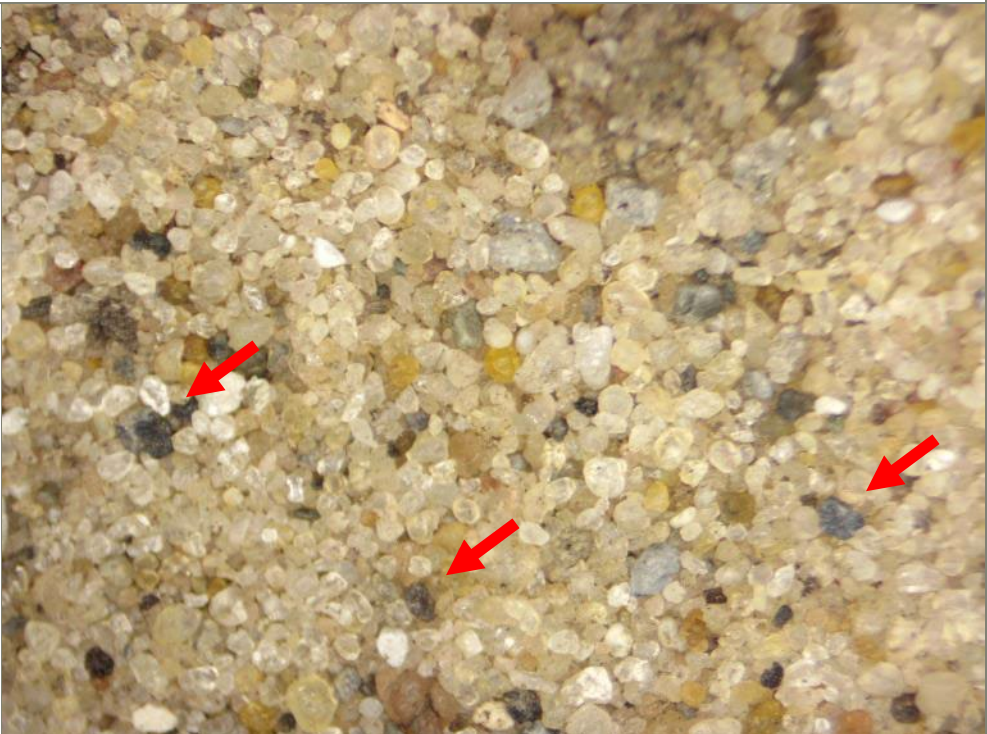
Client Name:	Site Location:	Microscopic Photographic Log
Muskegon Environmental Redevelopment Group, LLC (MERG)	Former B.C. Cobb Power Plant Bottom Ash Pond and Ponds 0-8 Muskegon, Michigan	HDR Project No. 10220433
<div data-bbox="131 380 464 422"> <b>Photograph No. 5</b> </div> <div data-bbox="131 453 464 743"> <p>Node: B24R</p> <p>HDR Microscopic Quantification Result: &lt;1%</p> <p>Note: Light colored and transparent quartz. Scarce CCR present.</p> </div>		
<div data-bbox="131 1157 464 1199"> <b>Photograph No. 6</b> </div> <div data-bbox="131 1230 464 1551"> <p>Node: B29R</p> <p>HDR Microscopic Quantification Result: 2-3%</p> <p>Note: Sporadic small CCR particles (red arrows) present mixed with clean sand.</p> </div>
