2024 Annual Inspection Report

For Compliance with the EPA Coal
Combustion Residuals (CCR) Rule
40 CFR §257.83(b)

Former B.C. Cobb Power Plant
Ponds 0-8 and Bottom Ash Pond

May 17, 2024

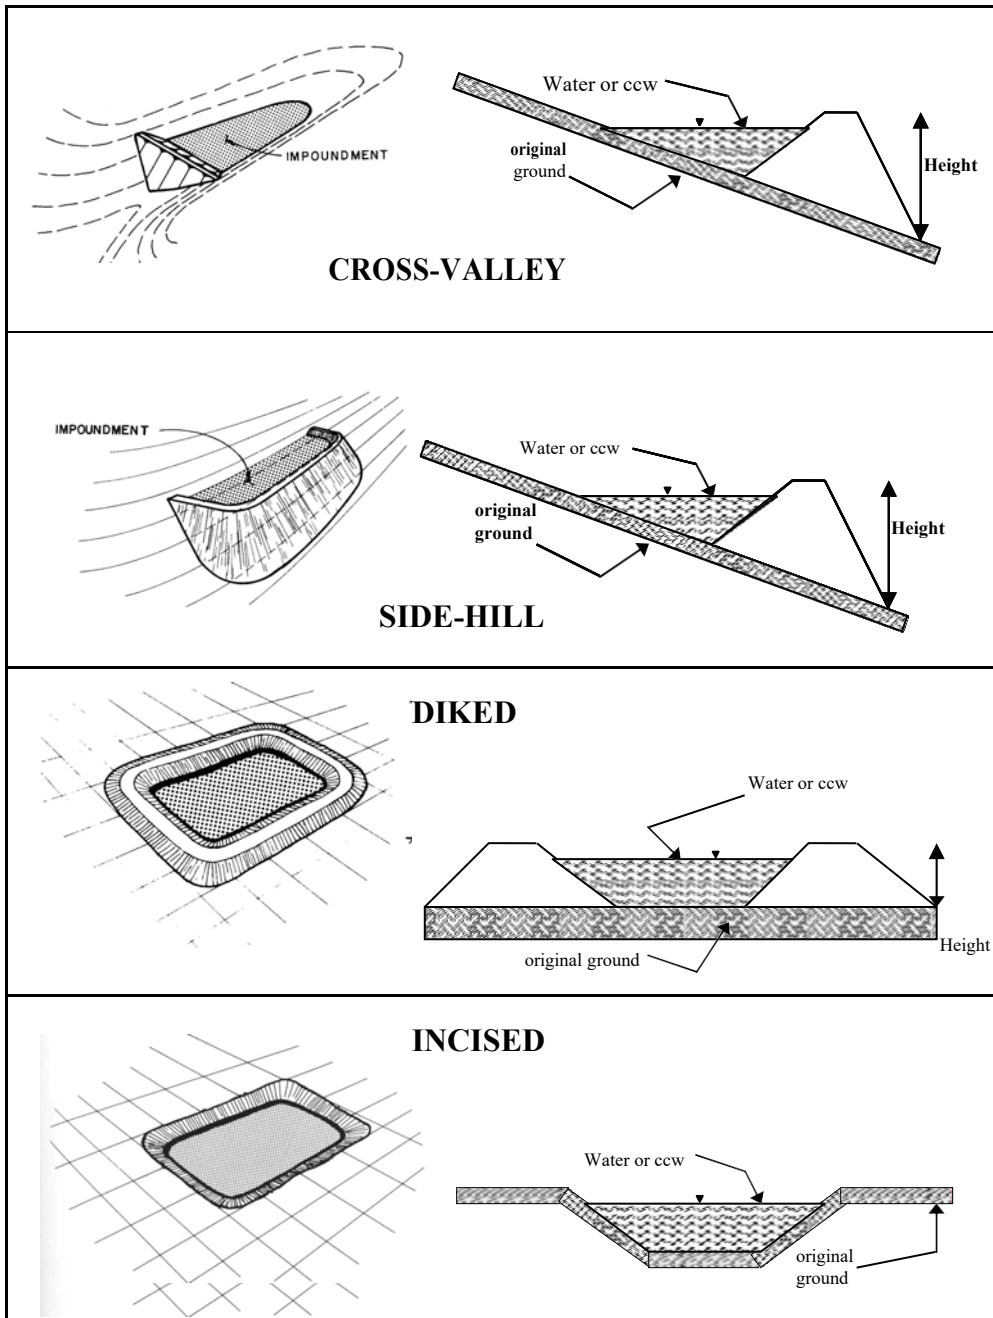
CONFIGURATION:

Cross-Valley
 Side-Hill
 Diked
 Incised (form completion optional)
 Combination Incised/Diked
 Embankment Height 10-12 feet Embankment Material: Sand/CCR
 Pool Area N/A acres Liner: No
 Current Freeboard N/A feet Liner Permeability: N/A

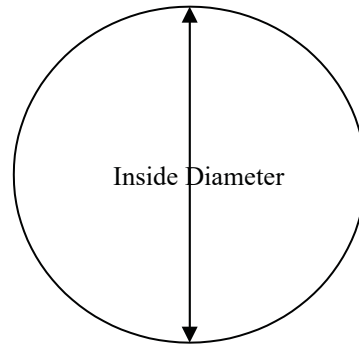
- corrugated metal
- welded steel
- concrete
- X plastic (hdpe, pvc, etc.)
- other (specify) _____

Is water flowing through the outlet? YES NO X

No Outlet
