CCR Removal Report

Supplement No. 3

Former B.C. Cobb Power Plant
Bottom Ash Pond and Ponds 0-8

December 7, 2023

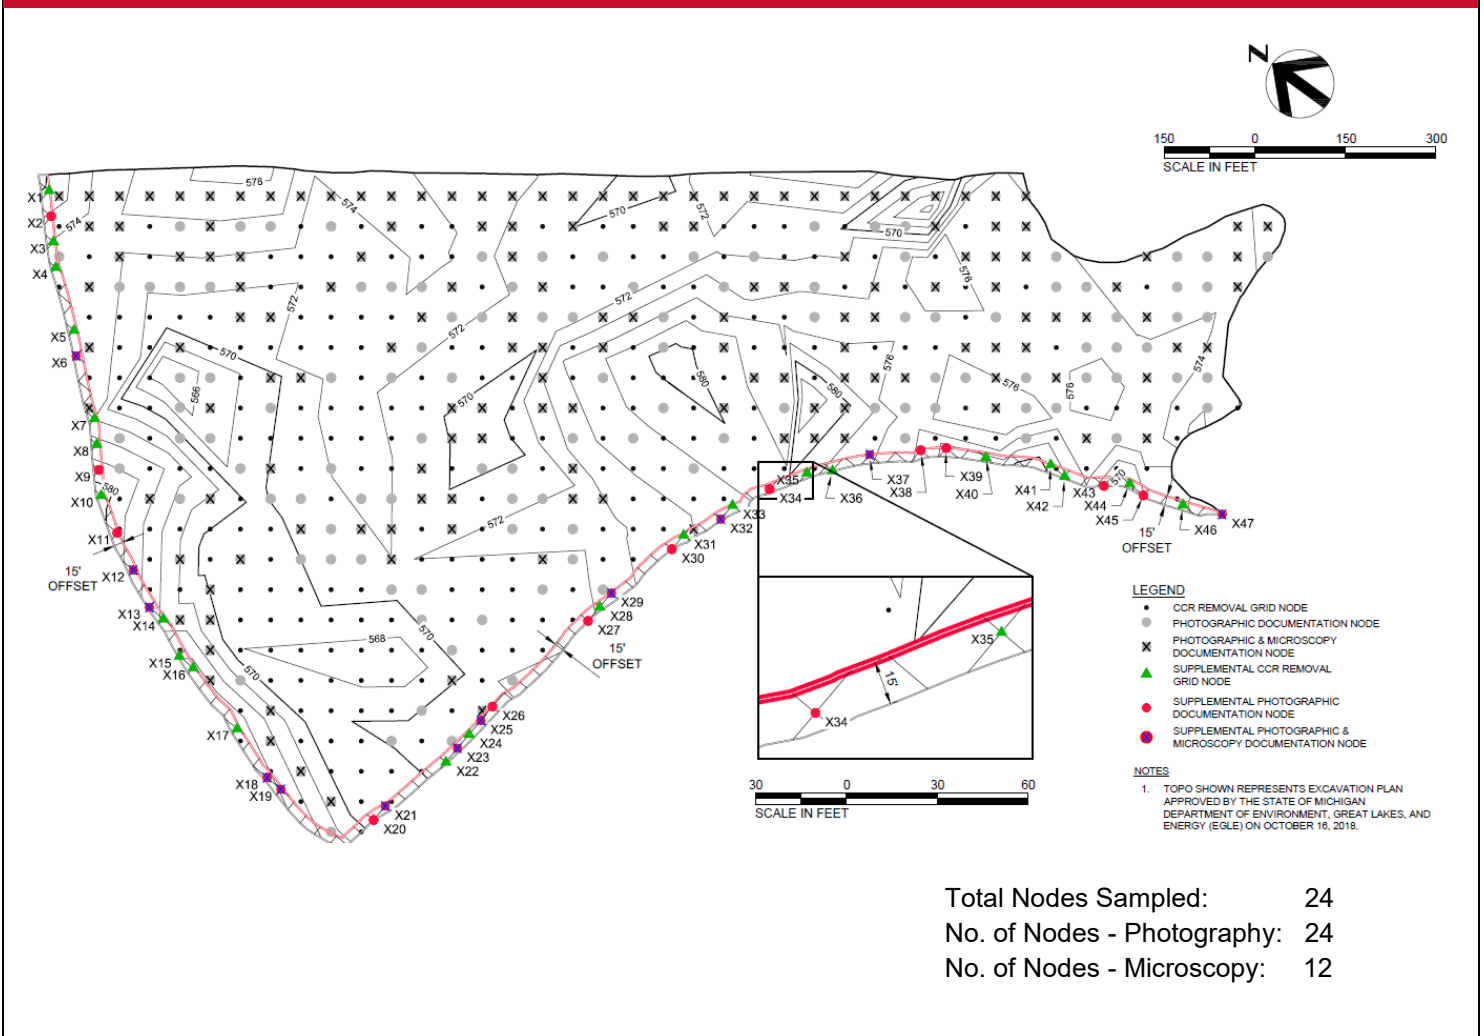
AREA INSPECTED

- The excavation has been inundated with water after the completion of slope repairs.
- The node areas that were visible in shallow water depths consisted of natural sands.
- Depths of water at the node locations ranged from approximately 2-4 feet.
