Emergency Action Plan for Coal Combustion Residuals Units

B. C. Cobb Facility

Prepared for
Muskegon Environmental Redevelopment Group, LLC

June 2021

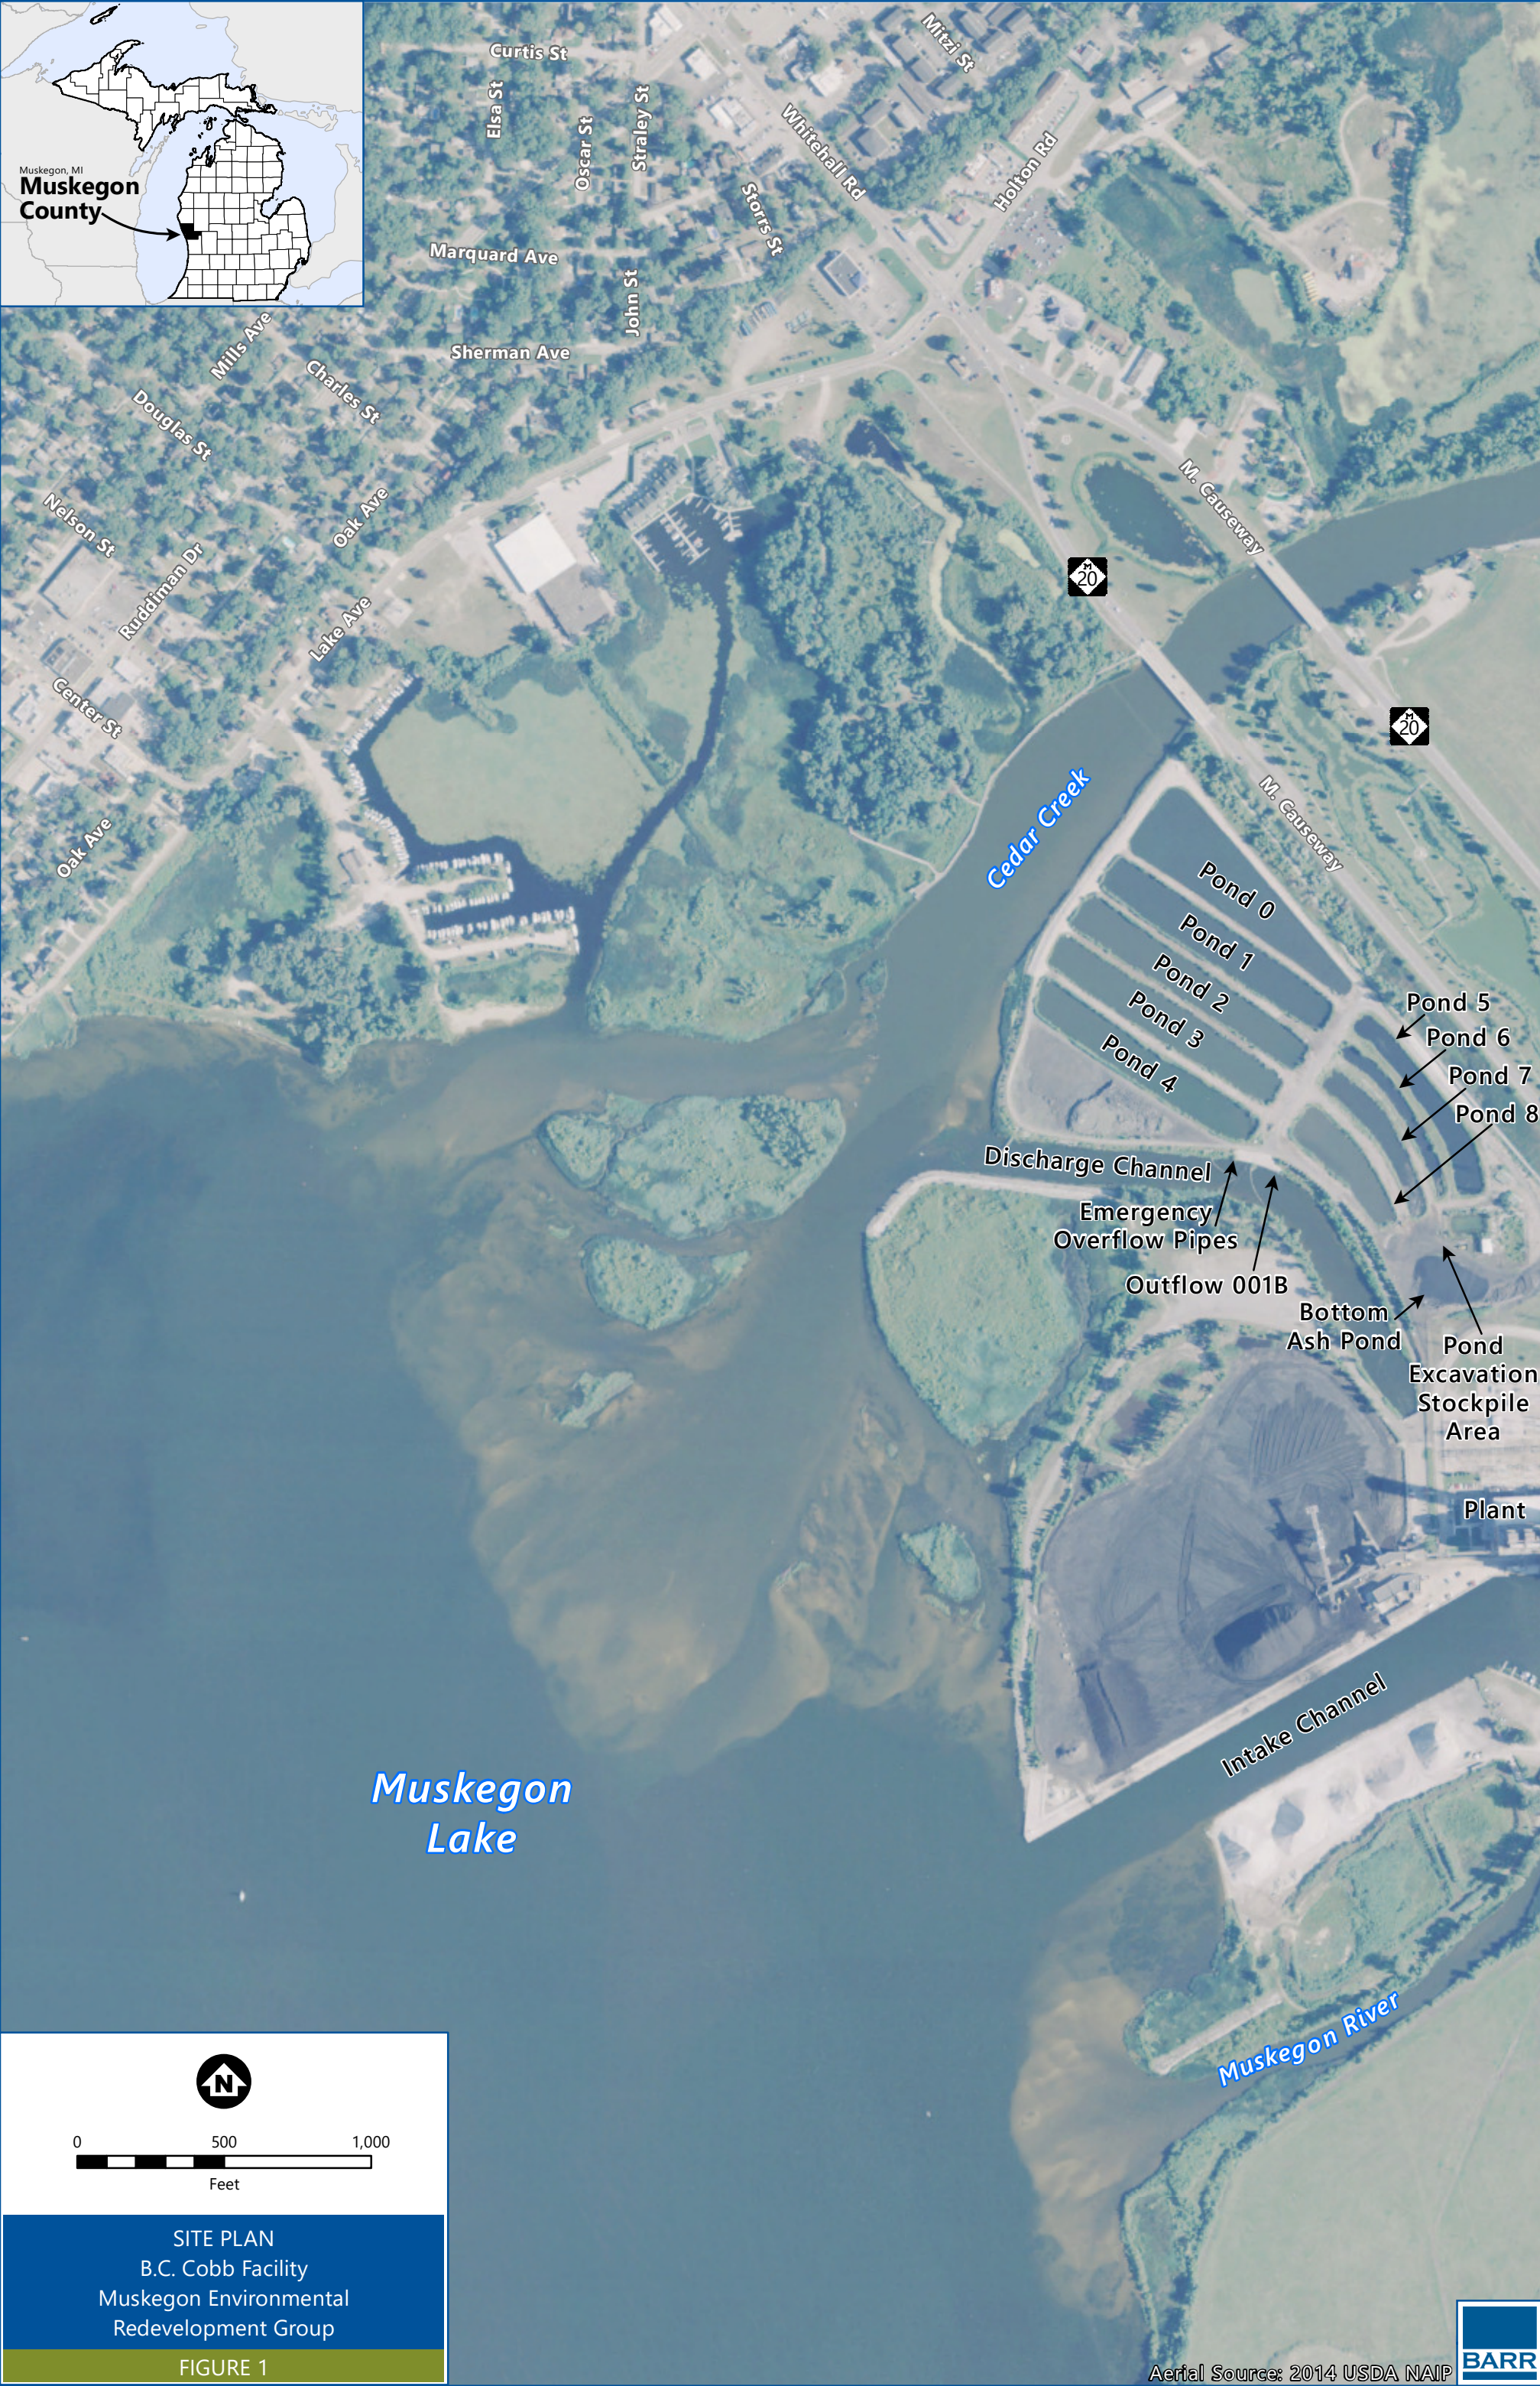
FIGURE 1

SITE PLAN
B.C. Cobb Facility
Muskegon Environmental
Redevelopment Group

The B. C. Cobb (BCC) facility, located in Muskegon, Michigan (refer to Figure 1), and owned by Muskegon Environmental Redevelopment Group, LLC (MERG), stores coal combustion residuals (CCR) in surface impoundments. Two of BCC's CCR surface impoundments (CCR units), Ponds 0-8 and Bottom Ash Pond, have been classified as "significant hazard potential CCR surface impoundments" (Golder, 2016a and Golder, 2016b). Therefore, pursuant to the United States Environmental Protection Agency's (EPA) 40 CFR Part 257 (specifically 40CFR§257.73(a)(3)(i)), this facility must prepare and maintain a written Emergency Action Plan (EAP). The purpose of the EAP is to define emergencies related to CCR surface impoundments, define responsible persons, and define notification procedures in the event of an emergency. The EAP must be completed and placed in the facility's operating record no later than April 17, 2017. 40CFR§257.73(a)(3)(i) requires that the owner or operator of the CCR Unit (EPA 2015):
